ICON
ARCHITECTURAL GROUP

FACILITY ASSESSMENT FOR DEVILS LAKE PUBLIC SCHOOLS

Devils Lake, ND

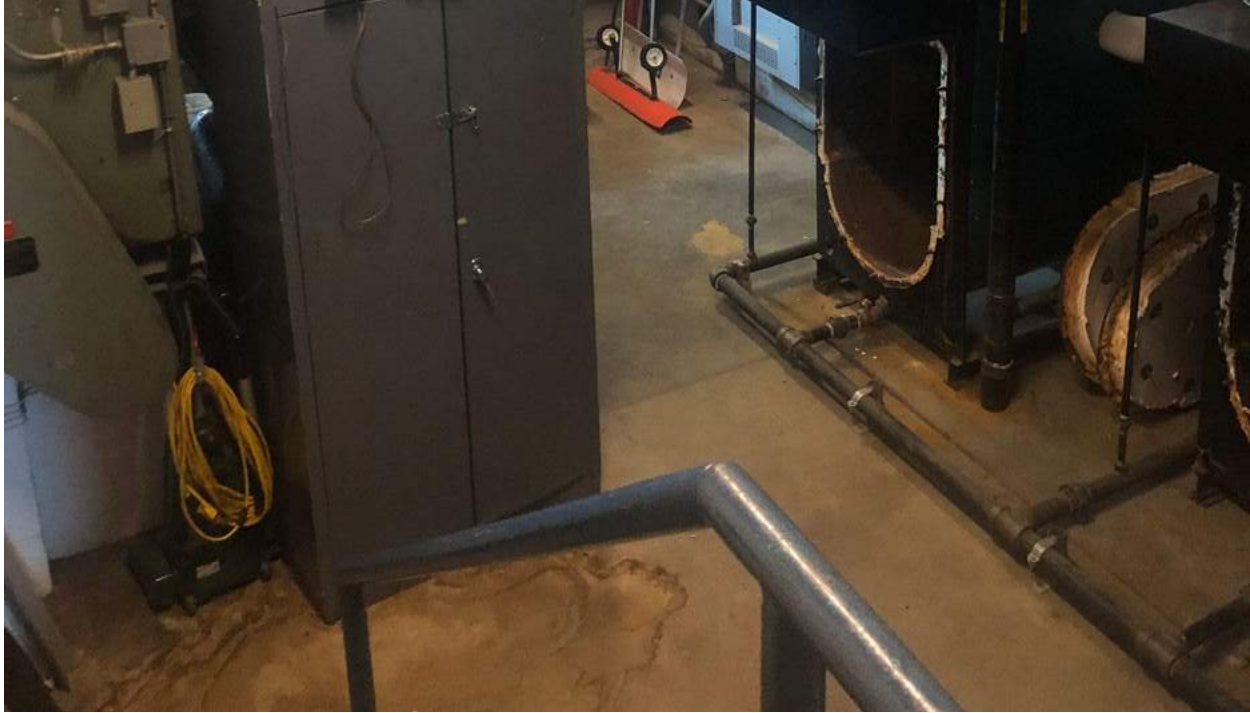
The boiler room is not handicap accessible. Existing stairs are not to code.

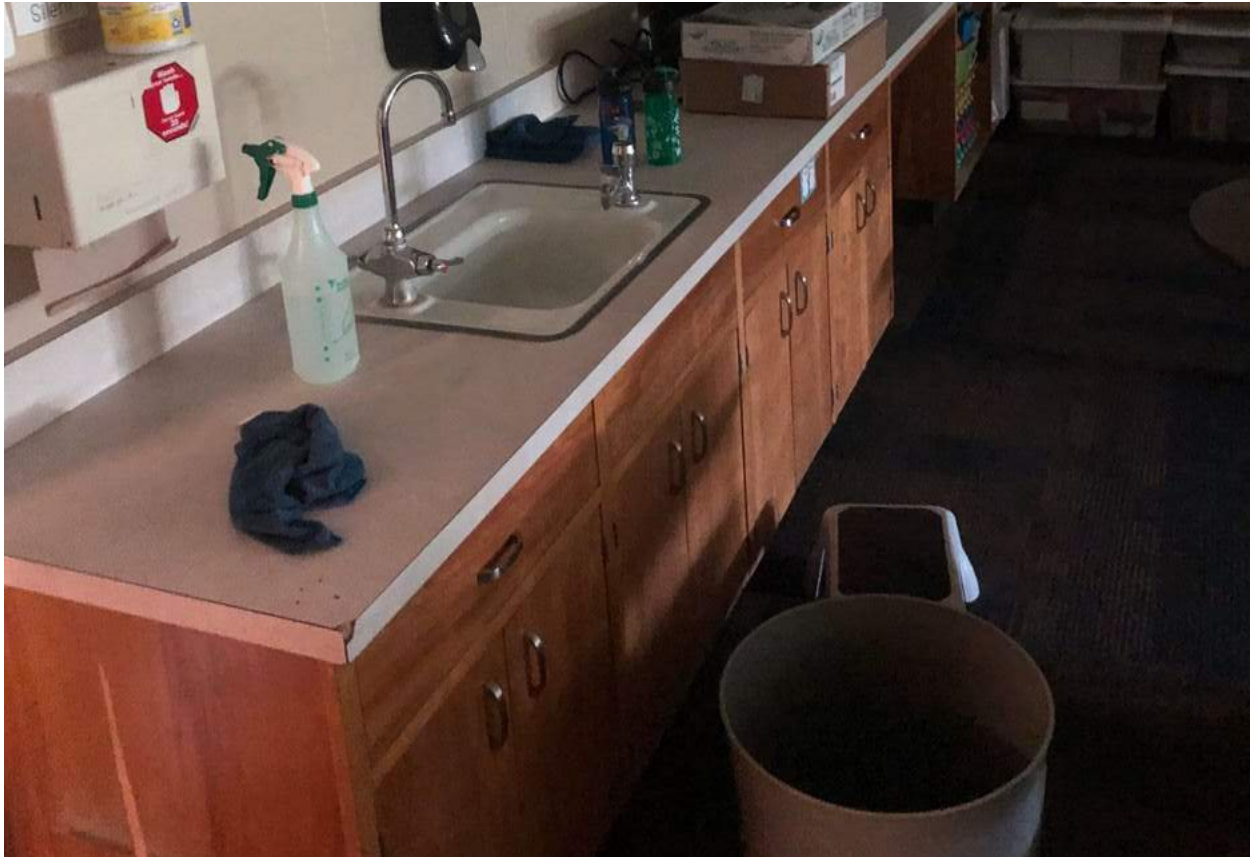
Sink has drinking fountain bubbler on it, which is not up to code and does not meet handicap accessibility clearances.

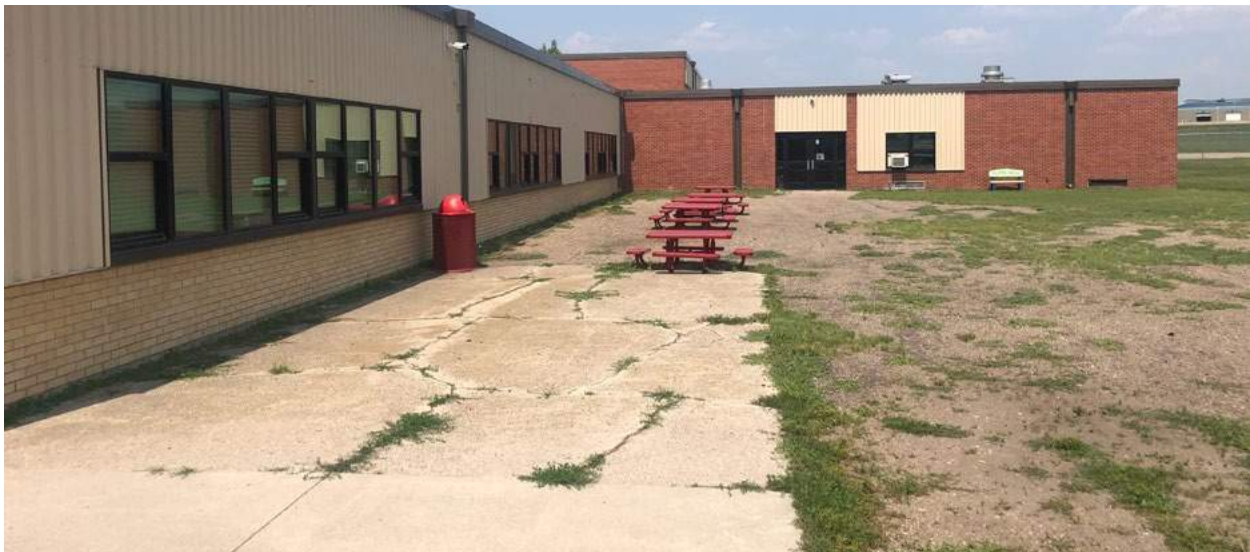
Cracked and settling concrete.

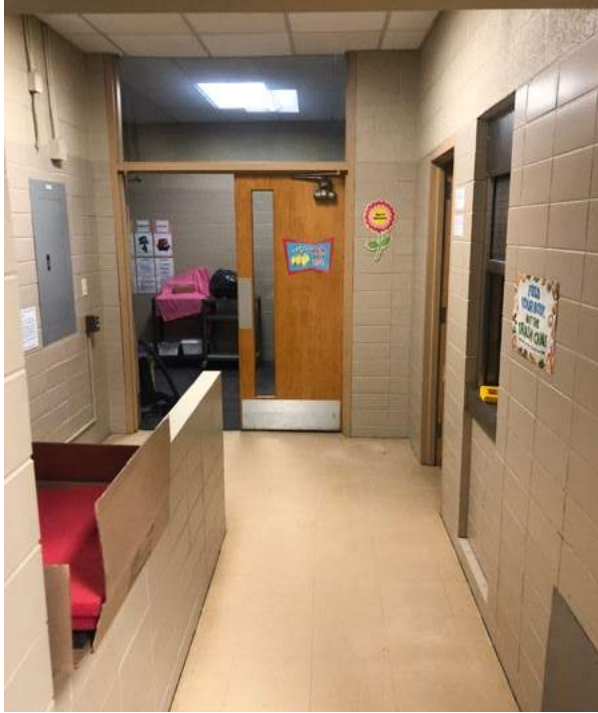
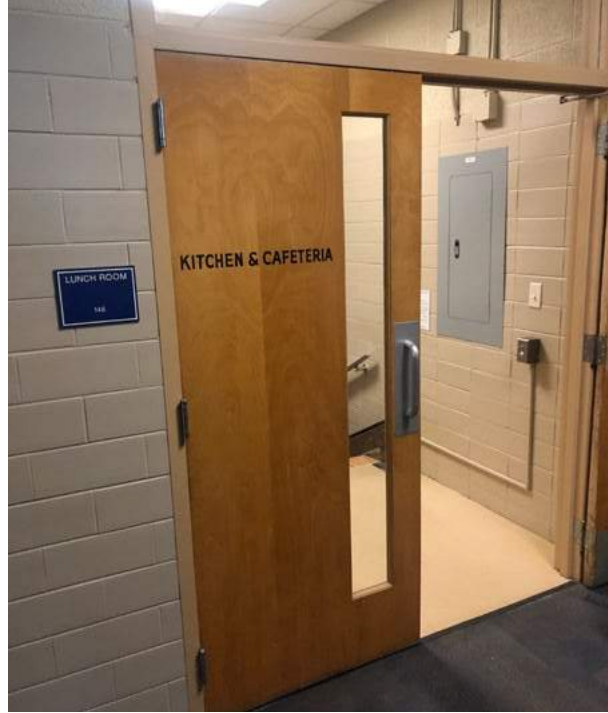
Doors and door hardware are aged and is not all code compliant.

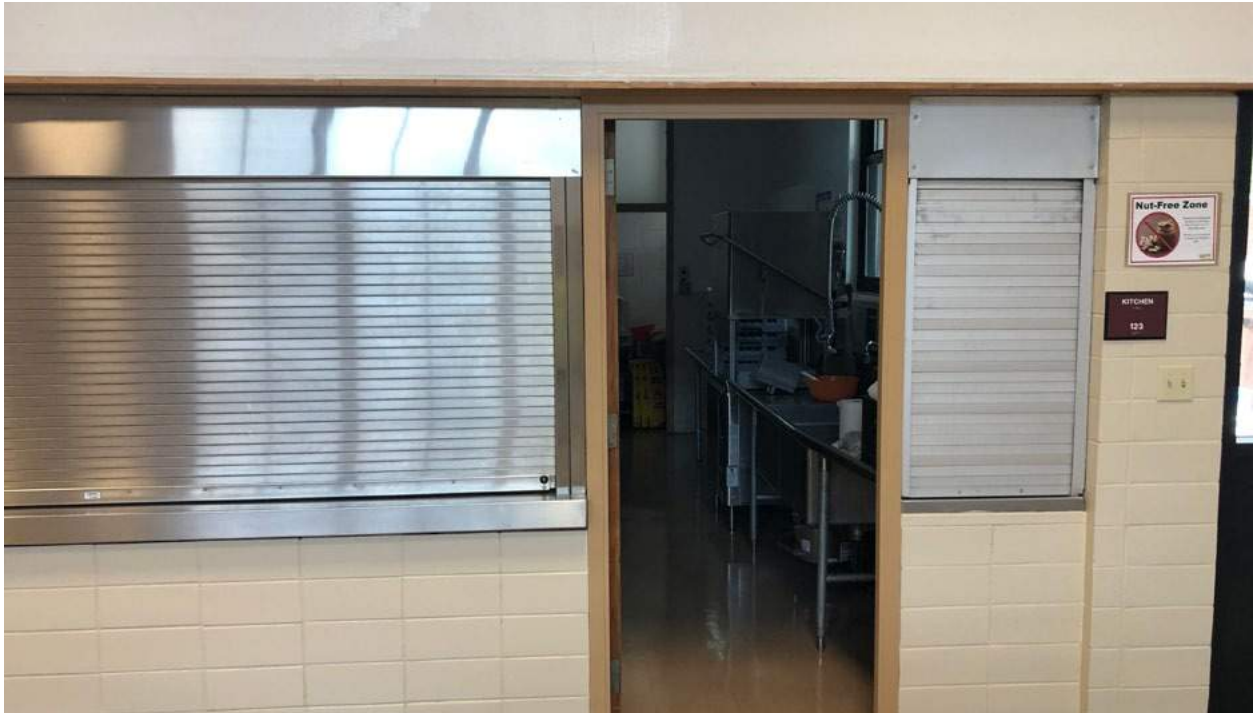
Door to kitchen does not meet push/pull clearance.

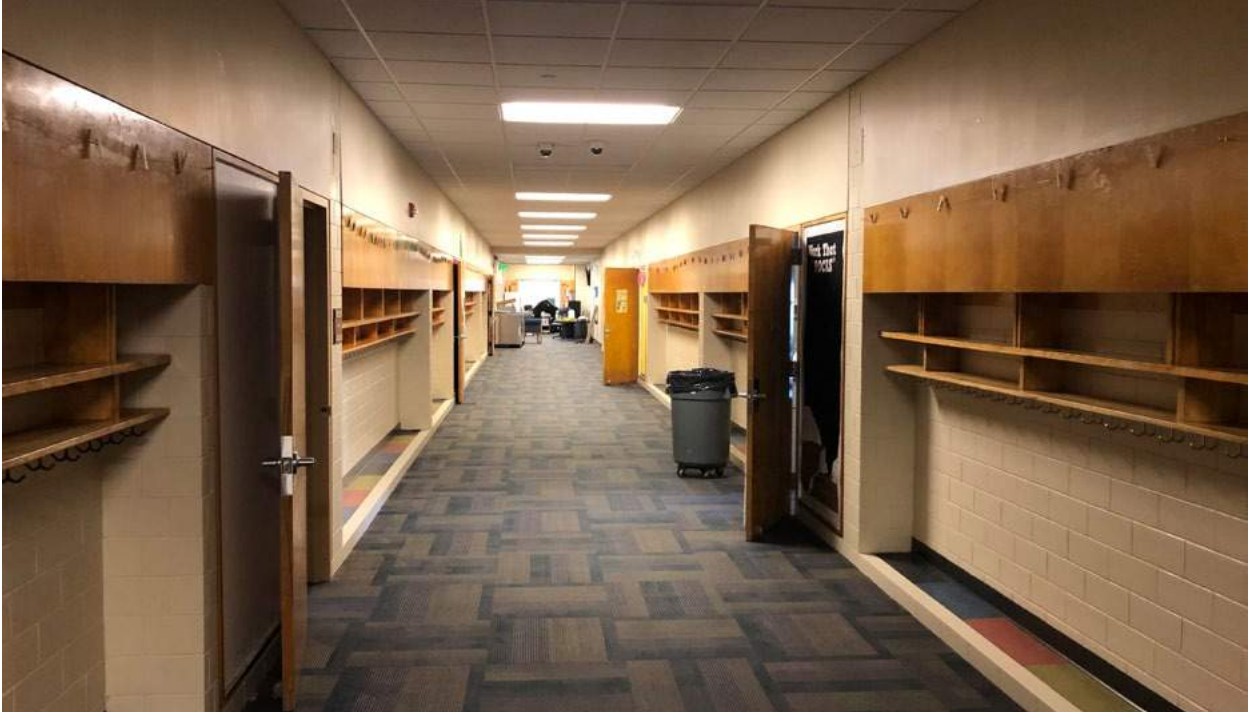
Casework is aged in corridors.

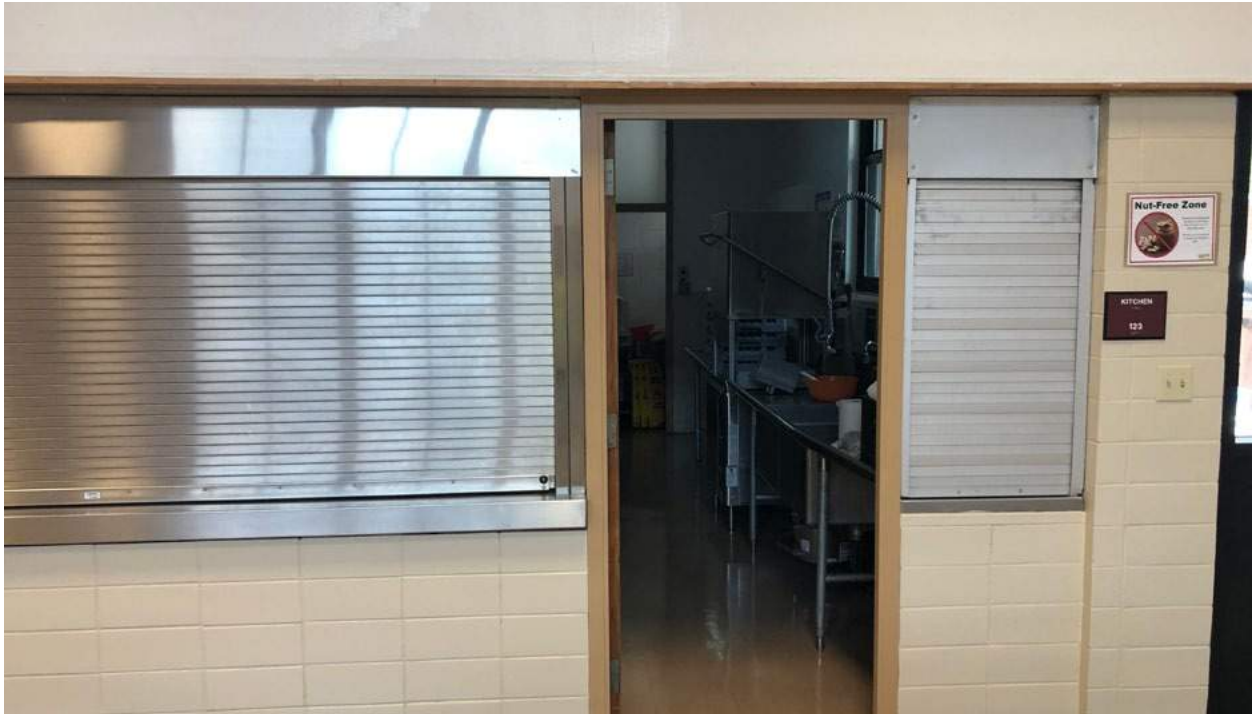
Door to kitchen does not meet push/pull clearance.

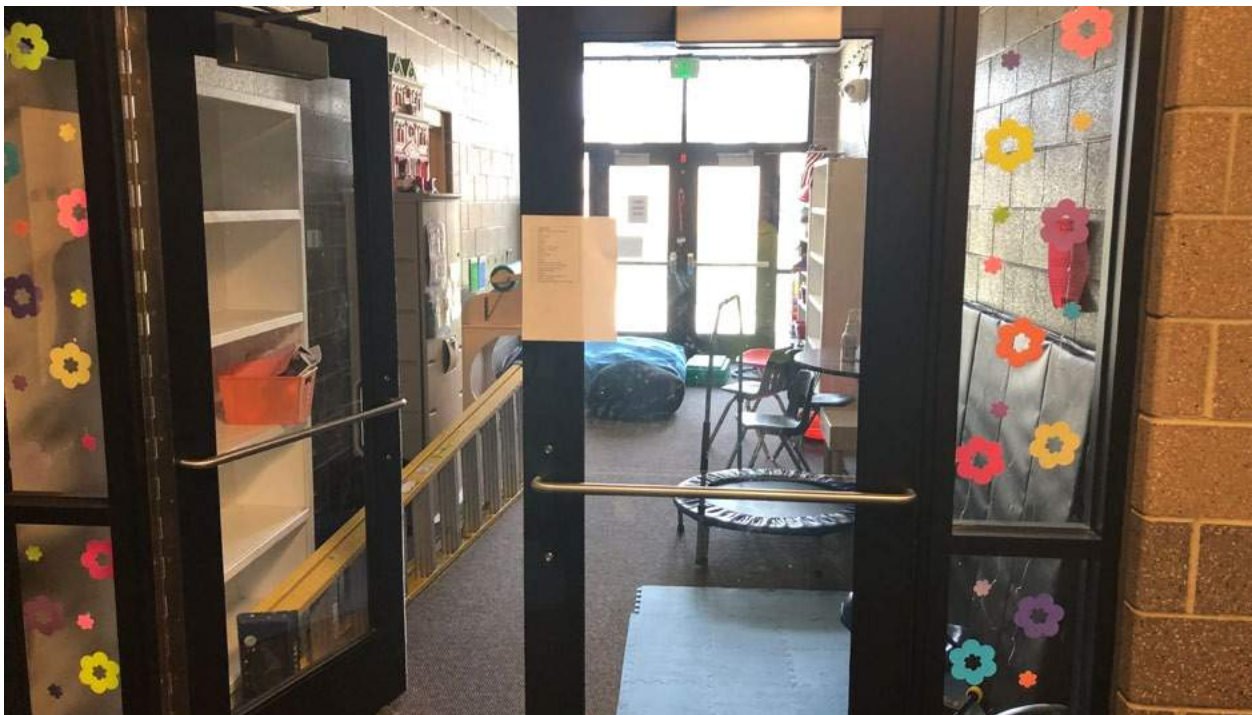
Exit vestibule used as a classroom space, does not meet fire code.

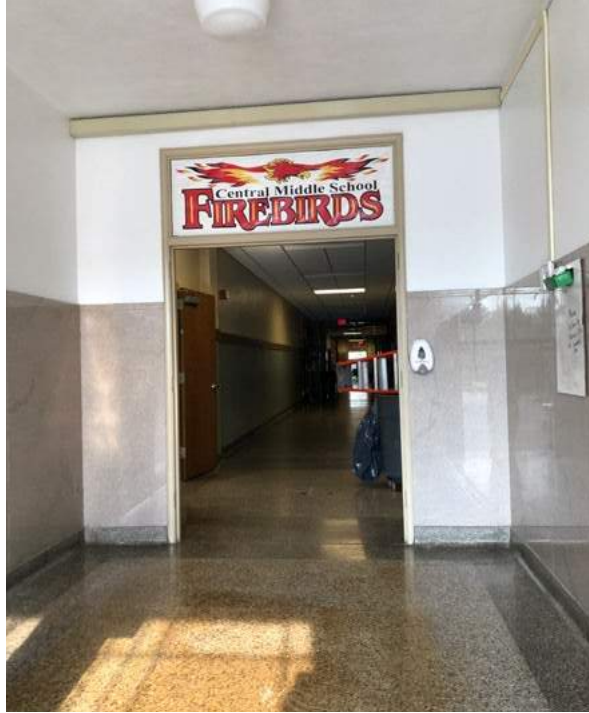
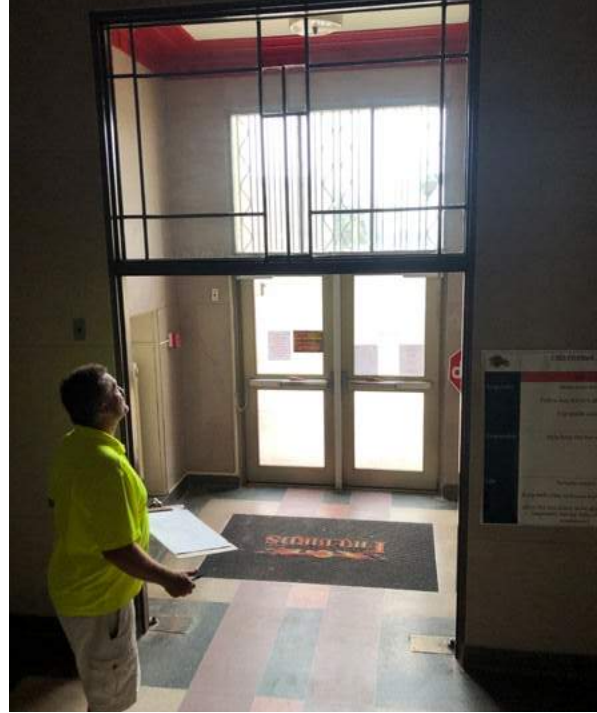
No interior vestibule doors.

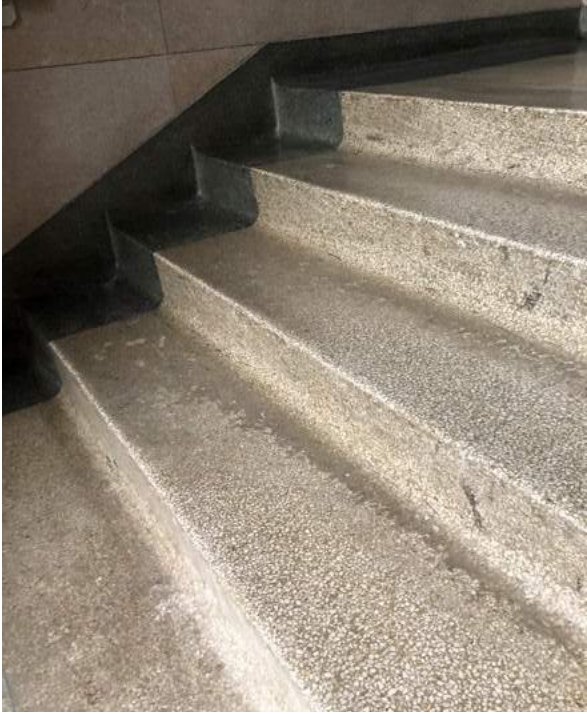
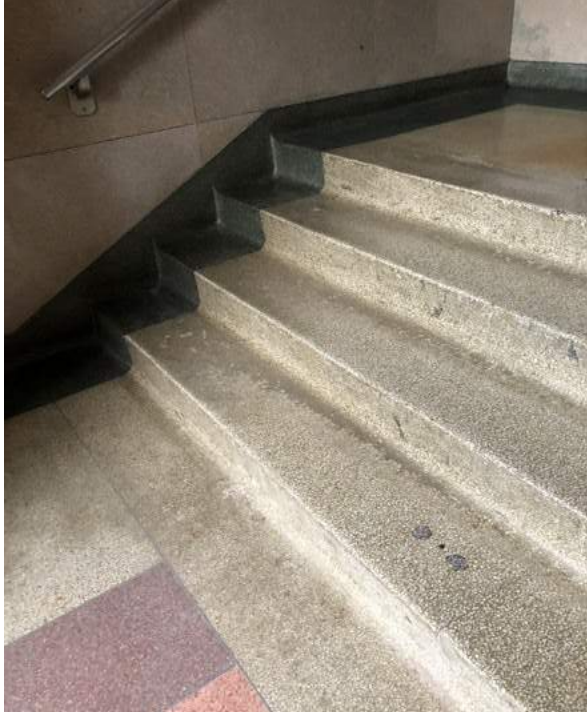
Terrazzo on steps is wearing.

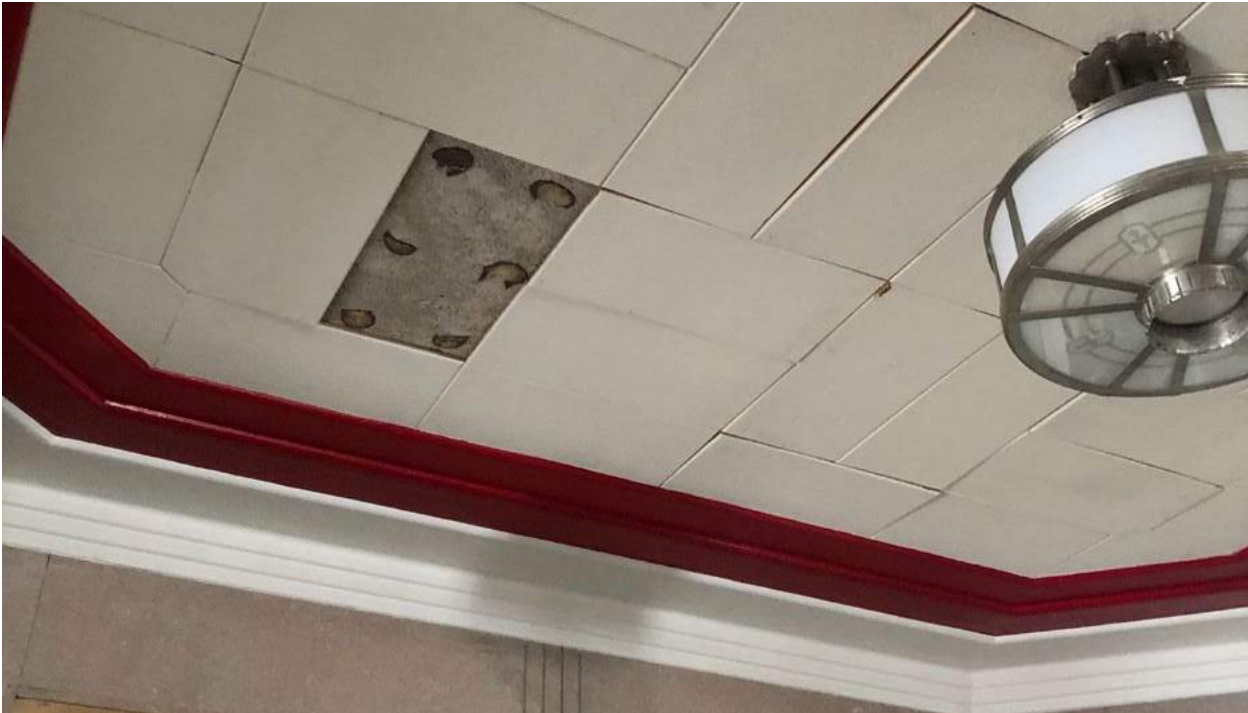
Missing ceiling tiles in main entrance area.

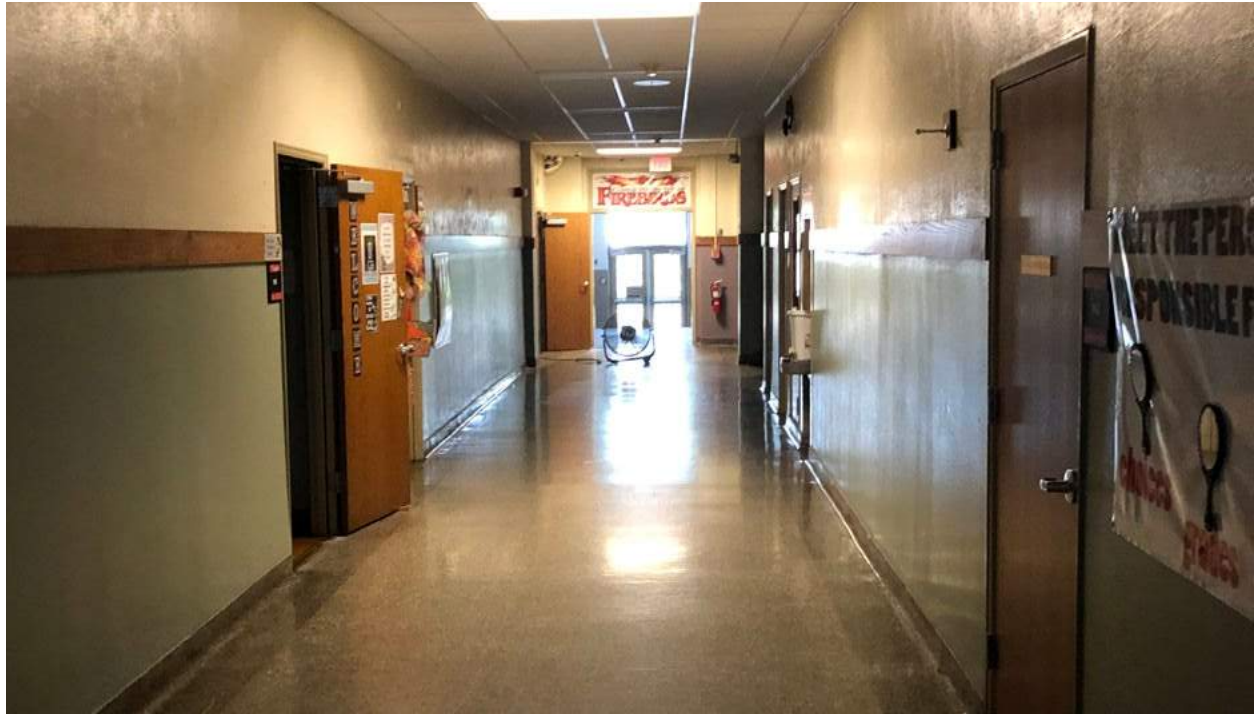
No sprinkler system throughout entire building.

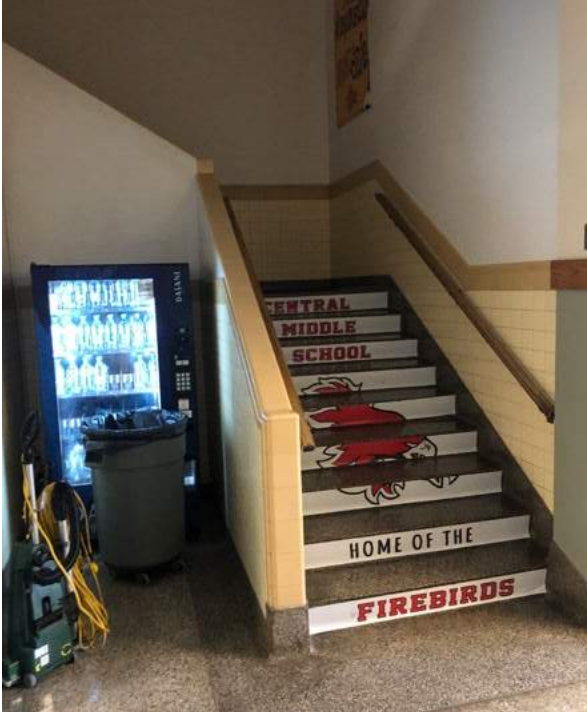
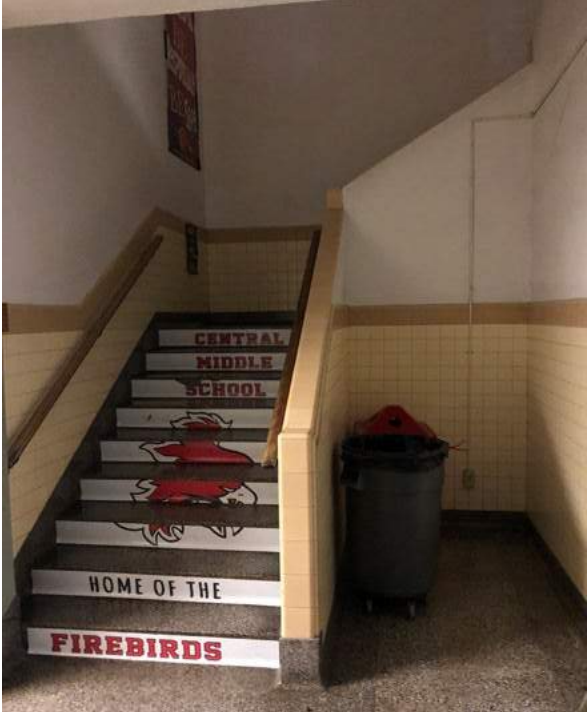
Staircases are not enclosed and do not lead directly to exterior. Handrail and guardrails are missing or not code compliant.

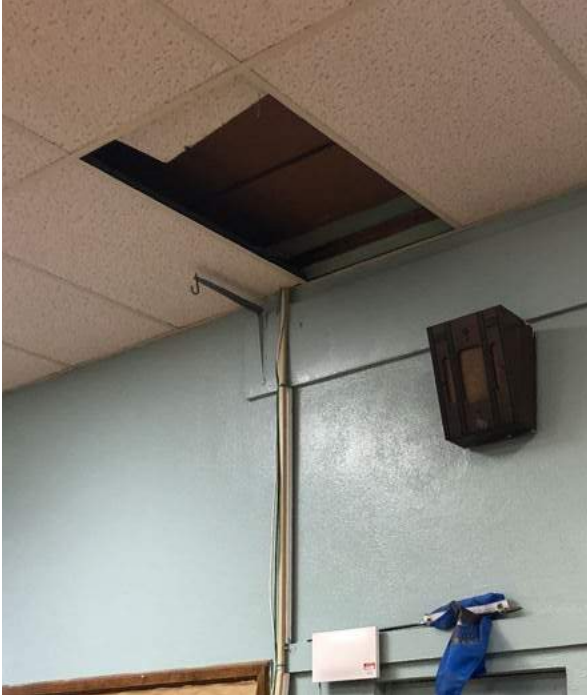
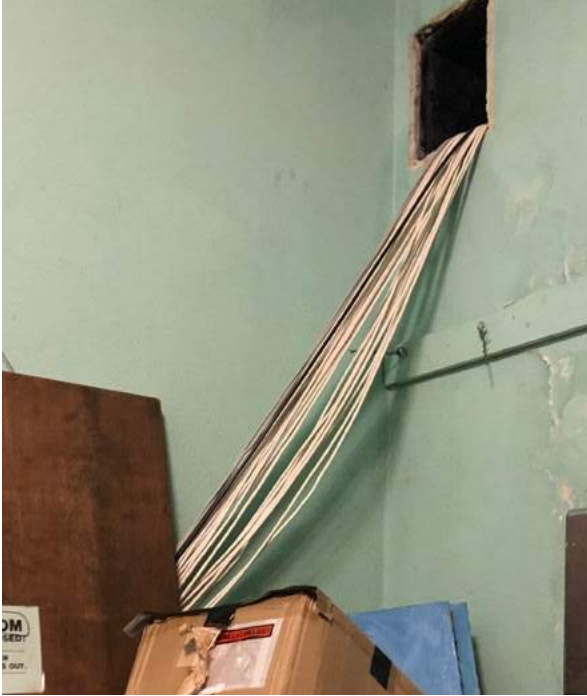
Missing ceiling tiles, and exposed wiring throughout the school.

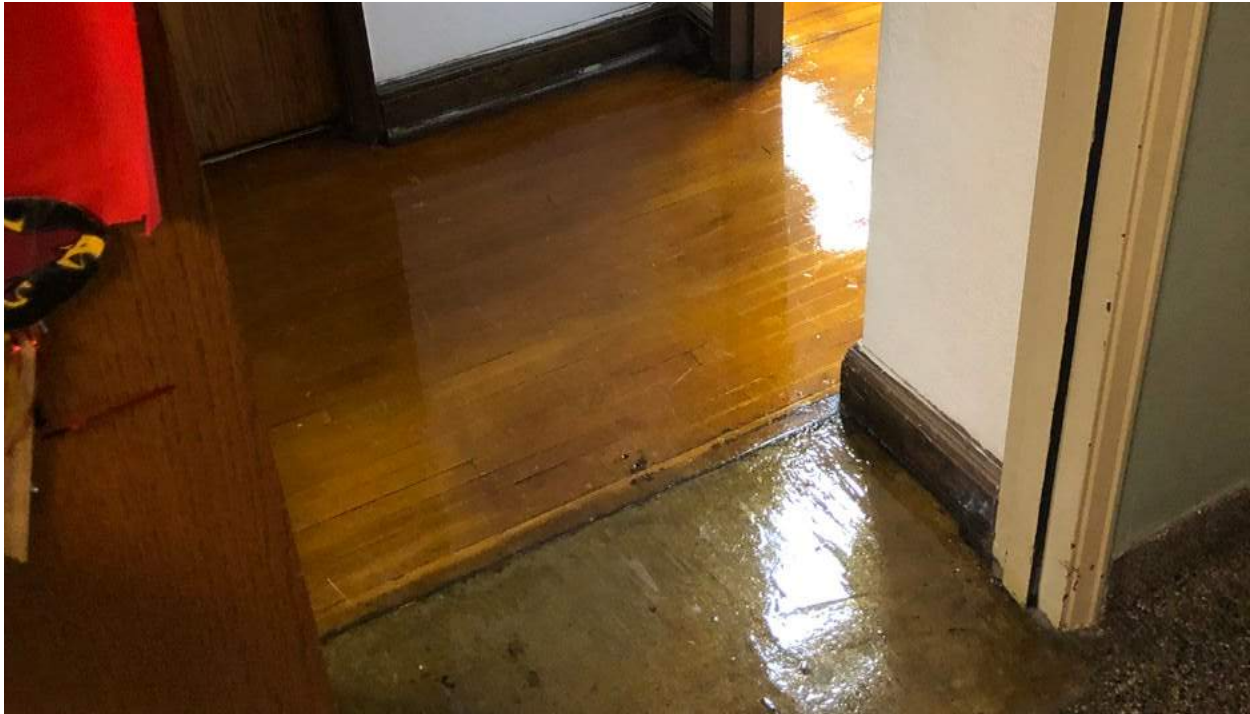
Classroom entrances are not wide enough for maneuverability clearances for ADA compliance.

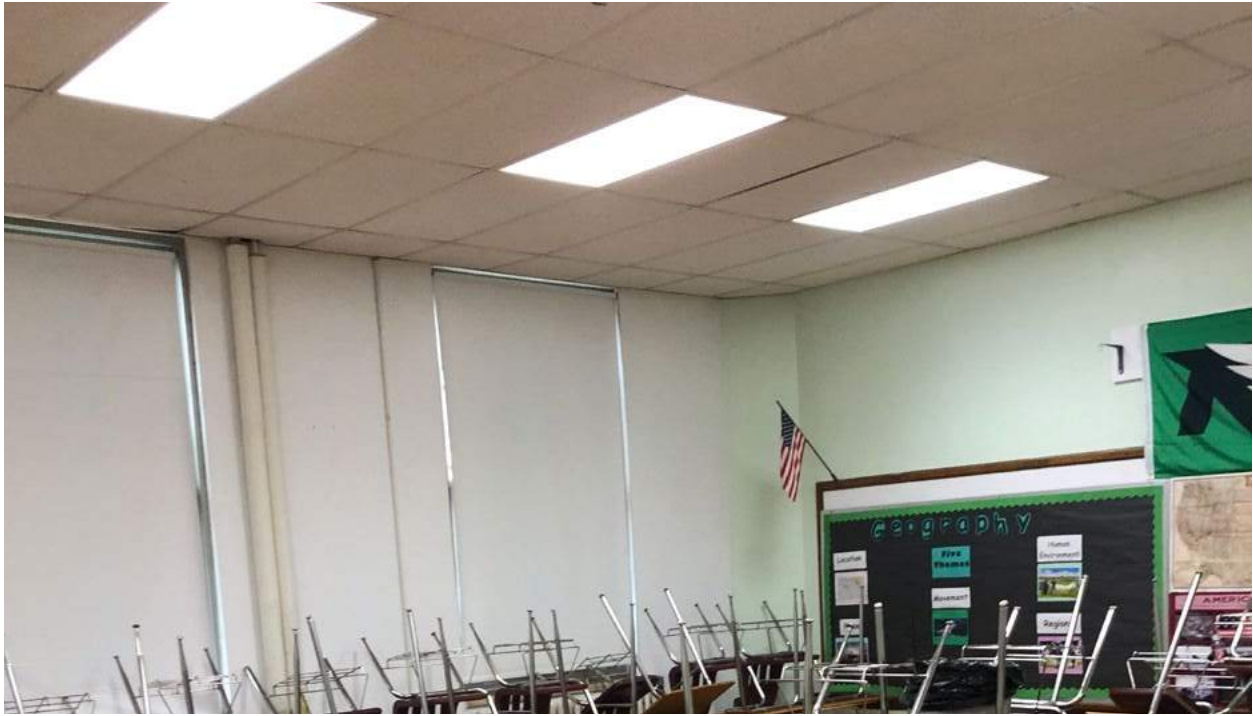
Ceiling tiles are in bad shape throughout the building.

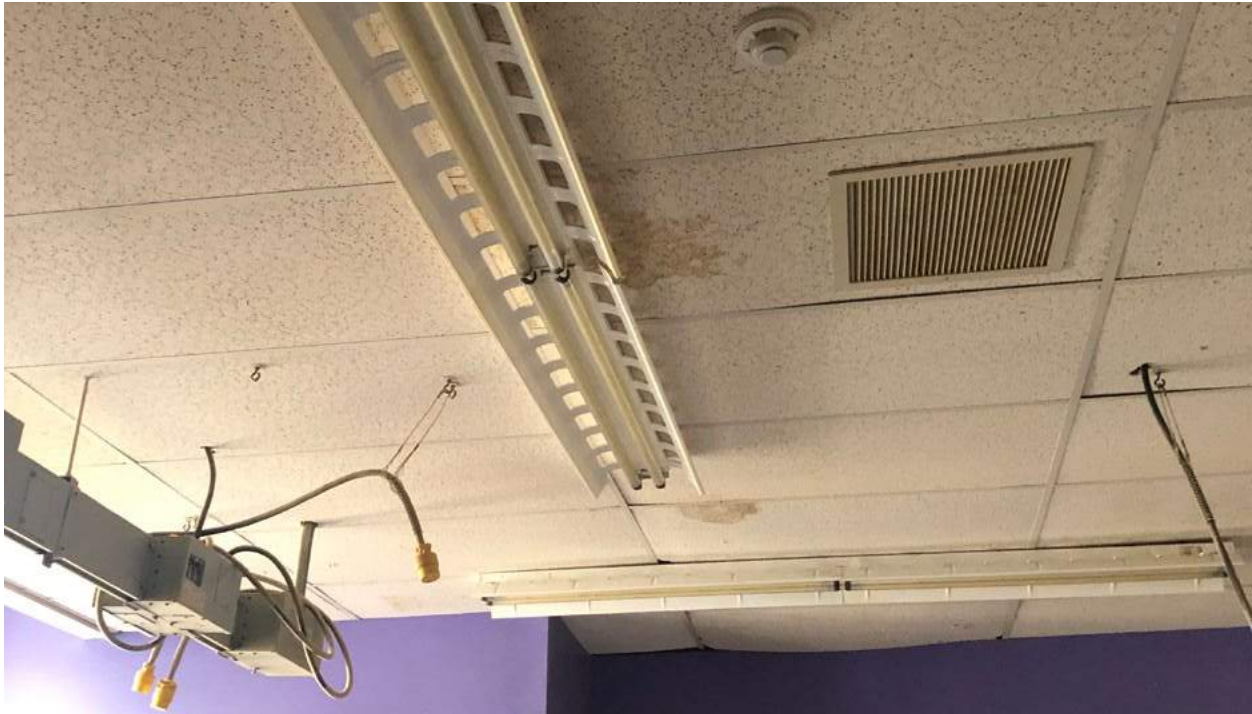
Room 104 Shop: Ceiling tiles in very bad shape. Water leaks on the ceiling.

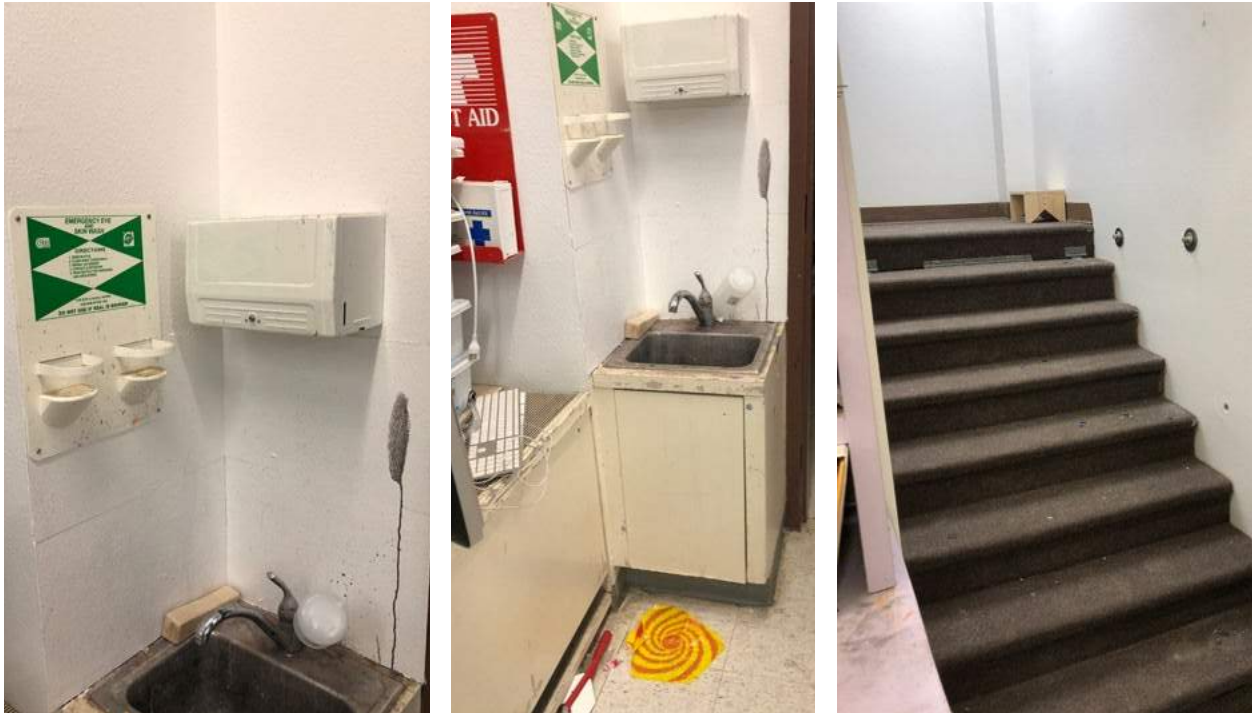
Room 104 stairs, sinks, and emergency eye wash station not up to code or handicap accessibility requirements.

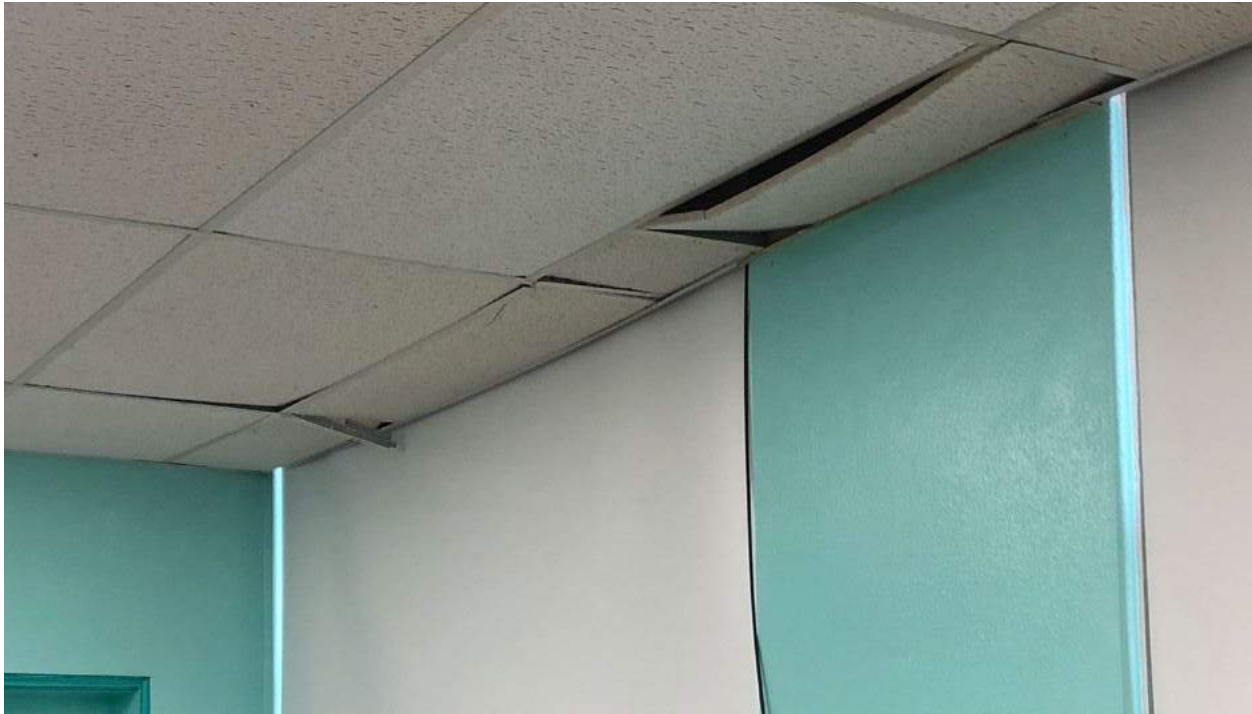
Ceiling tiles and grid are sagging and falling apart.

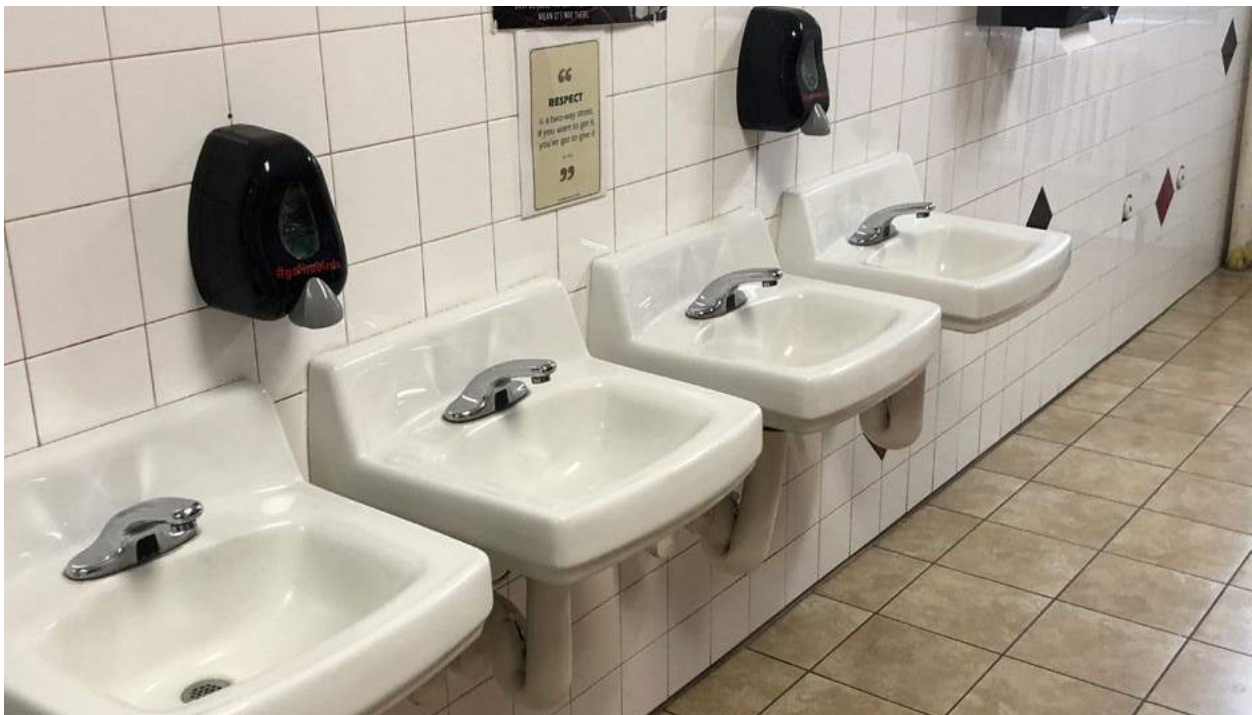
Sinks do not meet handicap accessibility. They are too low and have exposed piping that does not meet required clearances.

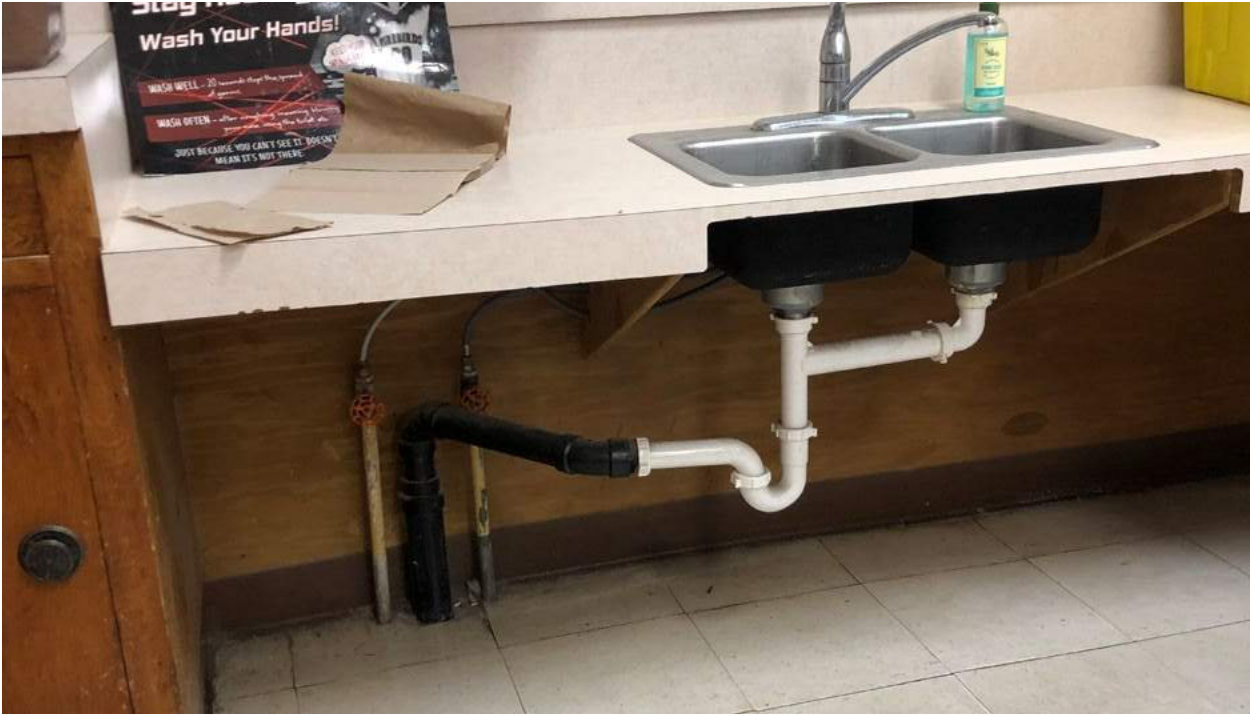
Exposed pipes underneath means this sink is not handicap accessible.

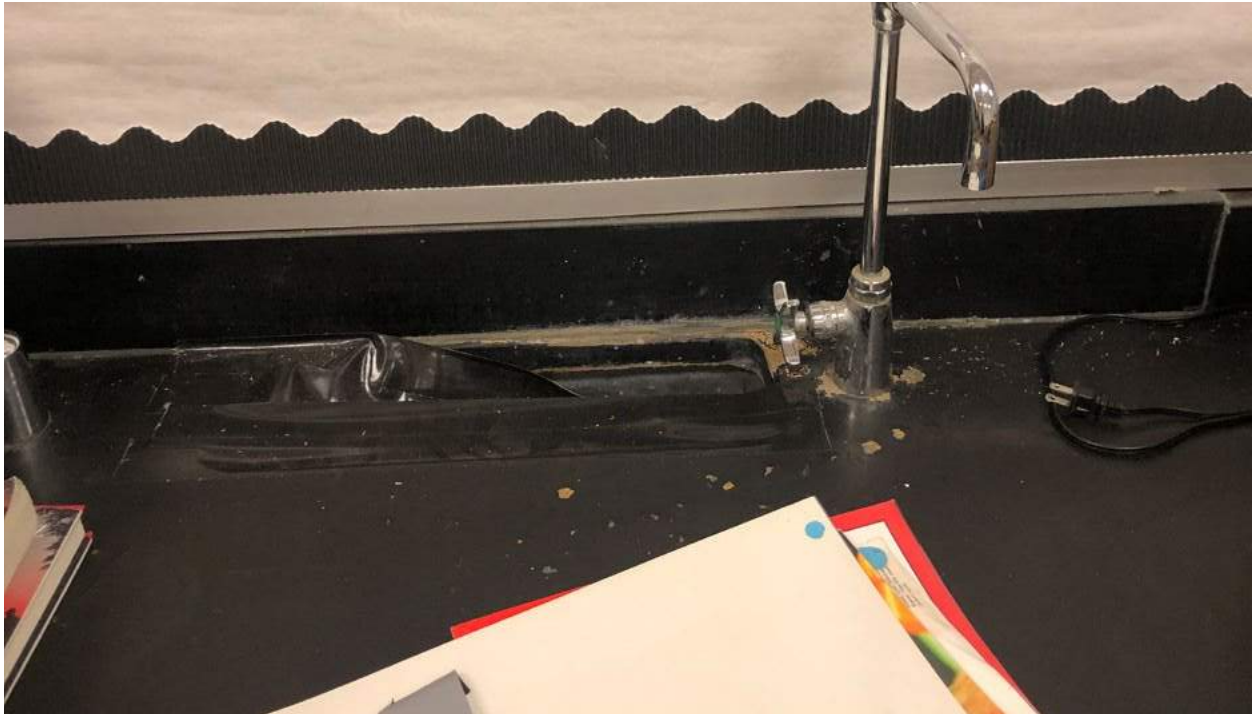
Sinks in science classroom are not working and are not accessible or code compliant.

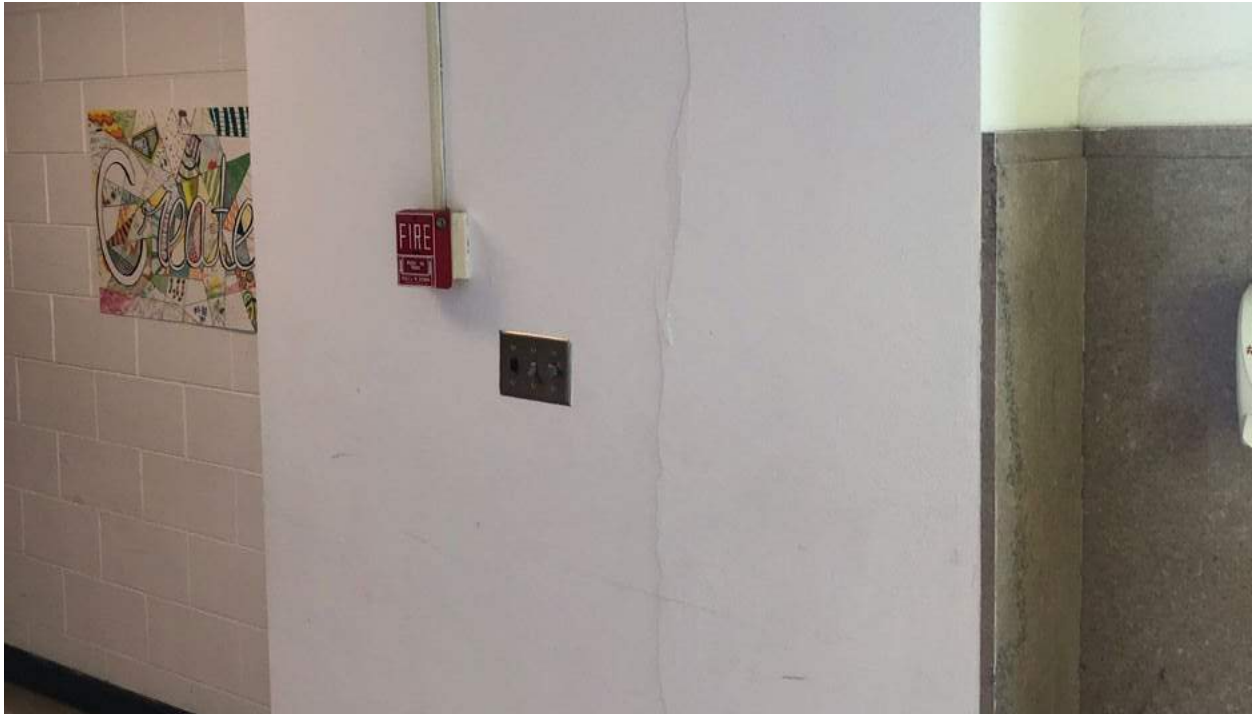
Crack and/or water damage on corridor wall.

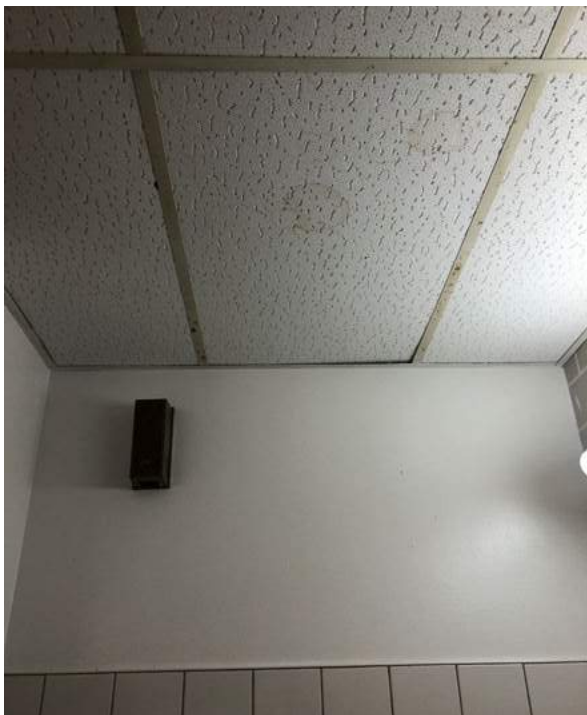
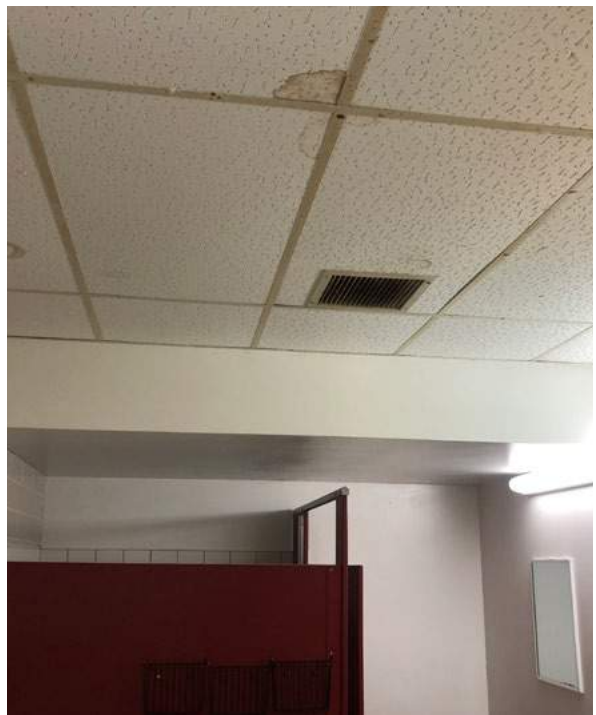
Ceiling tile in bad shape and has water damage in bathrooms.

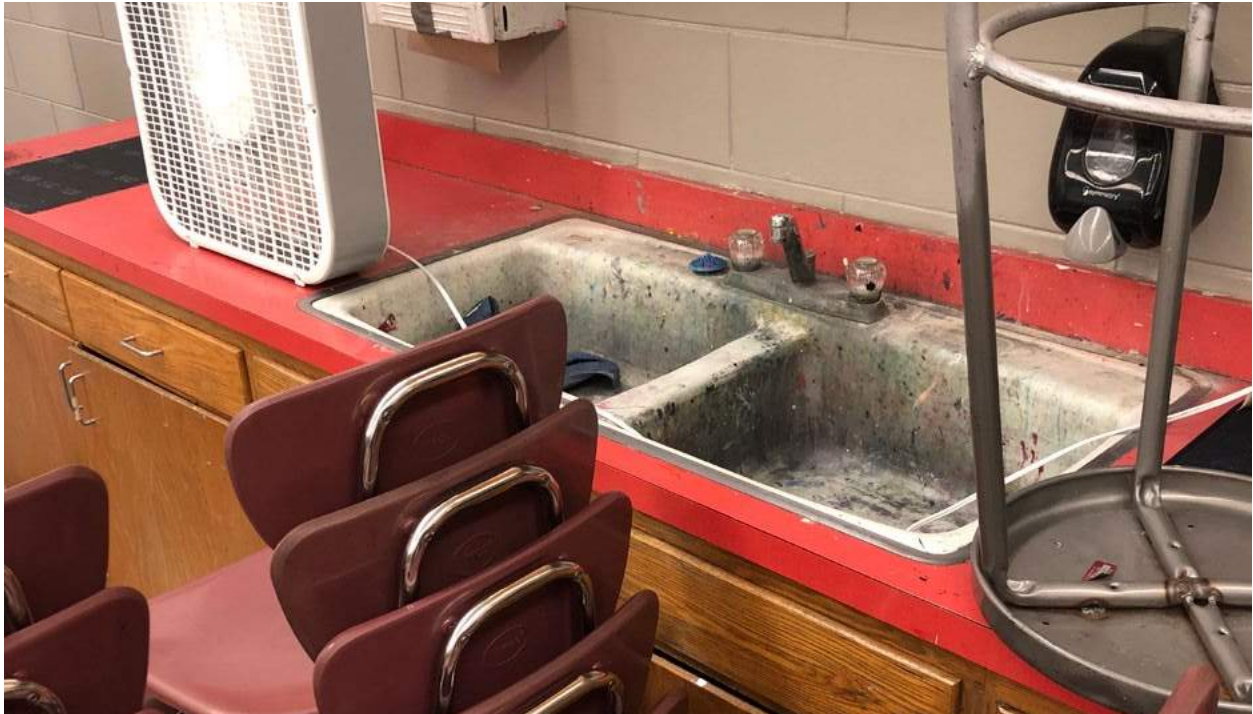
Art Room 123 sink is not handicap accessible.

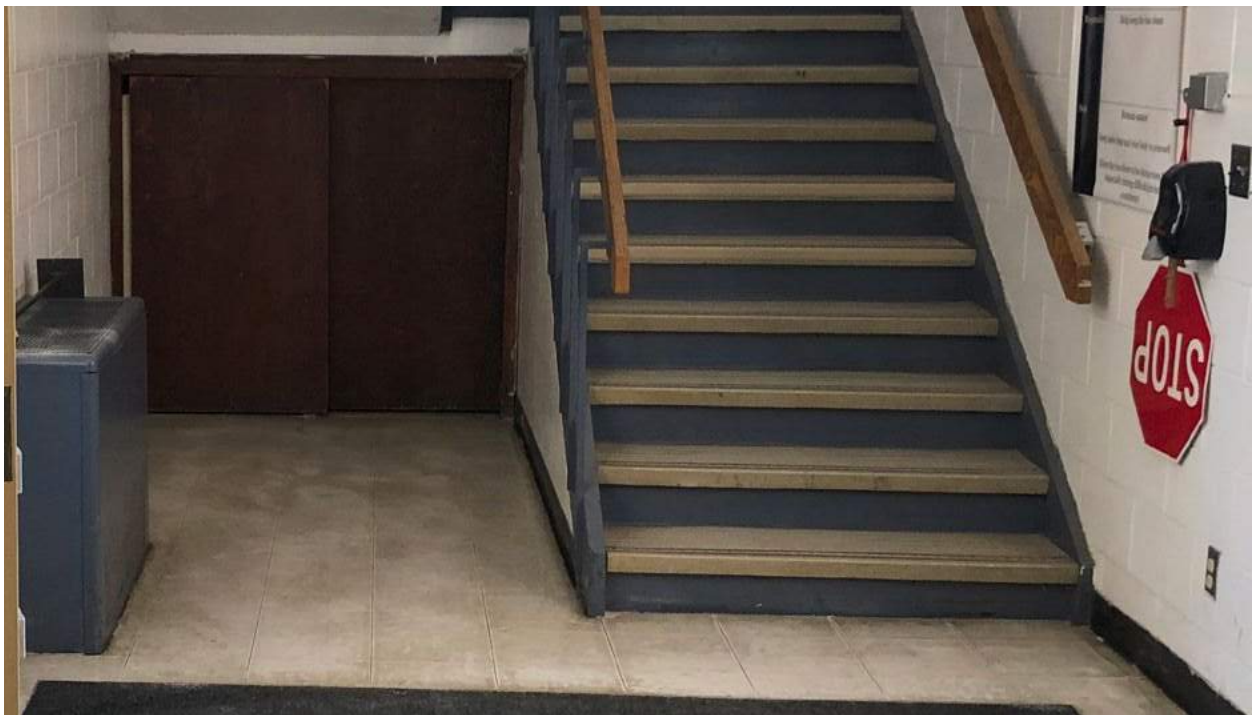
Code does not allow storage rooms under stairs.
