ICON
ARCHITECTURAL GROUP

FACILITY ASSESSMENT FOR DEVILS LAKE PUBLIC SCHOOLS

Devils Lake, ND

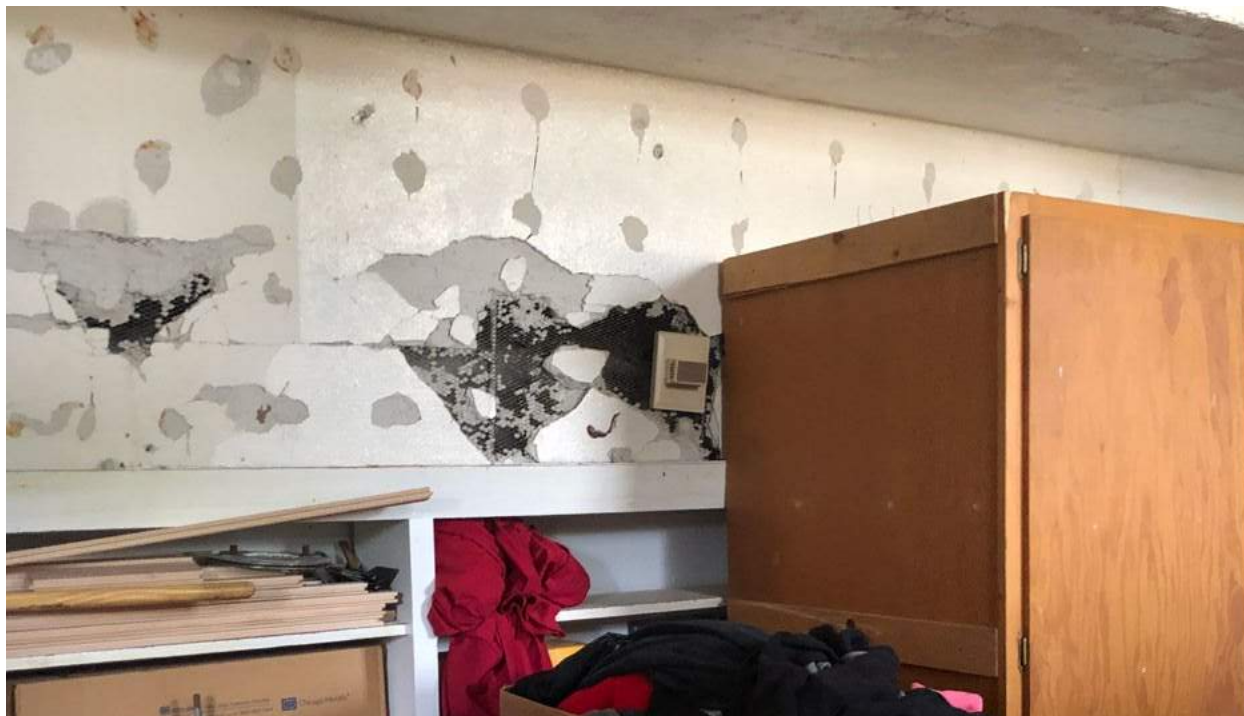
Wall has various damage marks.

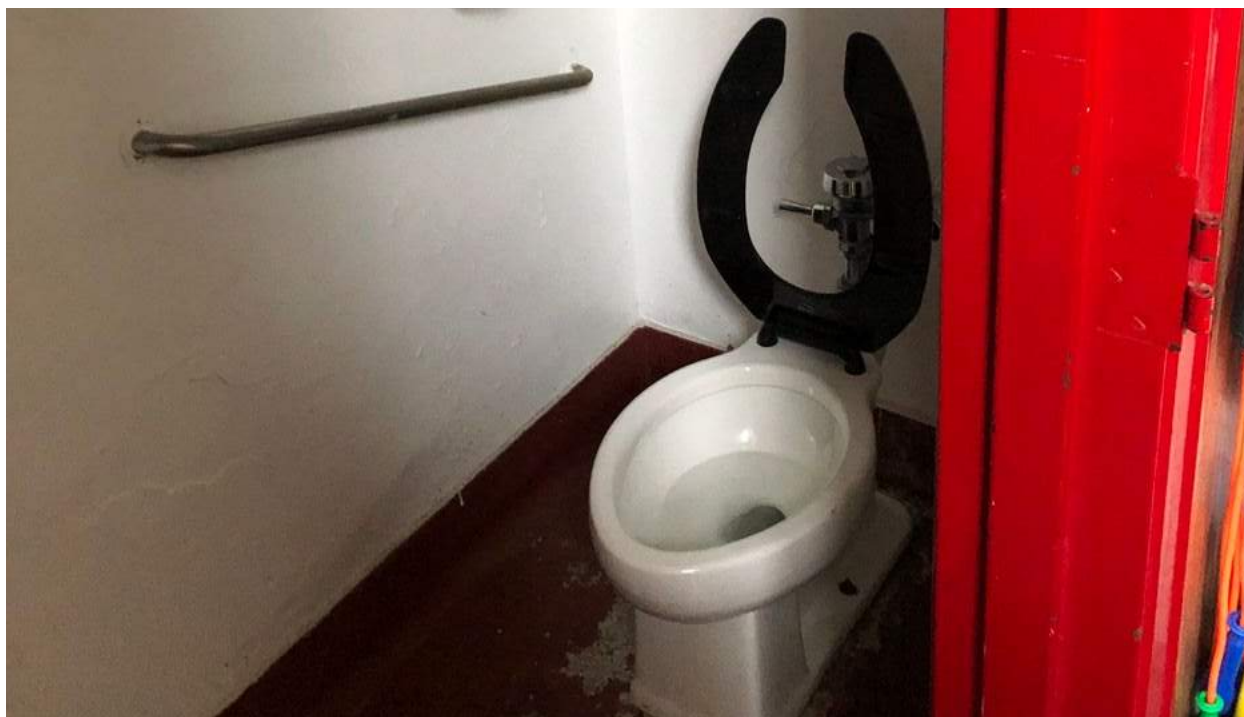
Bathroom in coach's office not accessible.

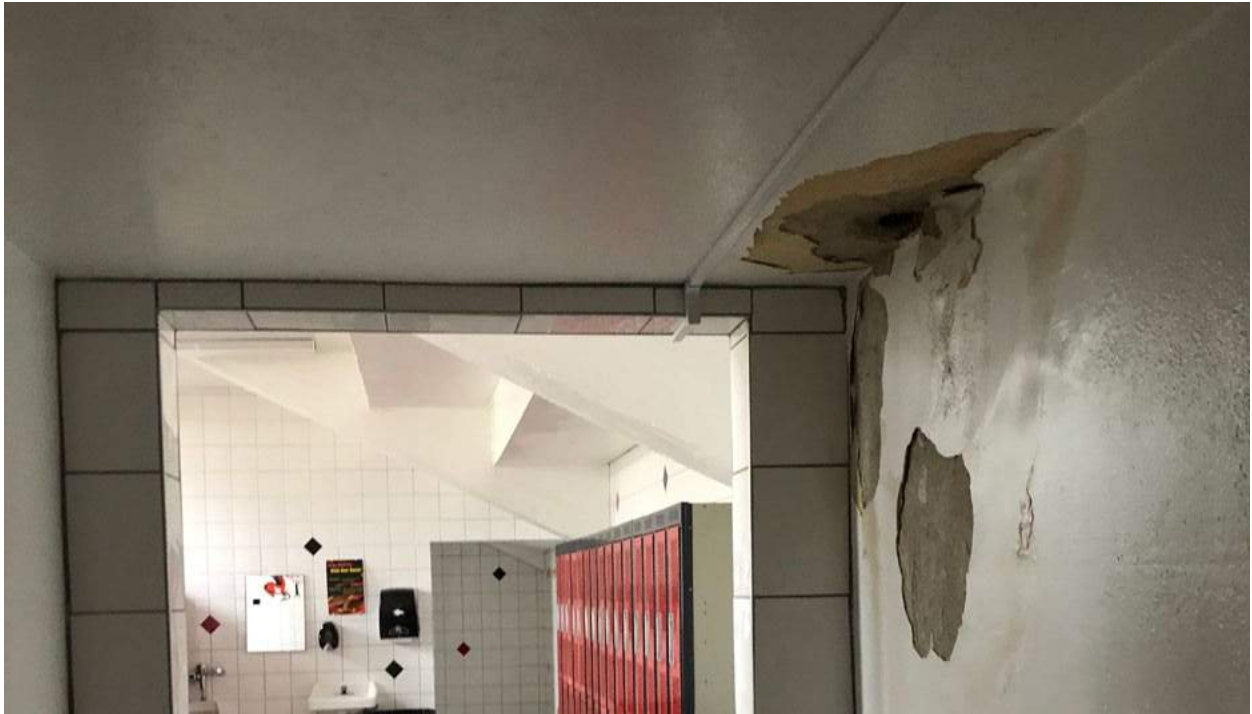
Water damage on ceiling and wall in boy's locker room.

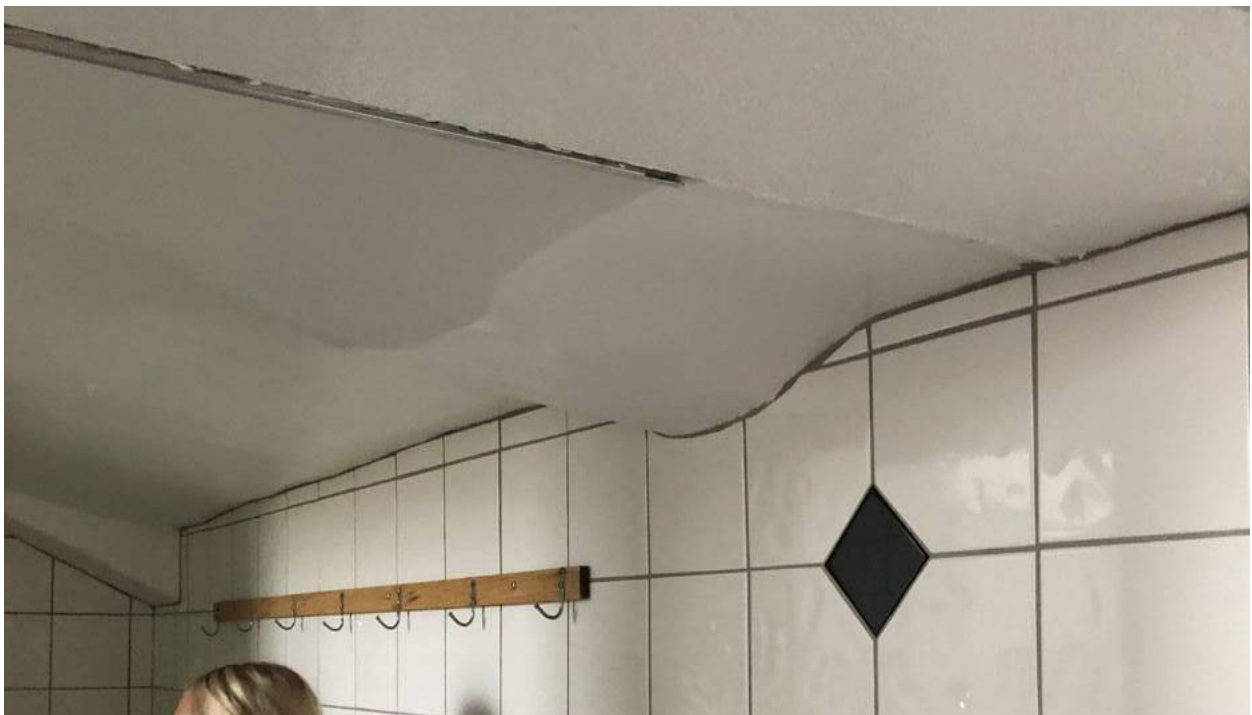
Ceiling caving in boy's locker room.

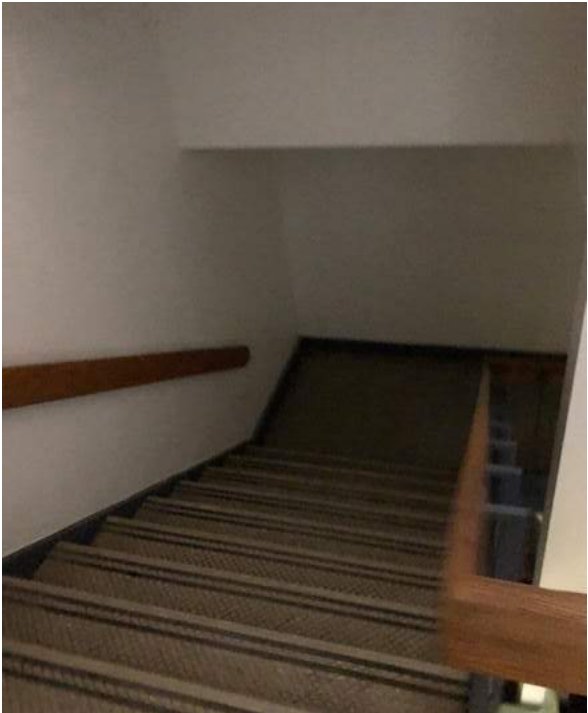
Stairs to basement do not meet code requirements; missing adequate handrail and guardrails.

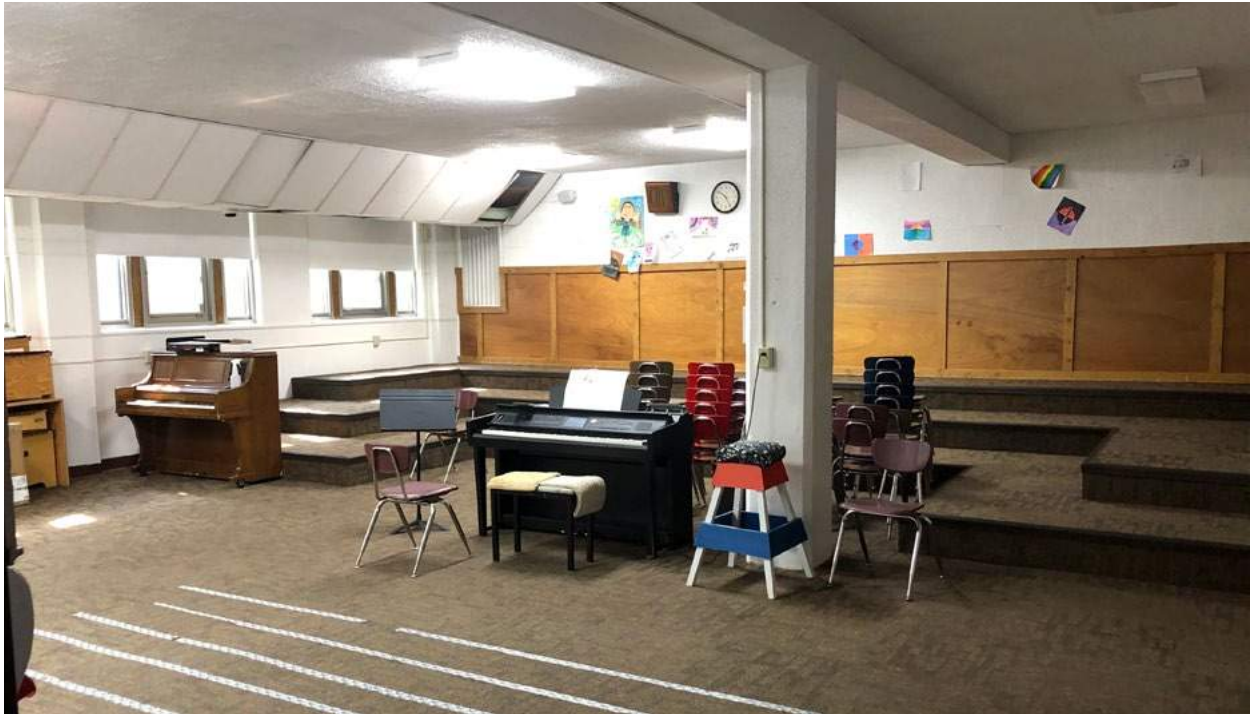
Choir room is not handicap accessible.

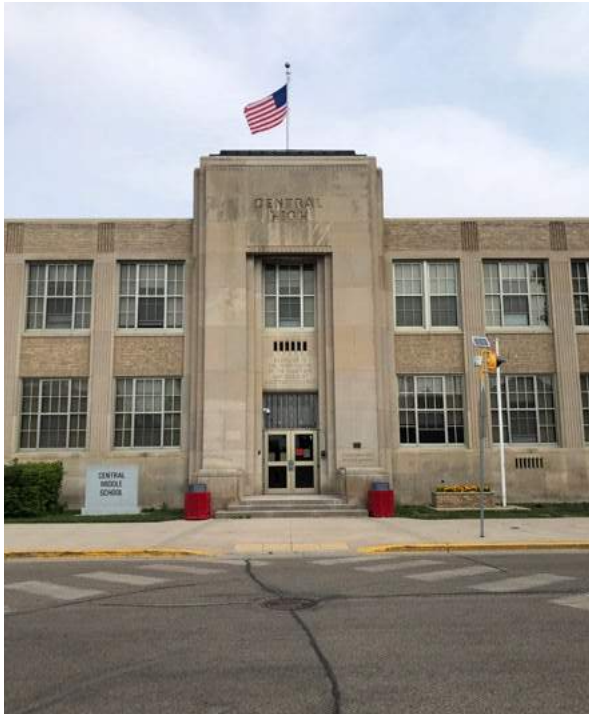
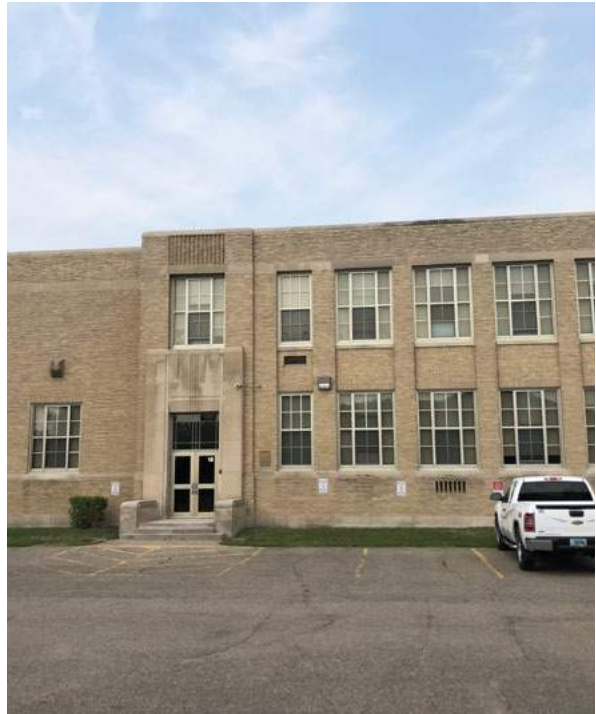
Exterior entrances are missing adequate handrails and guardrails, and do not have required ramps or handicap accessible entrances.

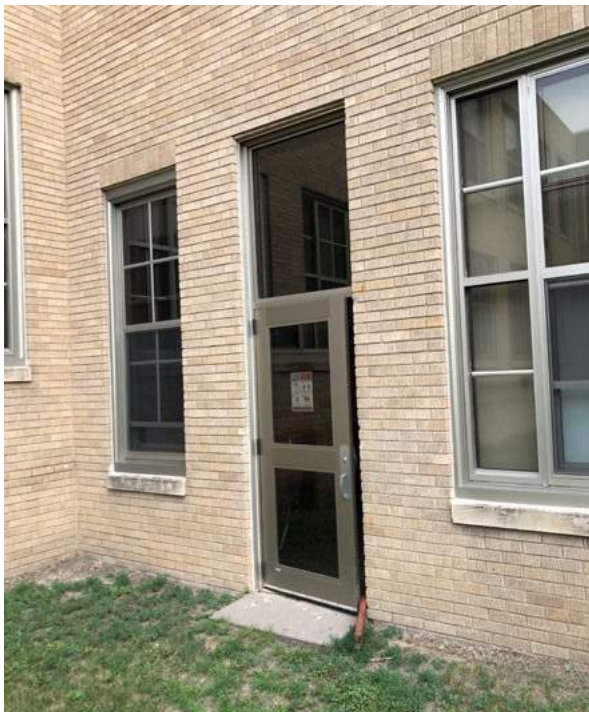
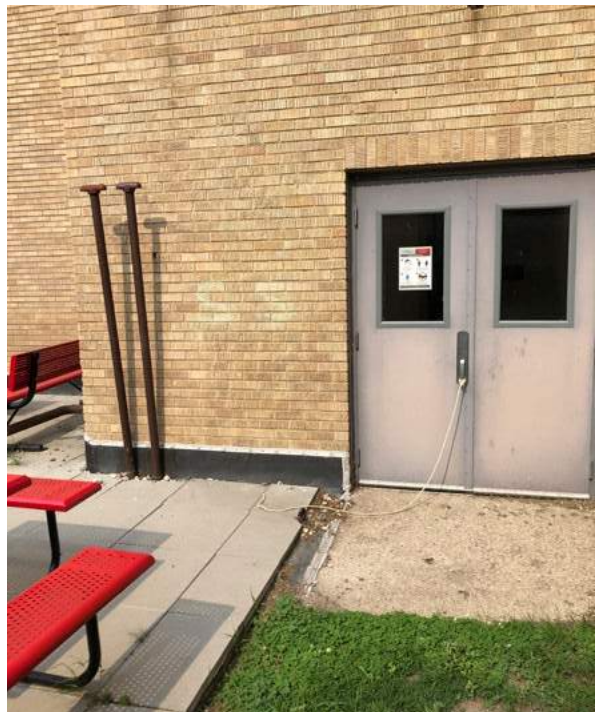
No accessible entrance to the courtyard and no exit out of the courtyard.

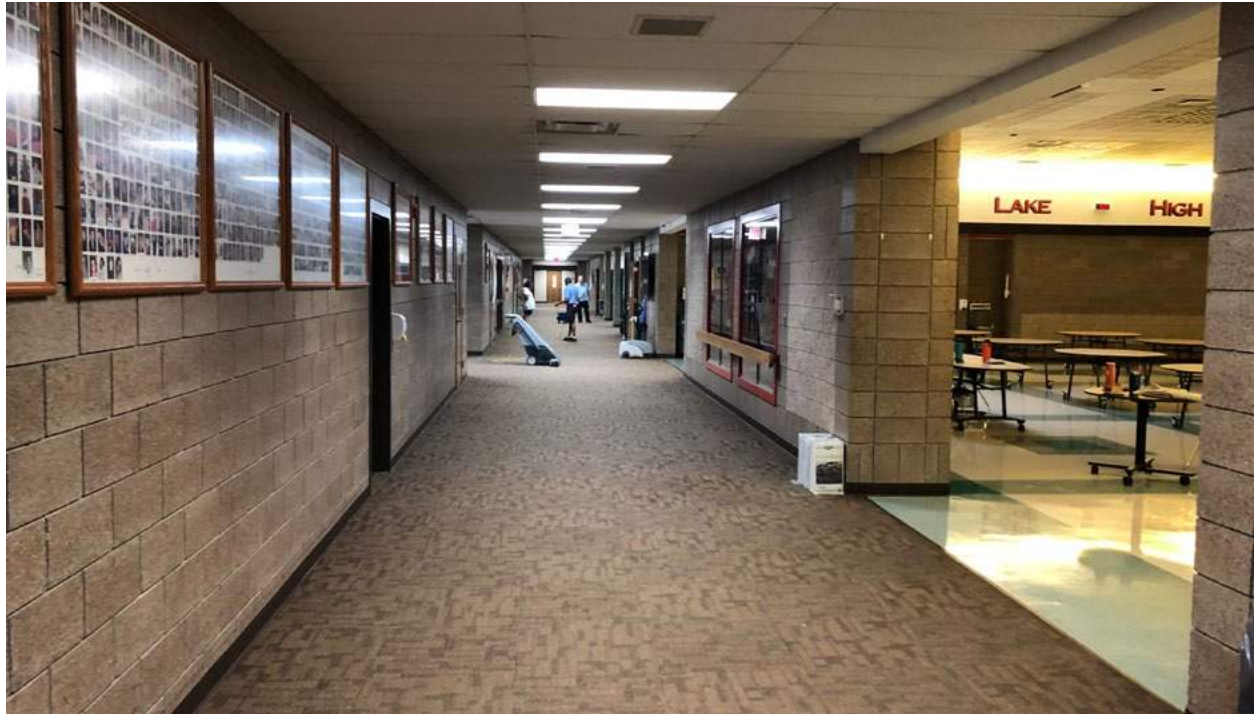
No sprinkler system.

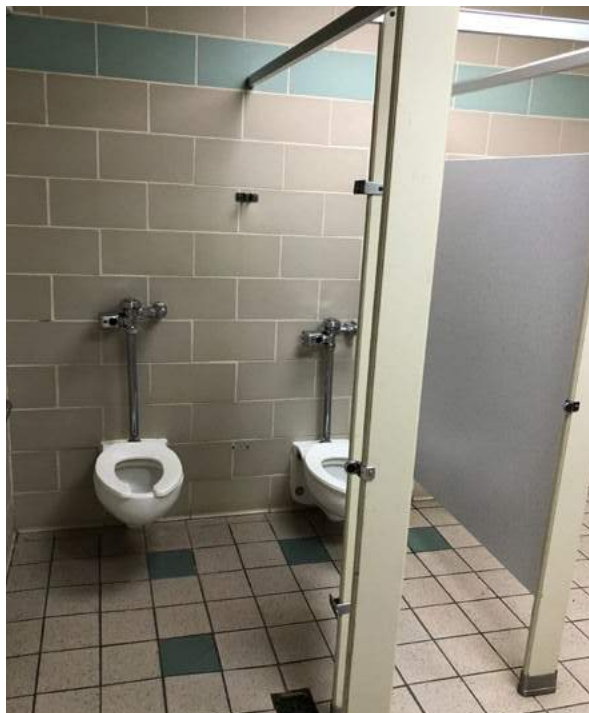
Missing stall doors in men's restroom.

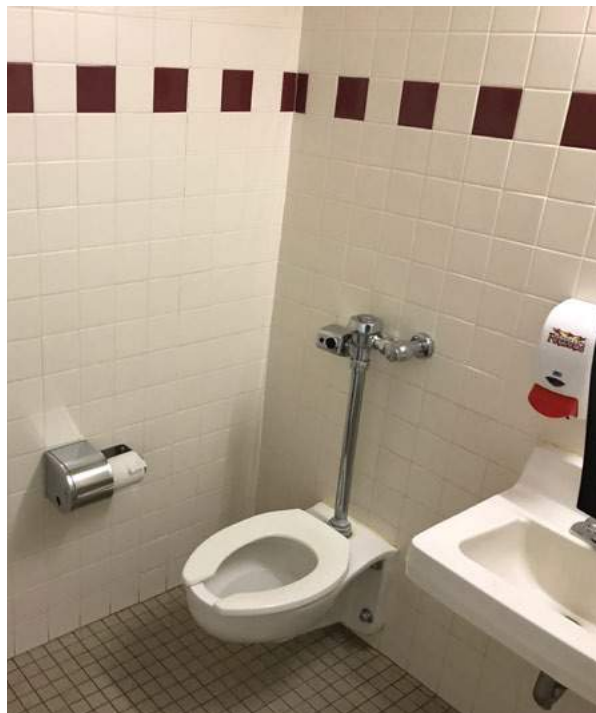
Staff restrooms are not handicap accessible and are missing grab bars.

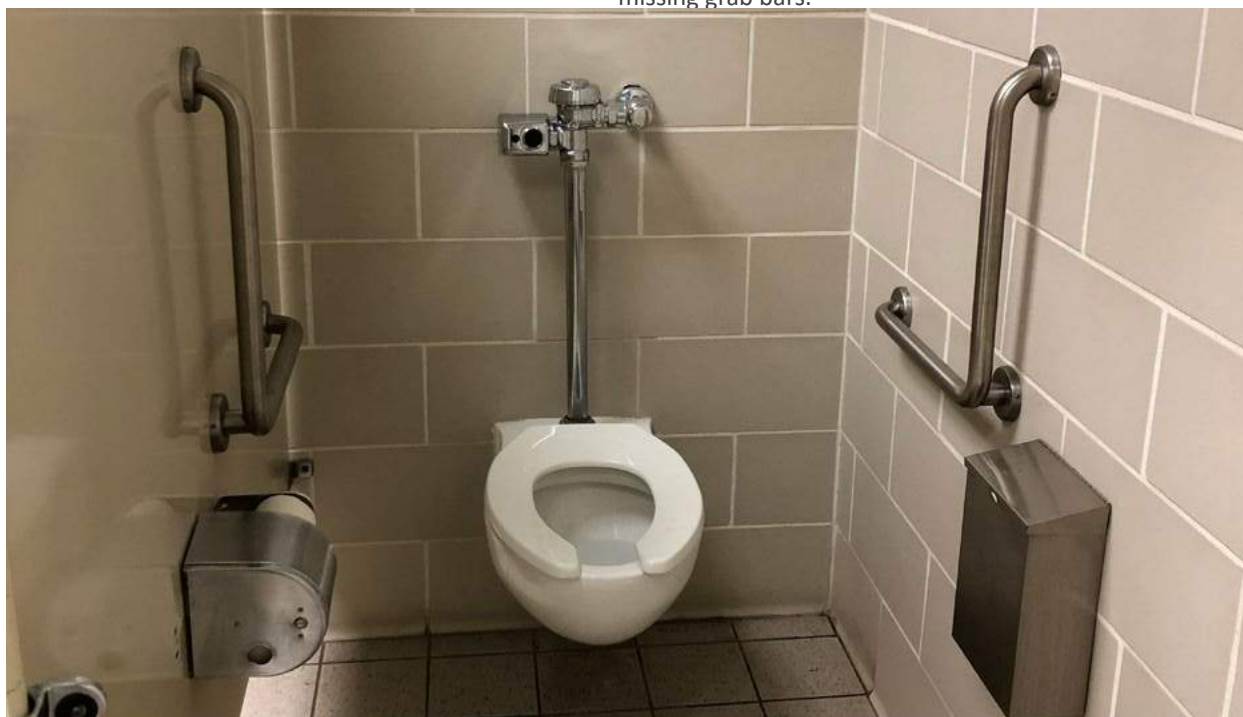
Grab bars in ADA stalls are not all code compliant in men's and women's restrooms.

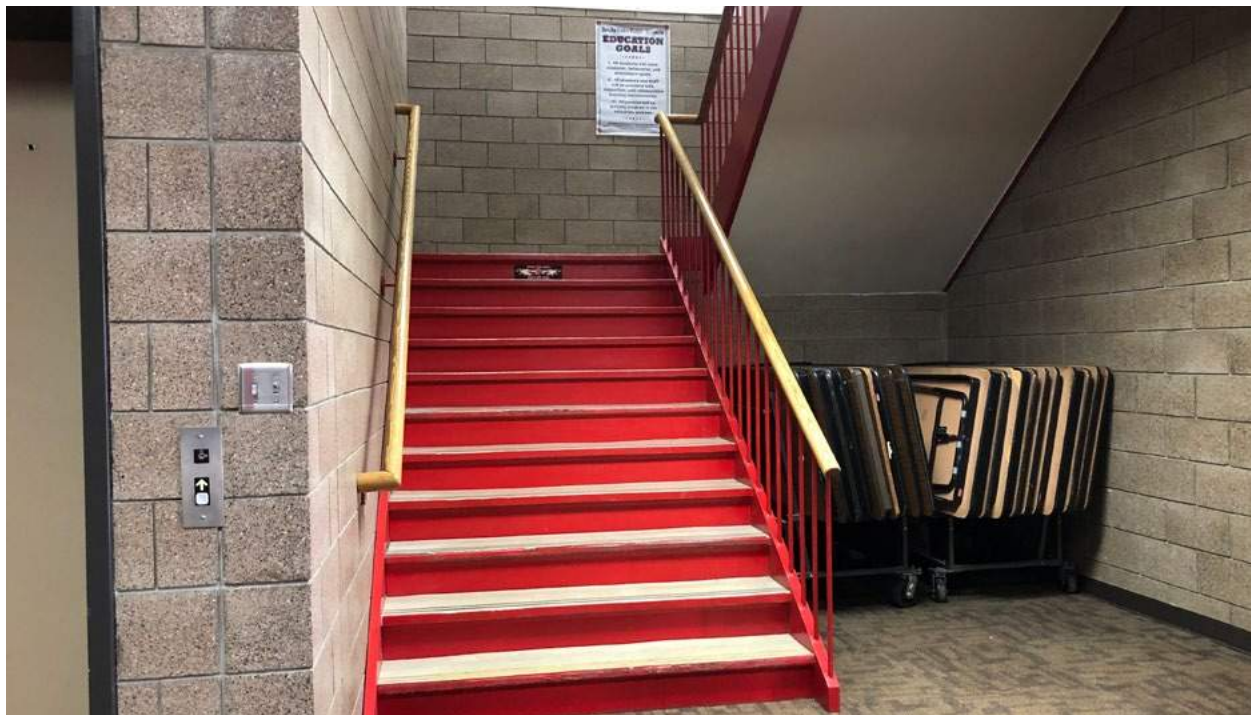
Hand and guard rails for stairs are not to code. Storing things under stairs does not meet code.

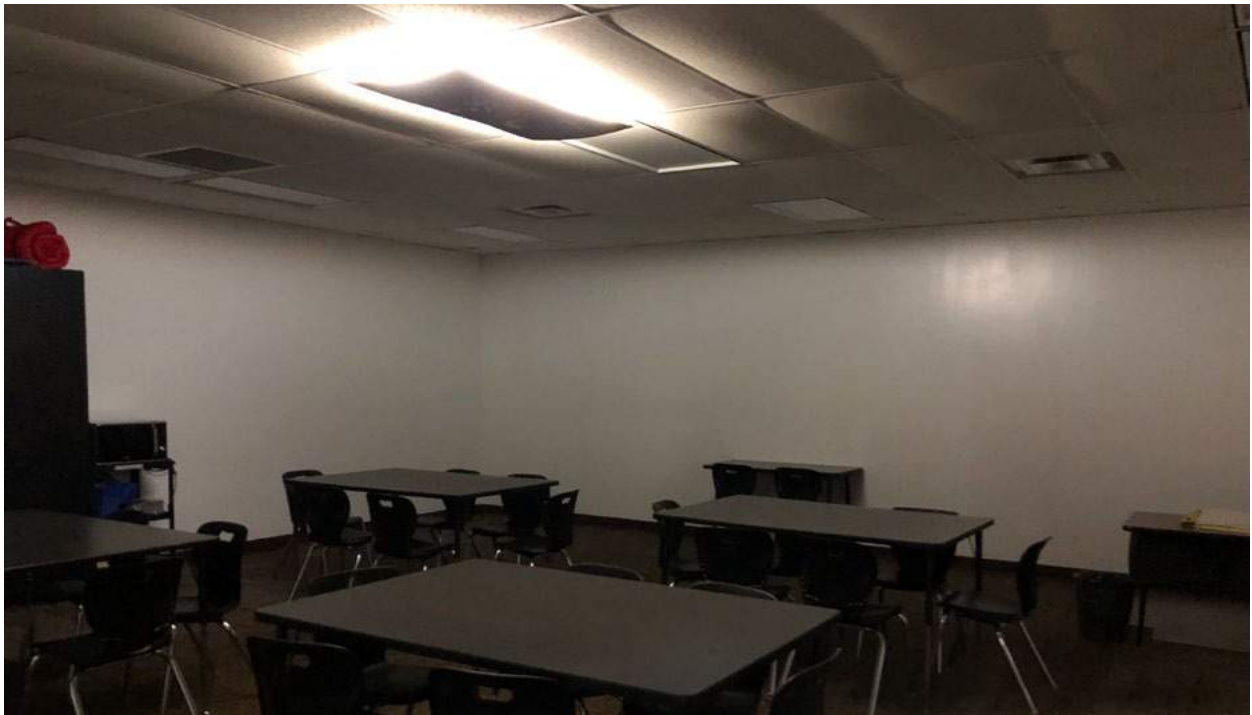
Ceiling tile is in bad shape throughout all the classrooms.

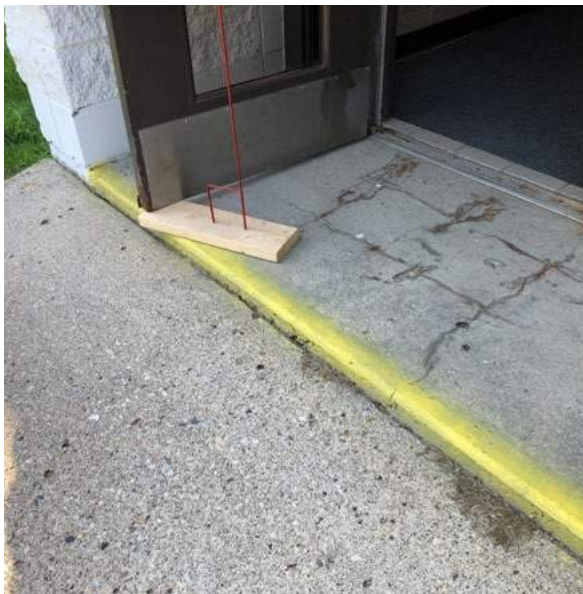
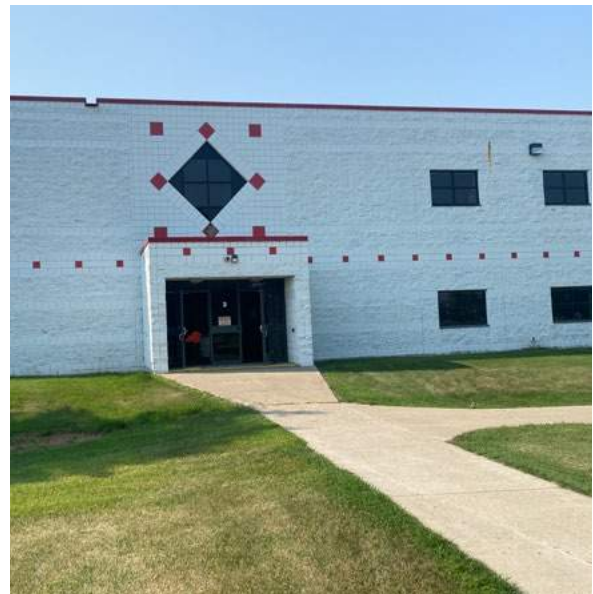
Sidewalk outside of Door 3 has sunk and is no longer handicap accessible.

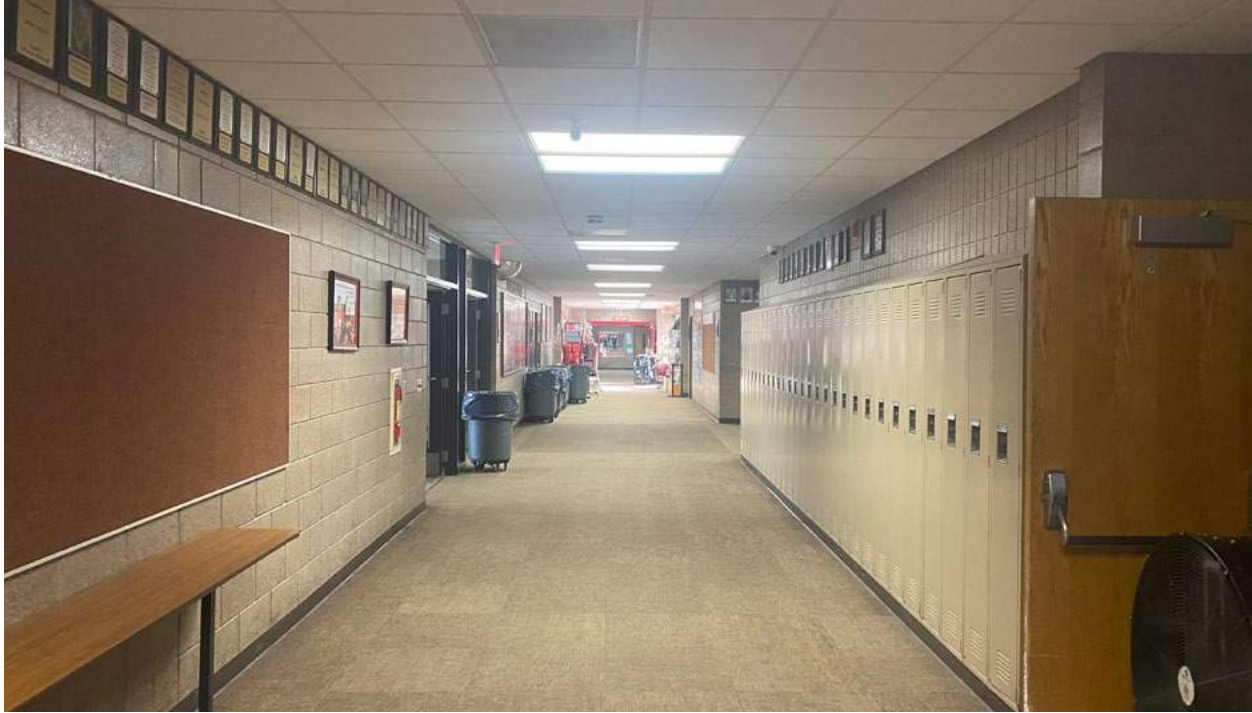
No sprinkler system.

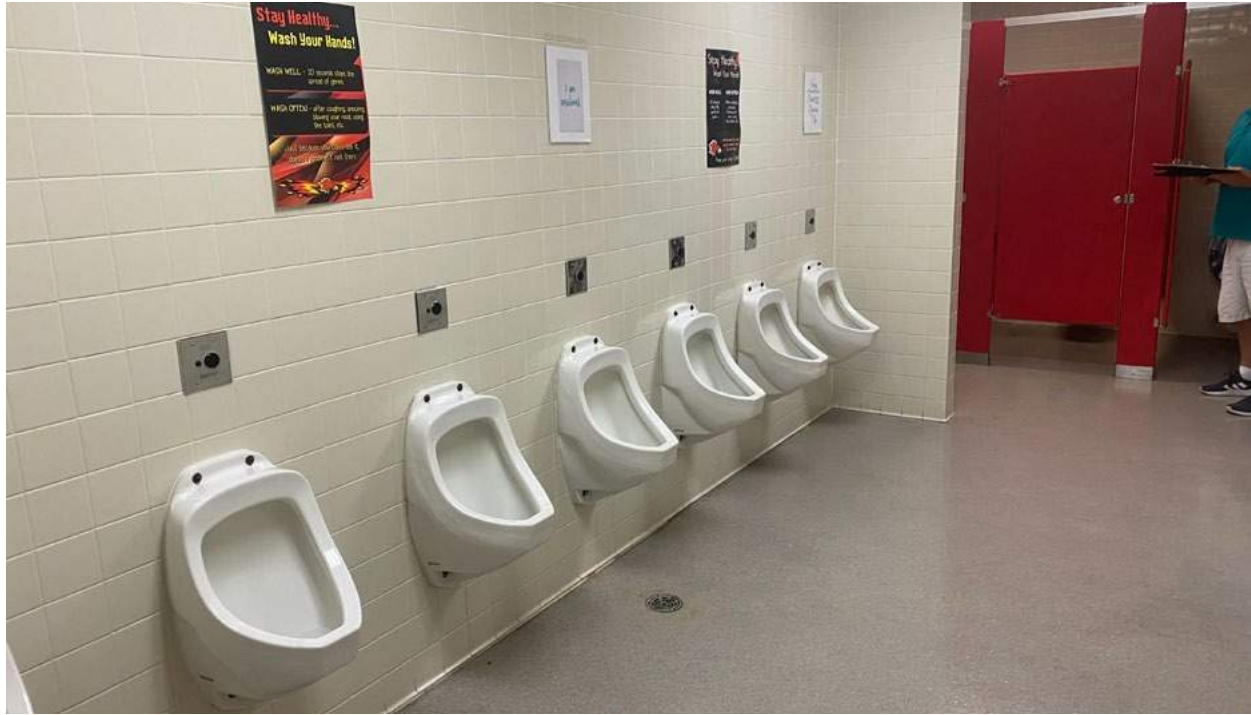
The men's restroom lacks a handicap accessible urinal.

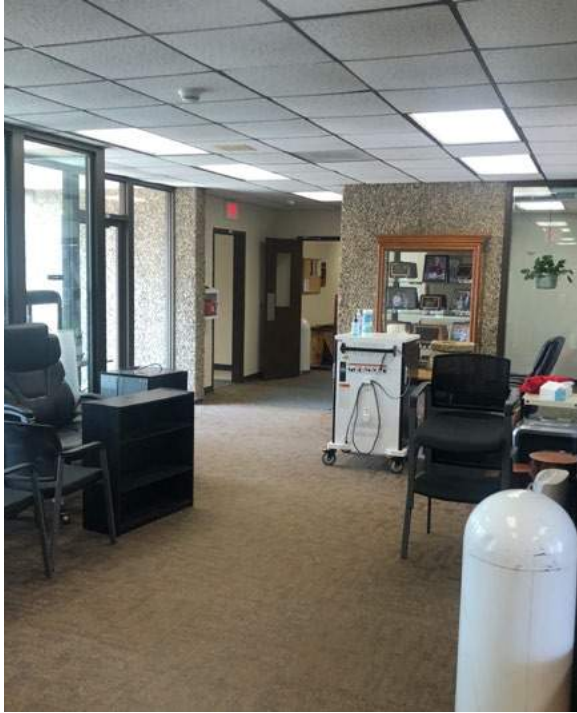
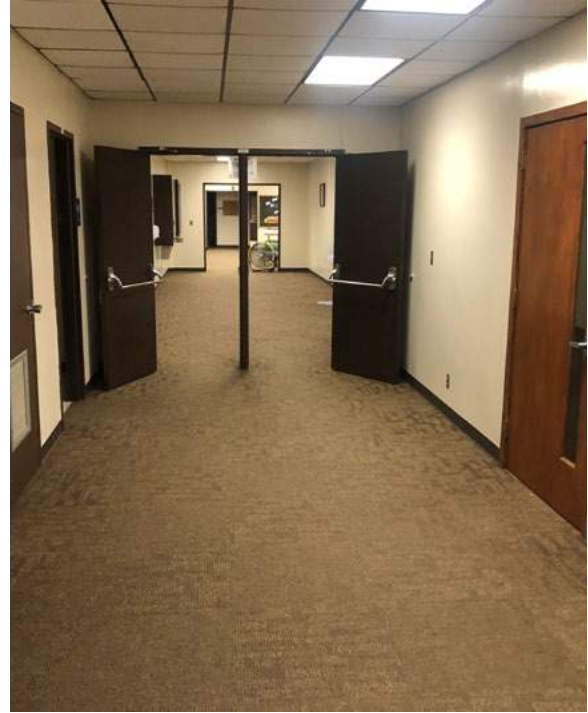
No sprinkler system.

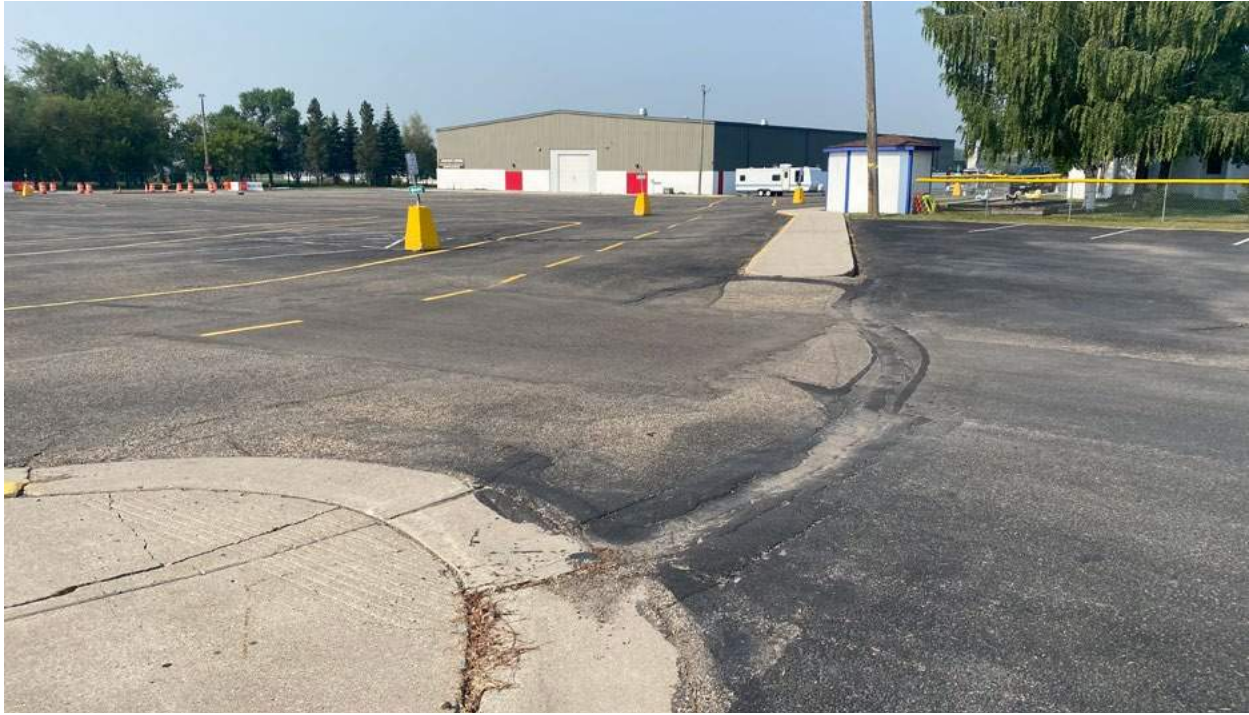
Sidewalk coming from High School to LACTC is not handicap accessible.
