ICON
ARCHITECTURAL GROUP

FACILITY ASSESSMENT FOR DEVILS LAKE PUBLIC SCHOOLS

Devils Lake, ND

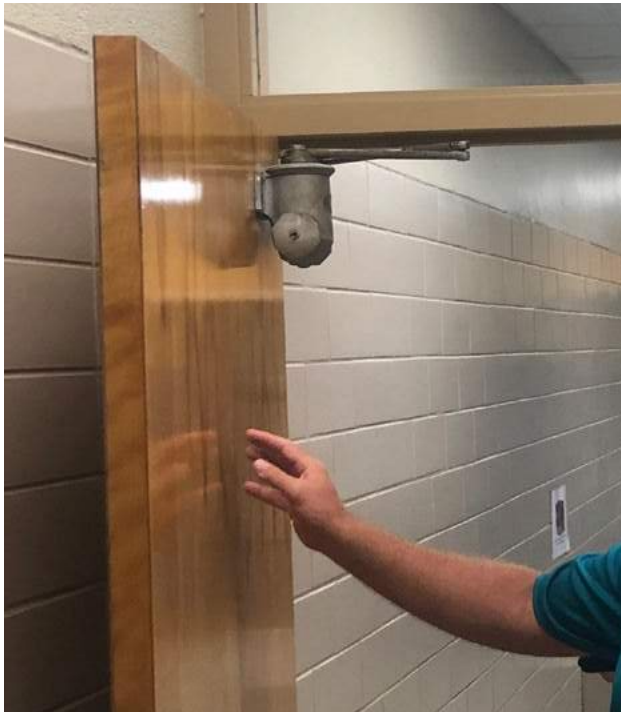
Doors and door hardware are aged.

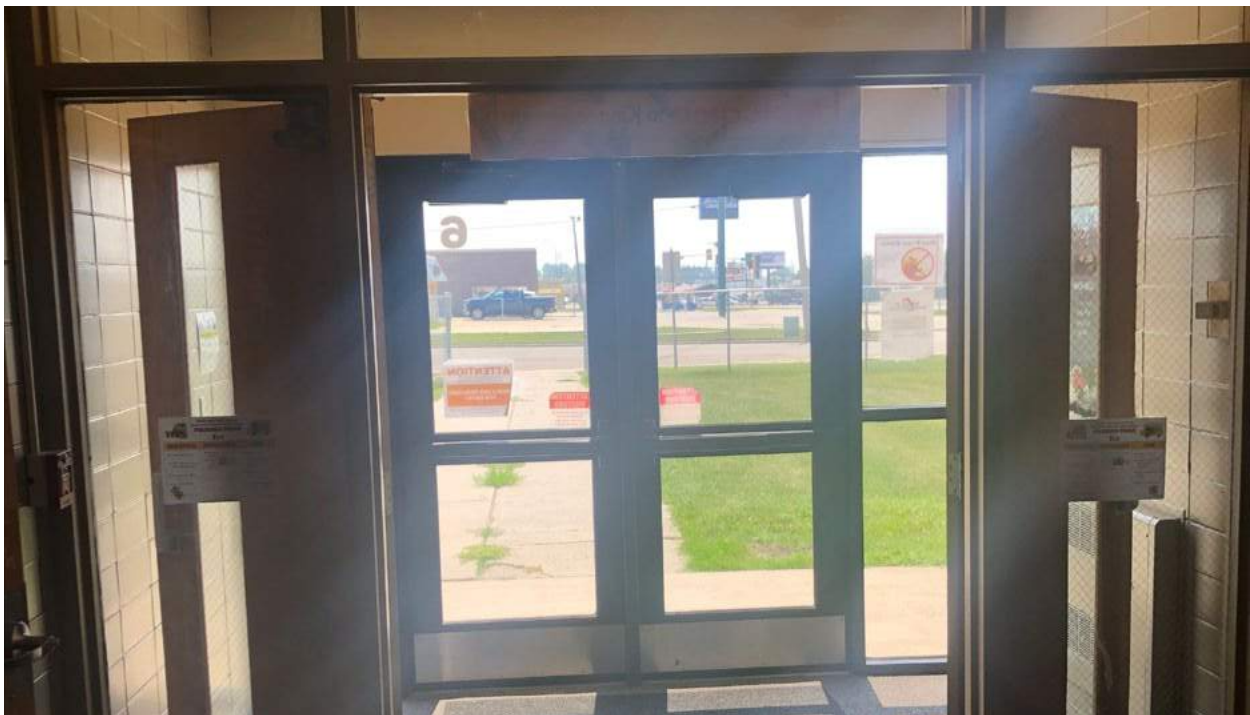
Interior vestibule doors do not have a closer.

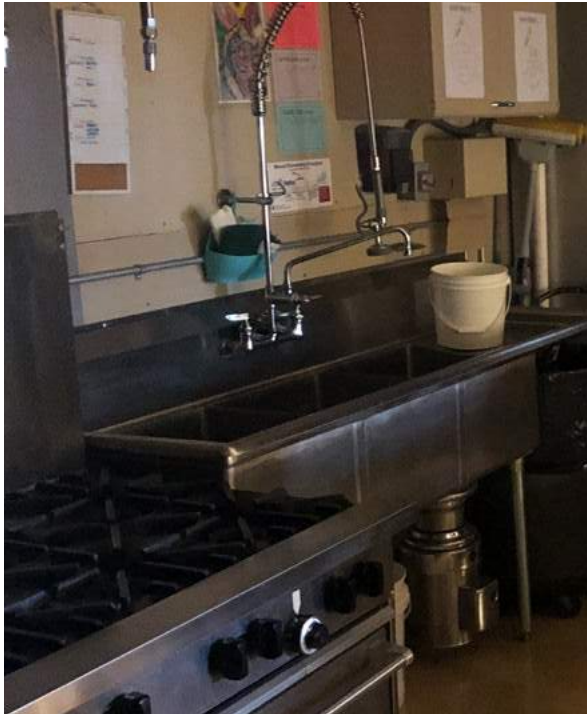
Kitchen is undersized, and not ADA compliant.

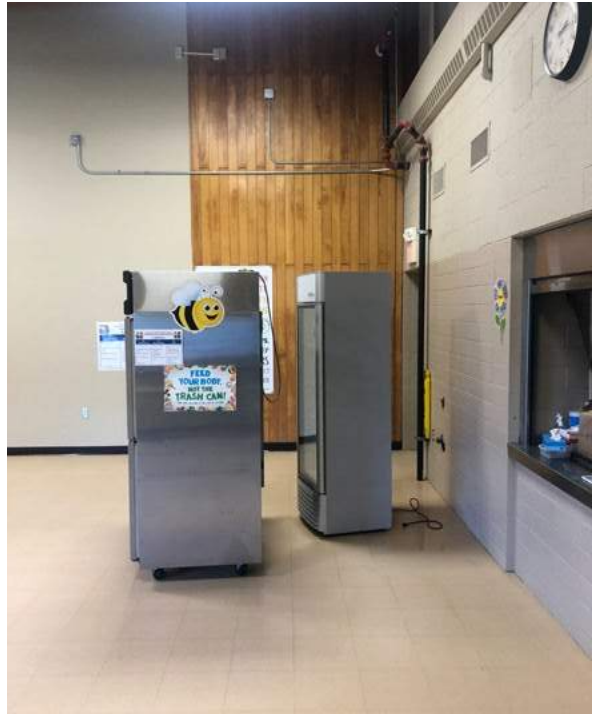
Cafeteria is undersized; kitchen freezers and food lines are kept in lunchroom as well.

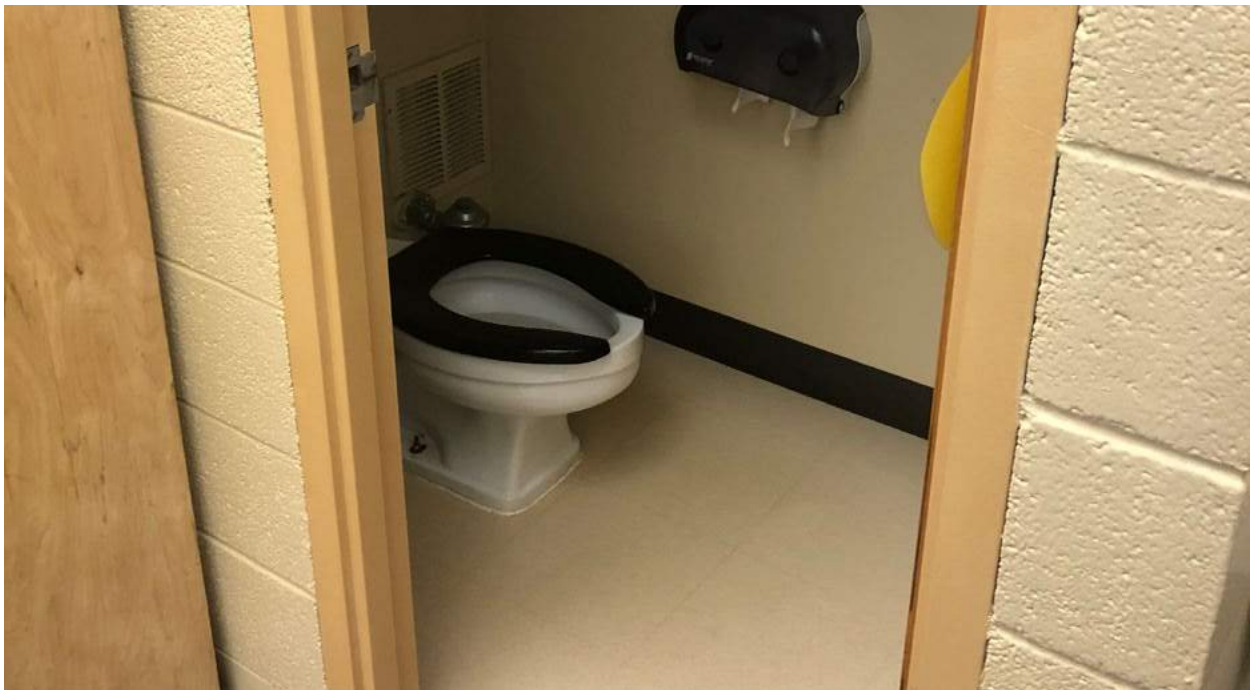
Restrooms in classrooms are very small and do not meet maneuverability and clearance requirements.

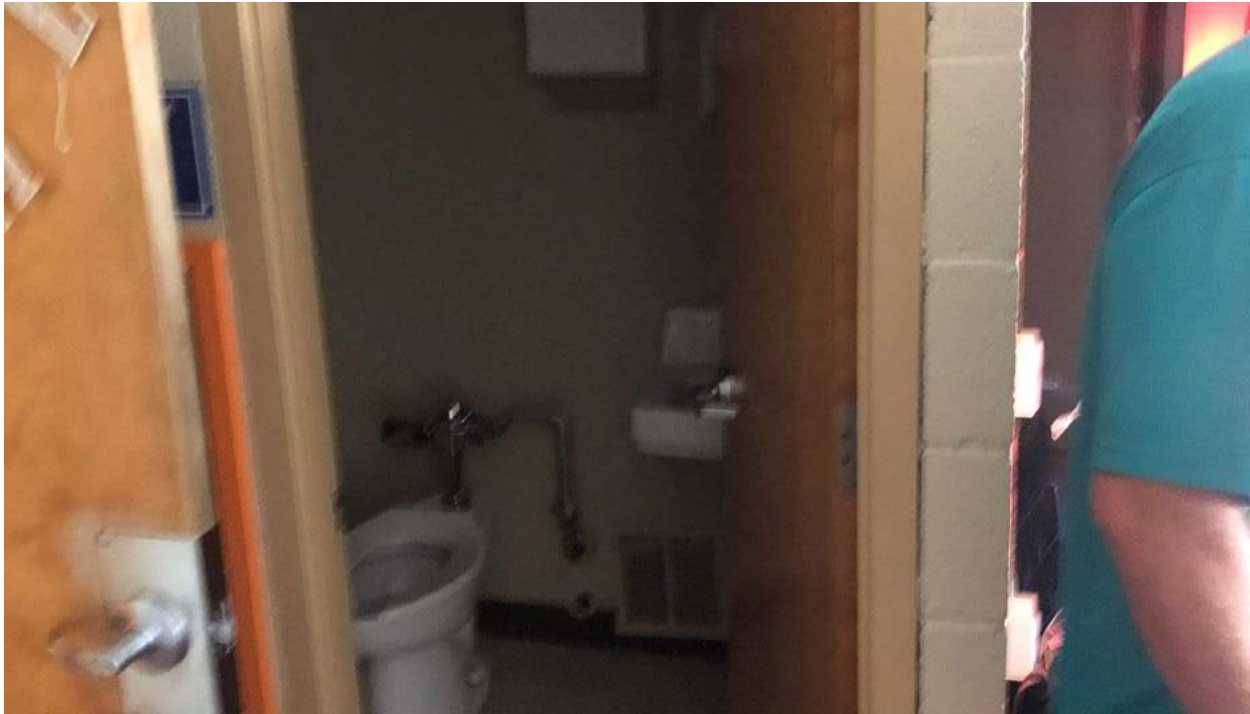
Restroom in Resource Room and Staff Lounge are not handicap accessible.

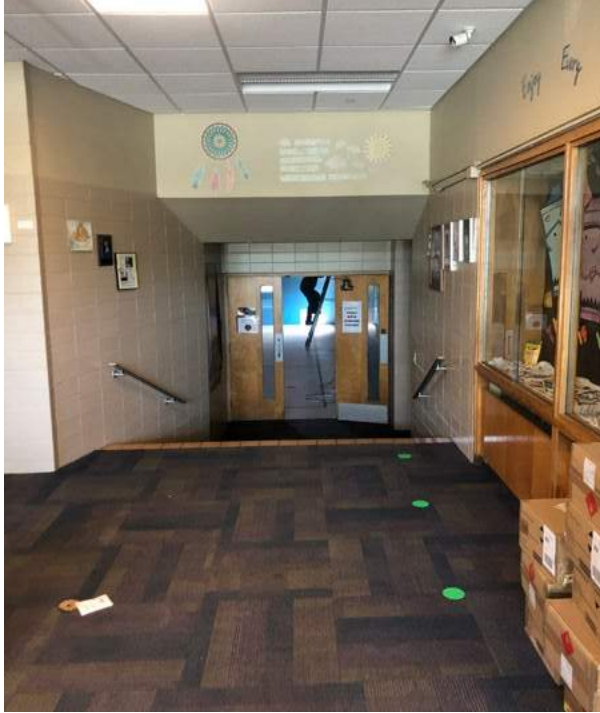
Gymnasium and associated spaces are not handicap accessible and lack adequate handrail and guardrails.

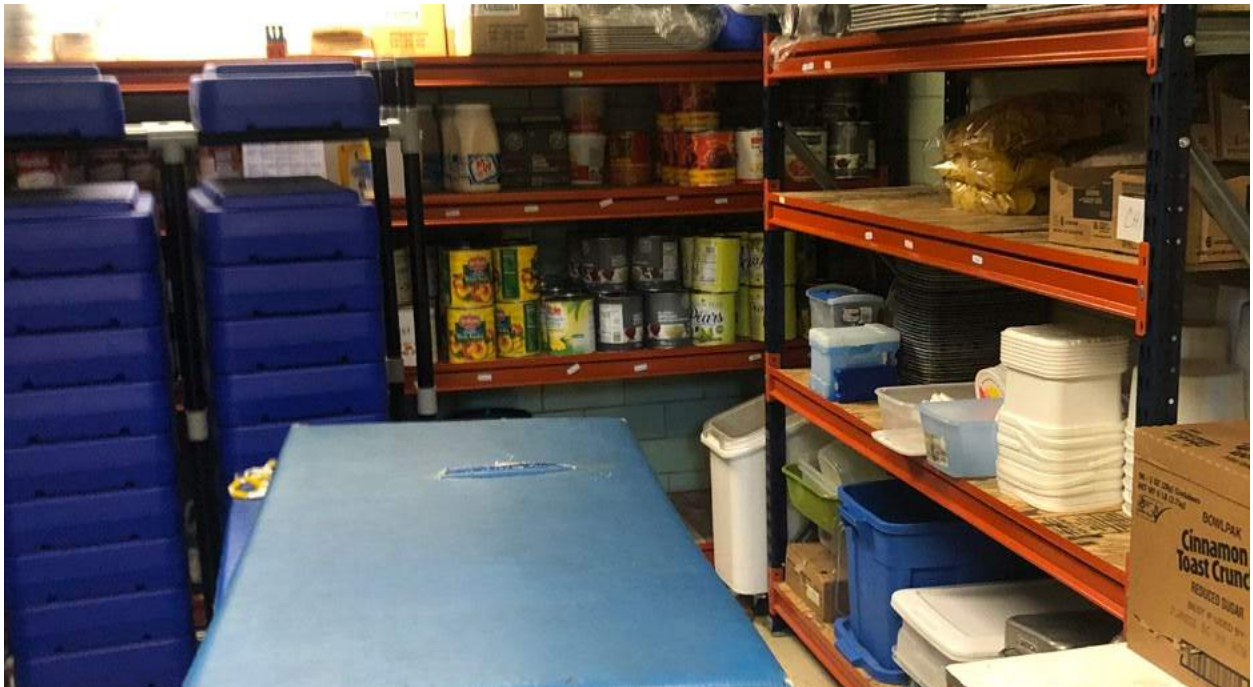
Gym equipment is stored with food in the pantry, not enough storage space.

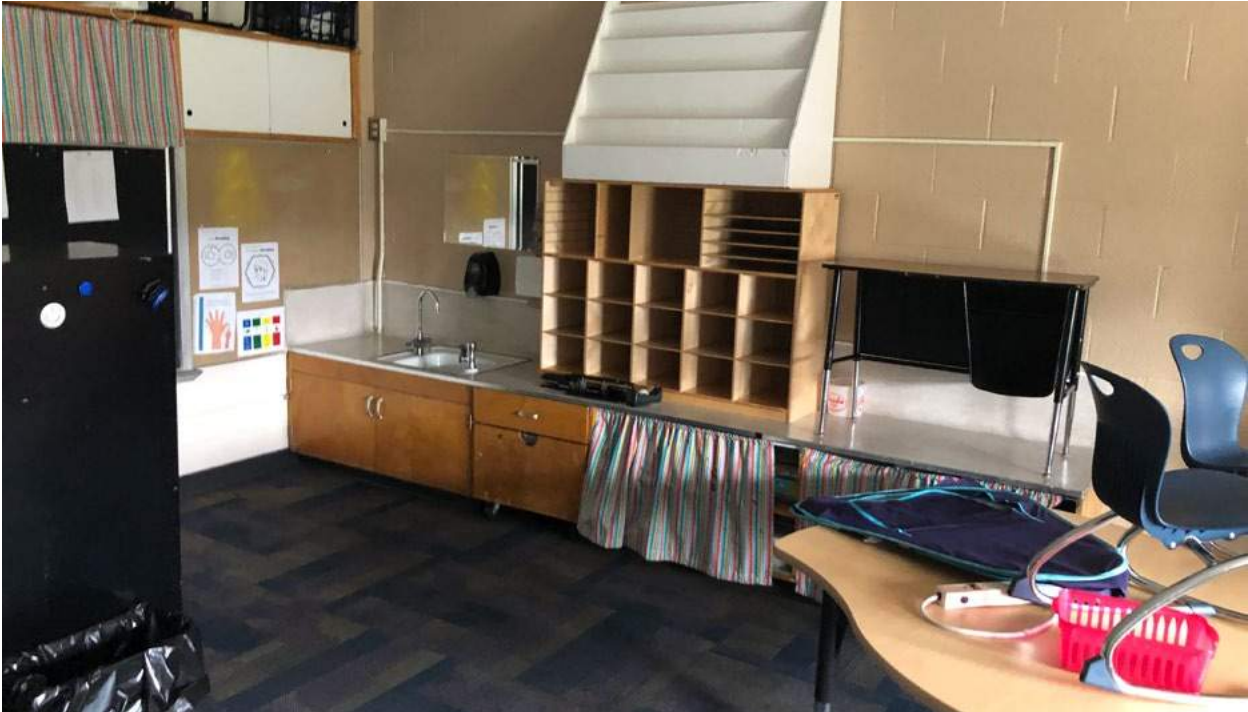
Casework is aged in older classrooms and sinks do not meet handicap accessibility.

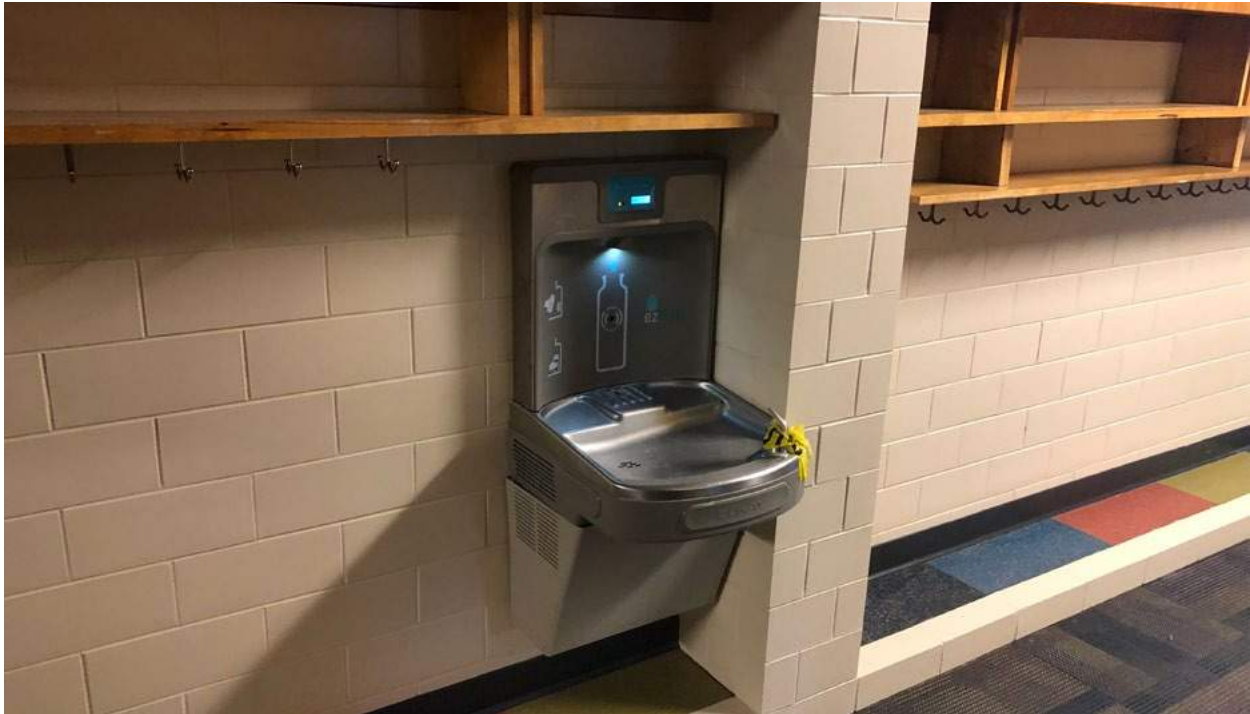
Drinking fountain in corridor is not code compliant.

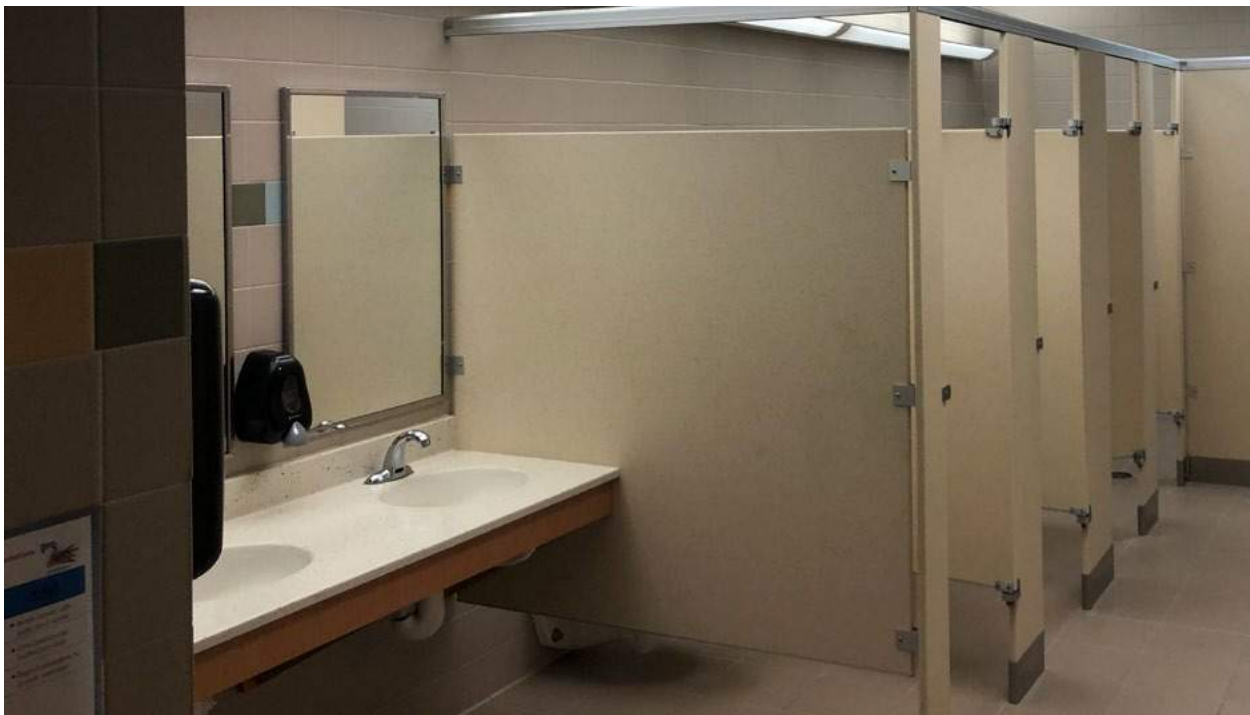
Sinks are not handicap accessible in both boy's and girl's restrooms.

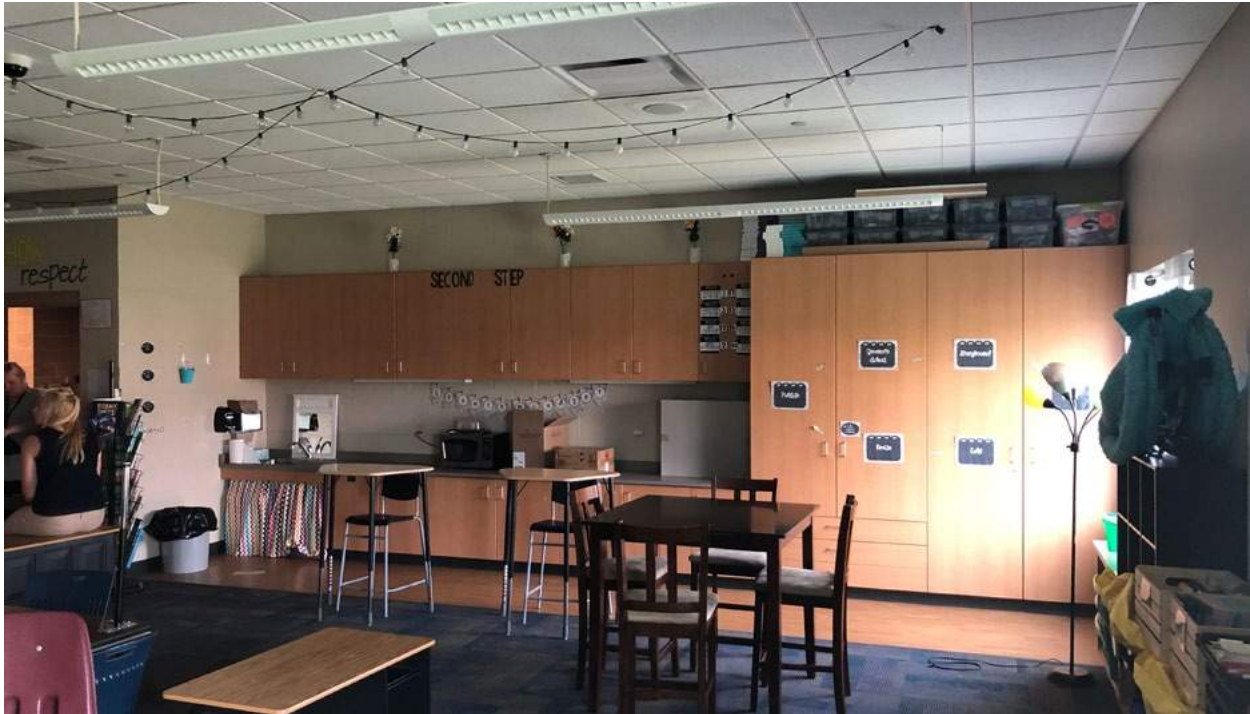
Sink in new casework is not handicap accessible because of exposed plumbing underneath.

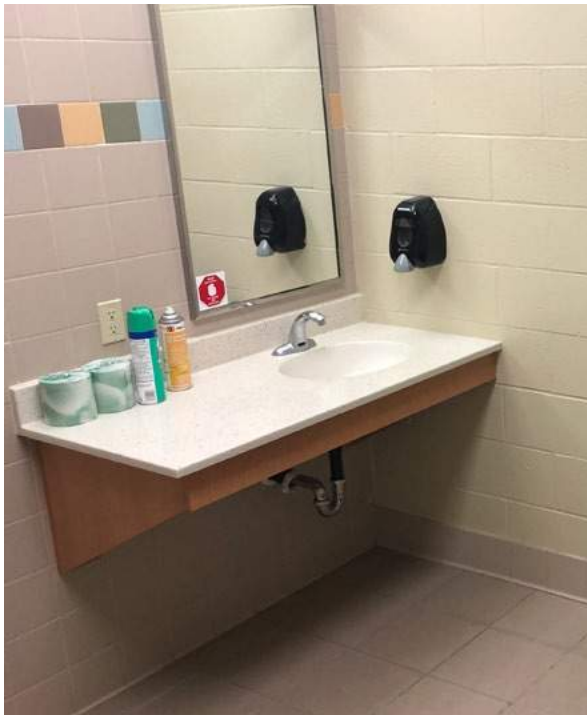
Sink in family restroom is not handicap accessible.

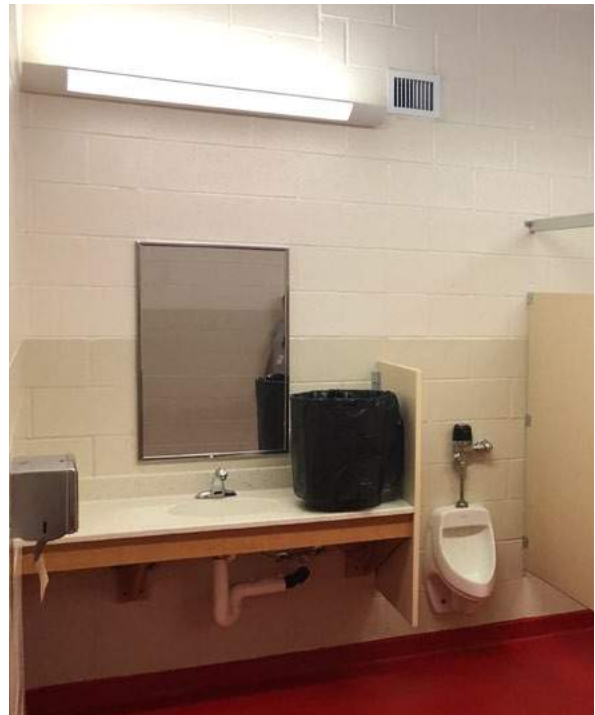
Sink in boy's locker room is not handicap accessible.

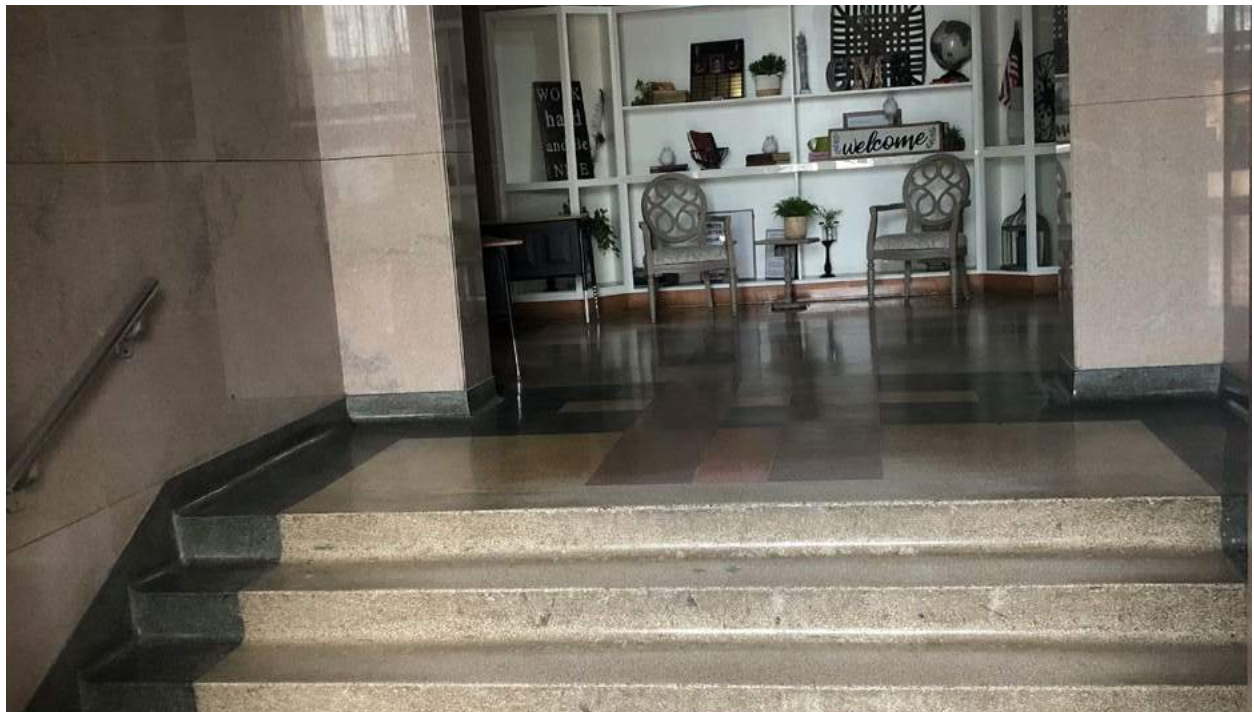
Main entrance not accessible. Handrails not to code. There is no ramp or middle railing.

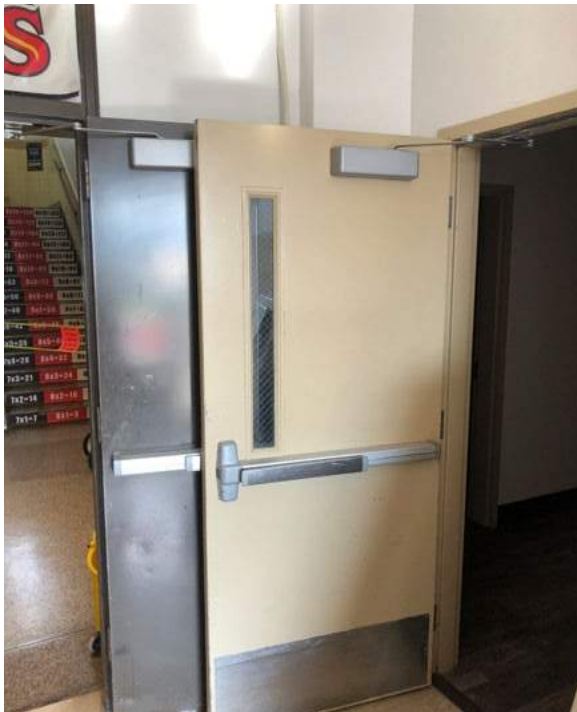
Vestibule and corridor doors overlap.

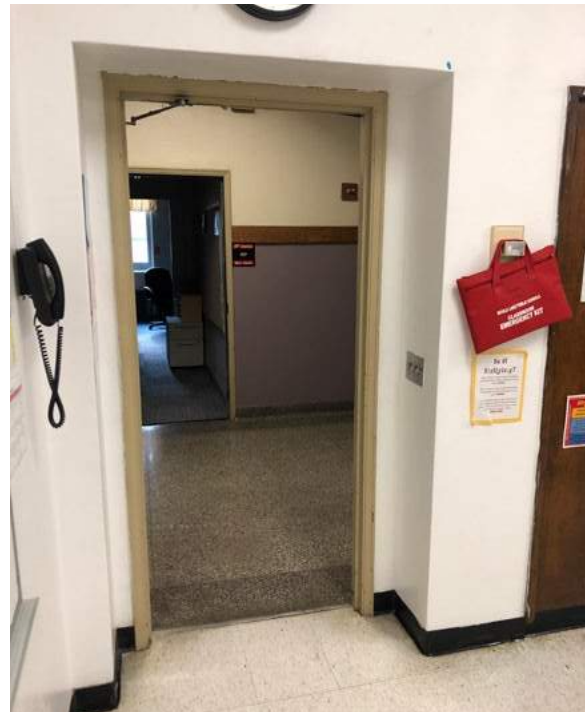
Classroom doors do not all have the minimum push/pull clearances required for handicap accessibility.

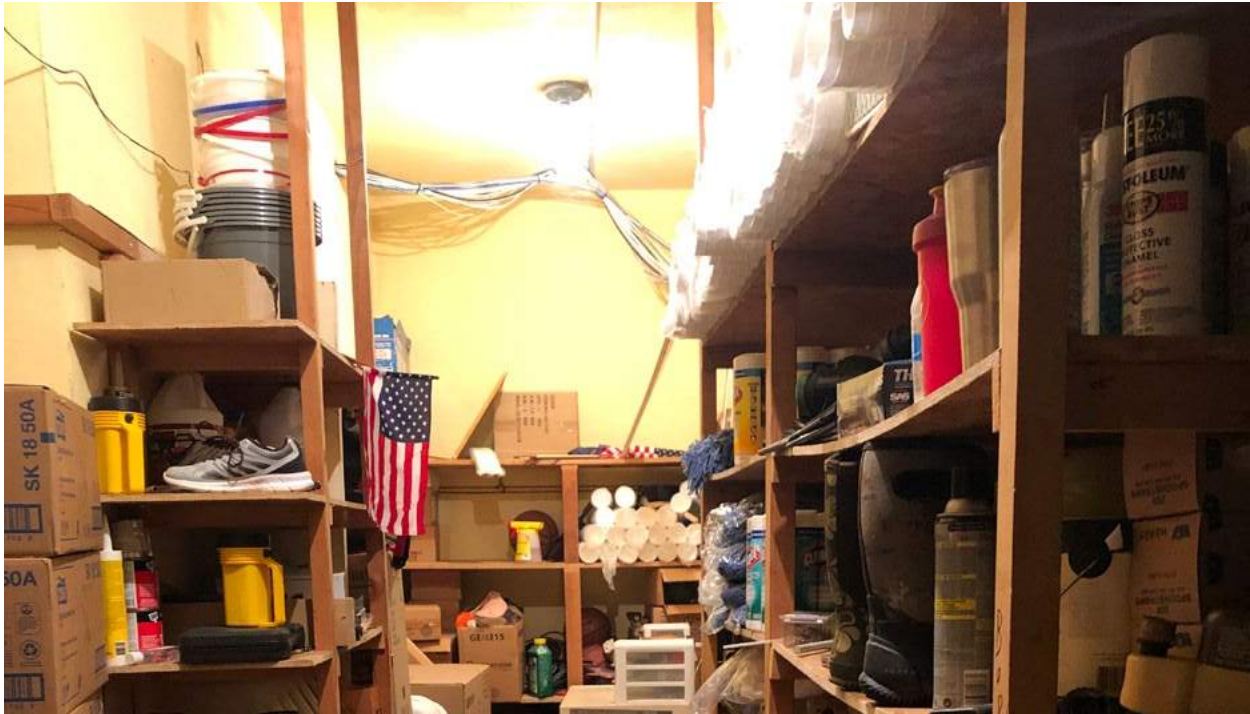
Exposed electrical wiring in storage area.

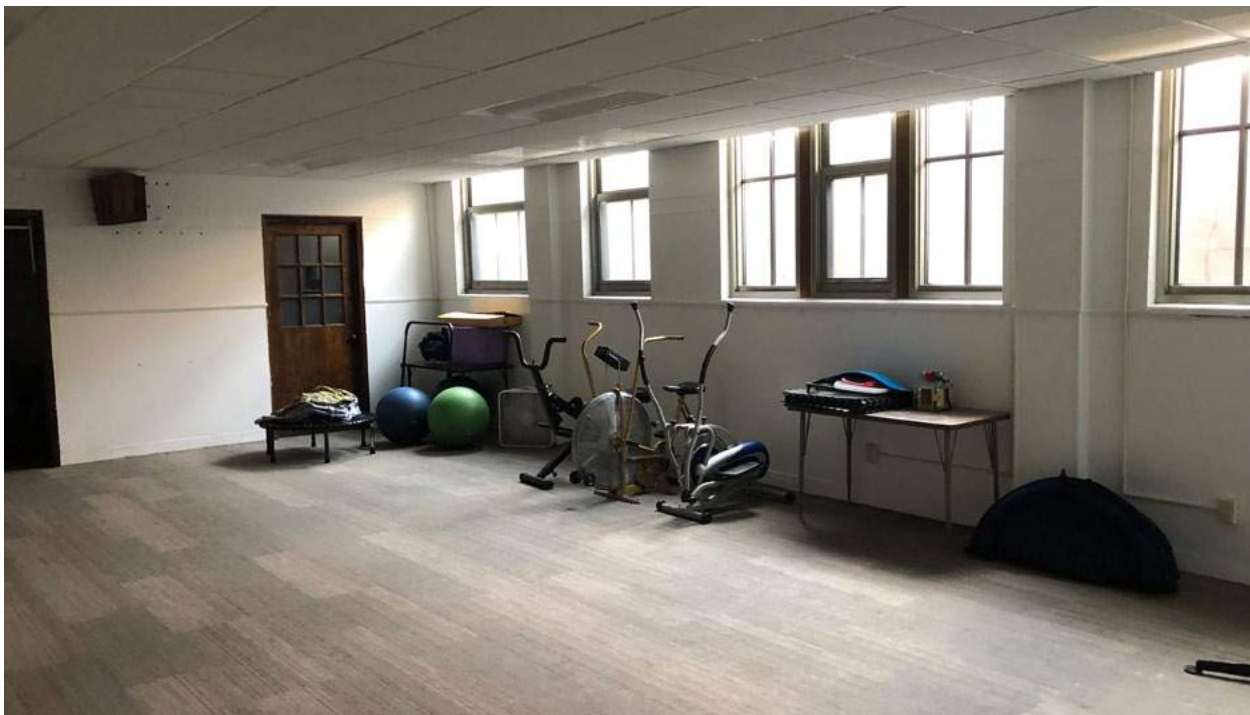
Basement windows in classrooms are not up to code. Egress windows are too high, and do not allow to adequate egress into the courtyard.

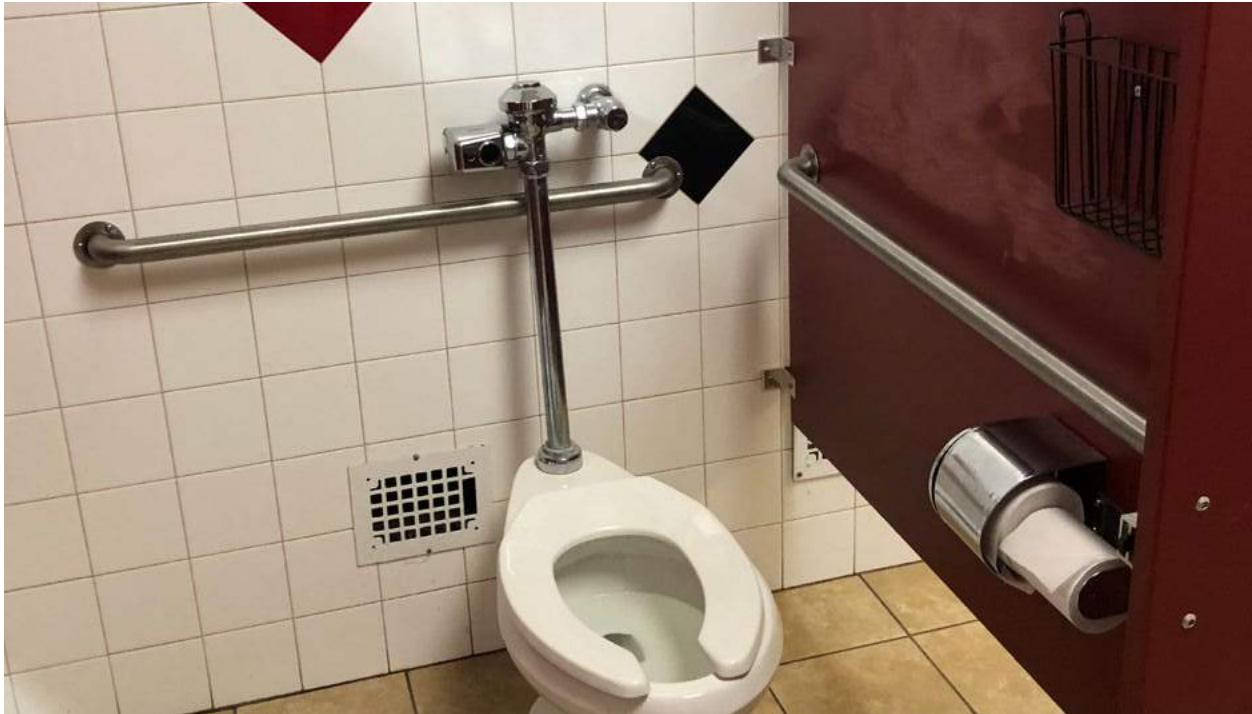
There is no vertical grab bar in the ADA stall in boy's bathroom.

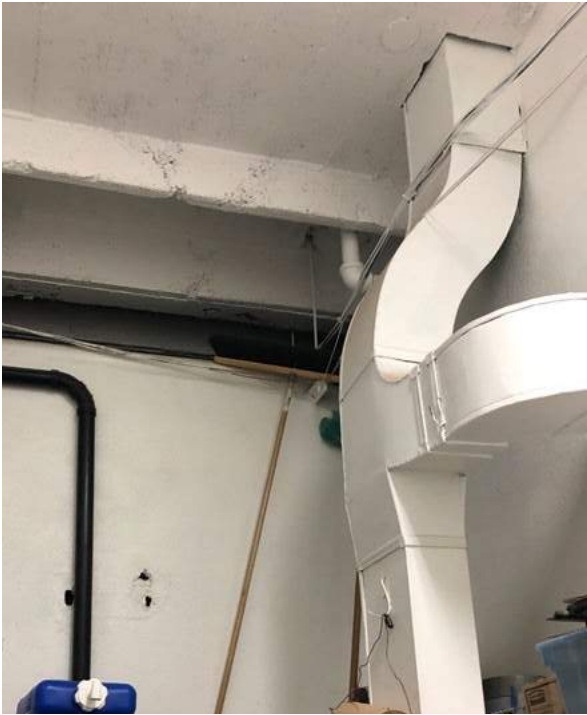
Exposed wiring in custodial closet.

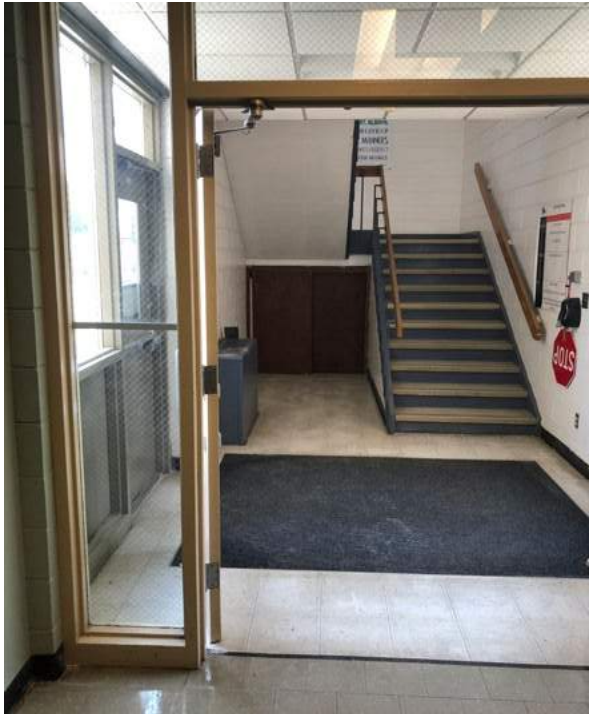
Door 10 has wire in the vestibule windows, this is no longer to code.

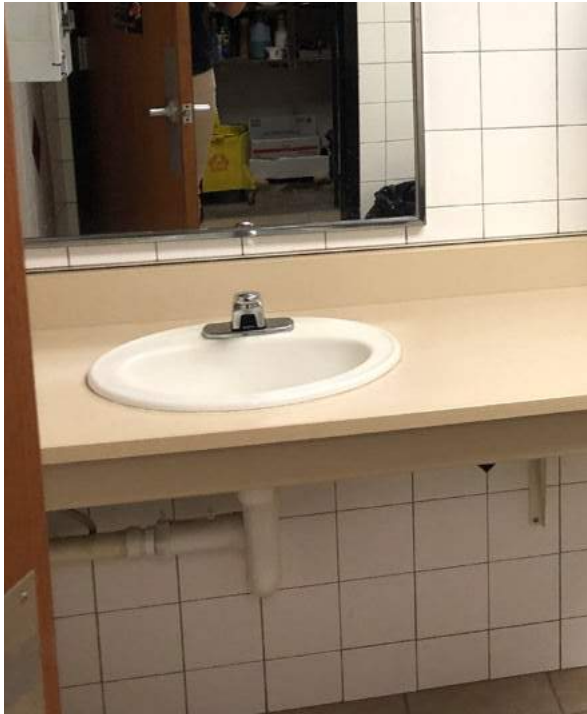
Sink is not handicap accessible in women's bathroom.

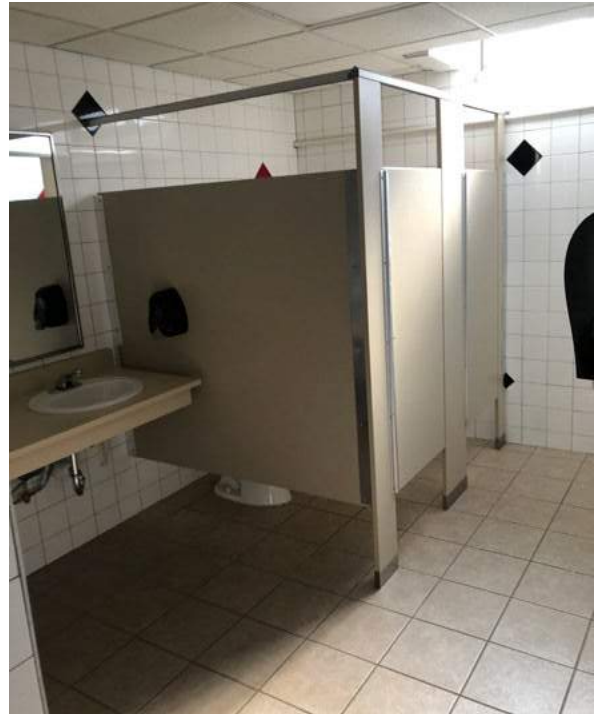
No handicap accessible toilet or sink in women's locker room.

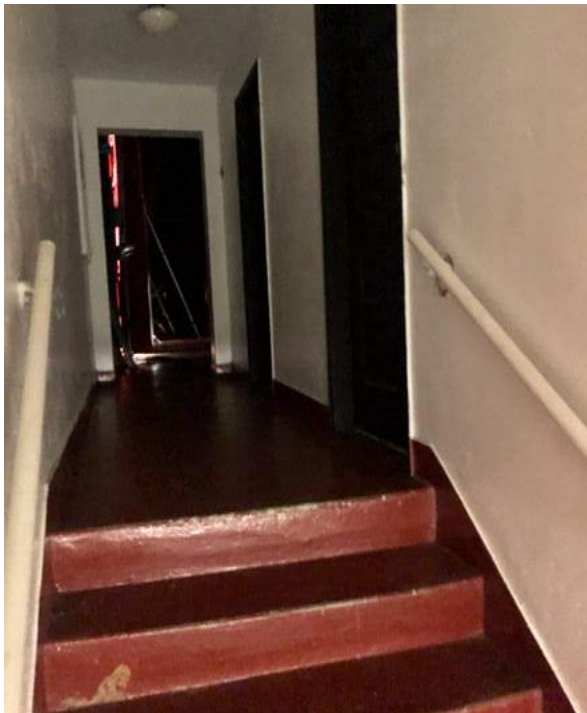
Stage is not handicap accessible, only has stairs.

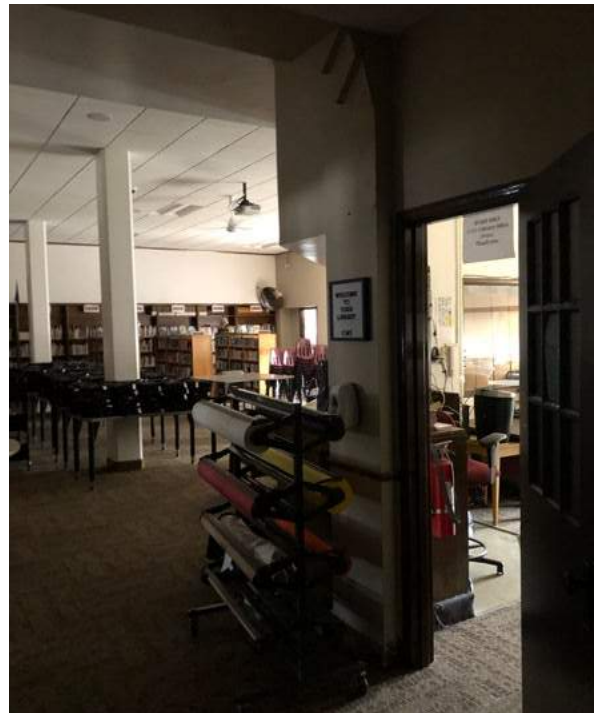
Library only has one exit. A space of this size requires a second exit.

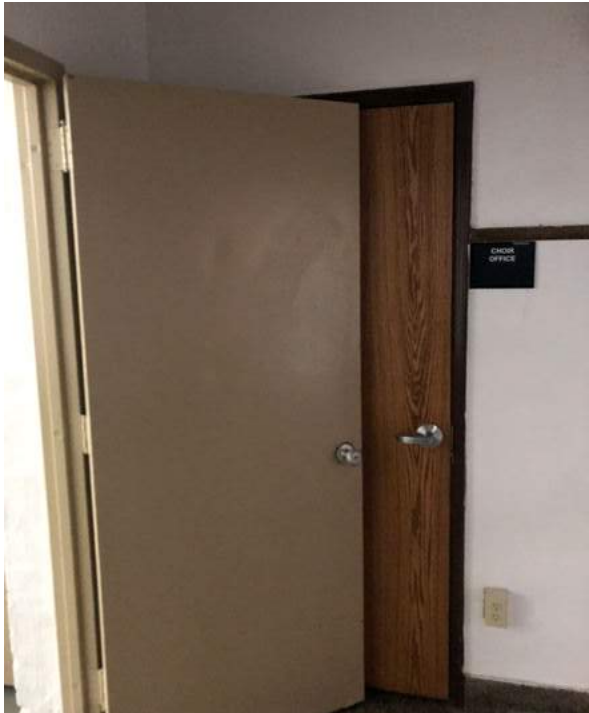
Doors are overlapping.

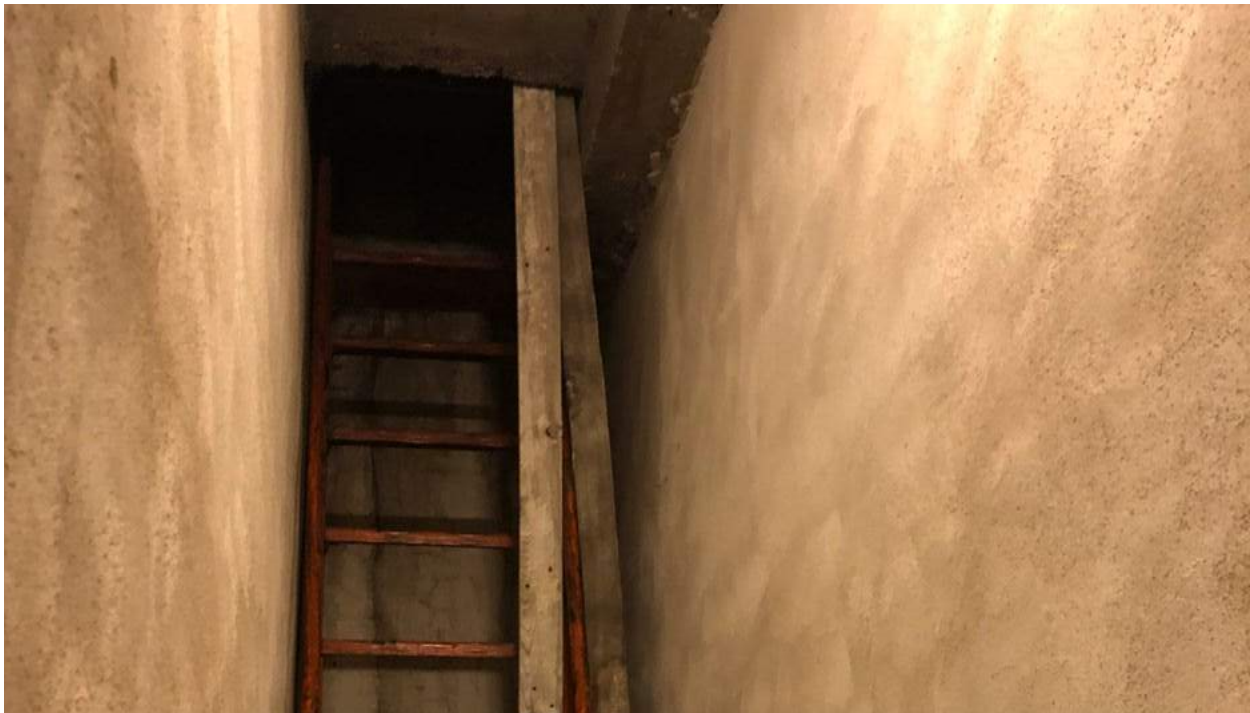
There is no door to the roof access.

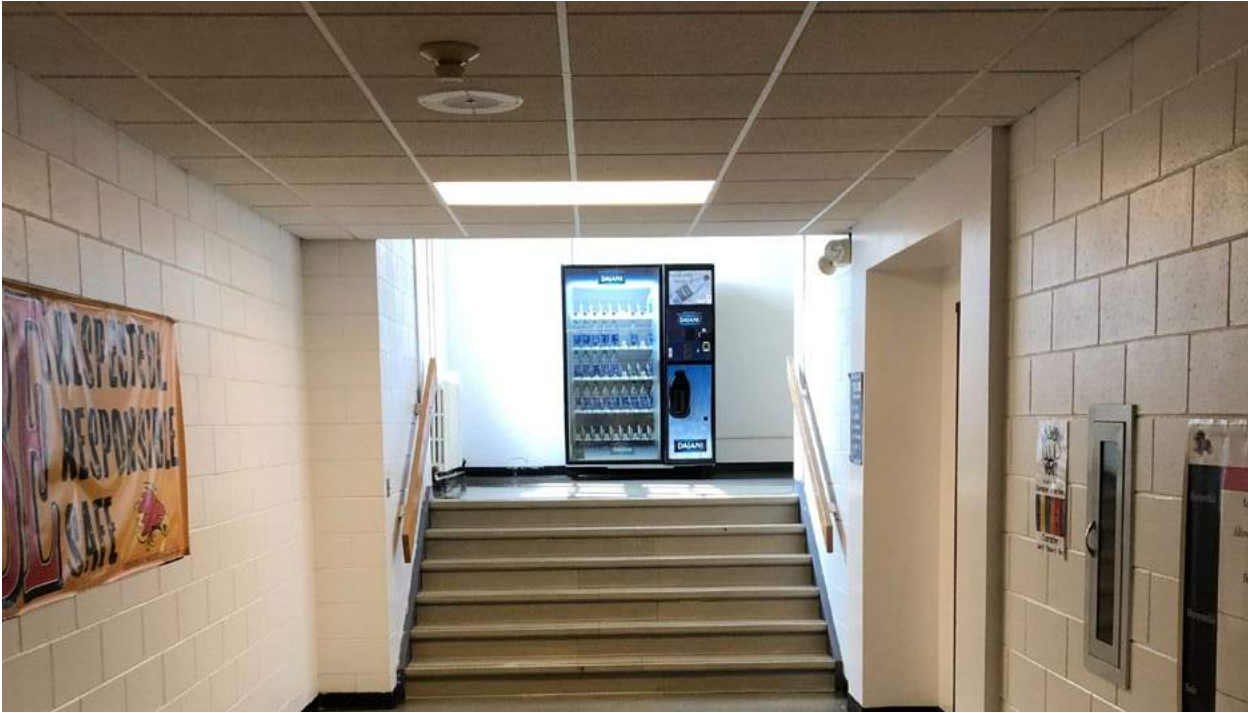
Dead end corridor coming from 1964 addition into the main building.

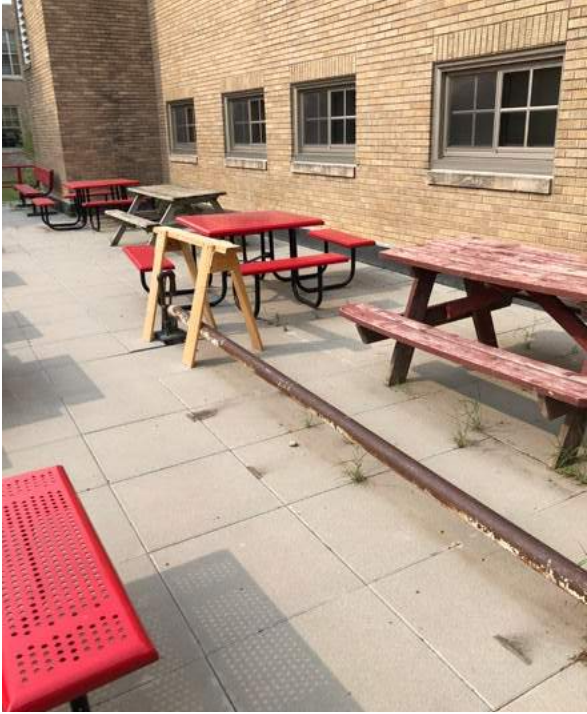
Exposed piping in the courtyard area.

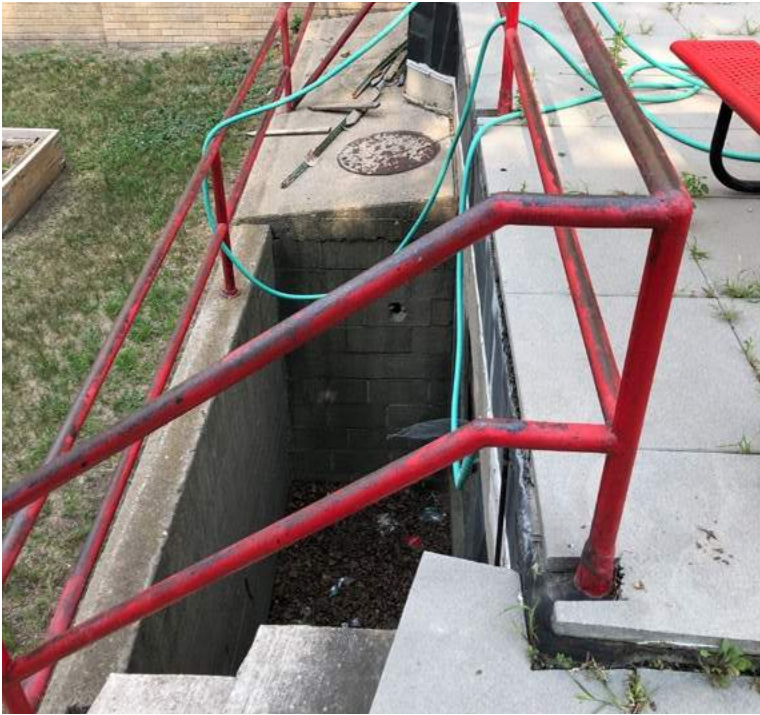
Handrails on steps in courtyard are not to code.

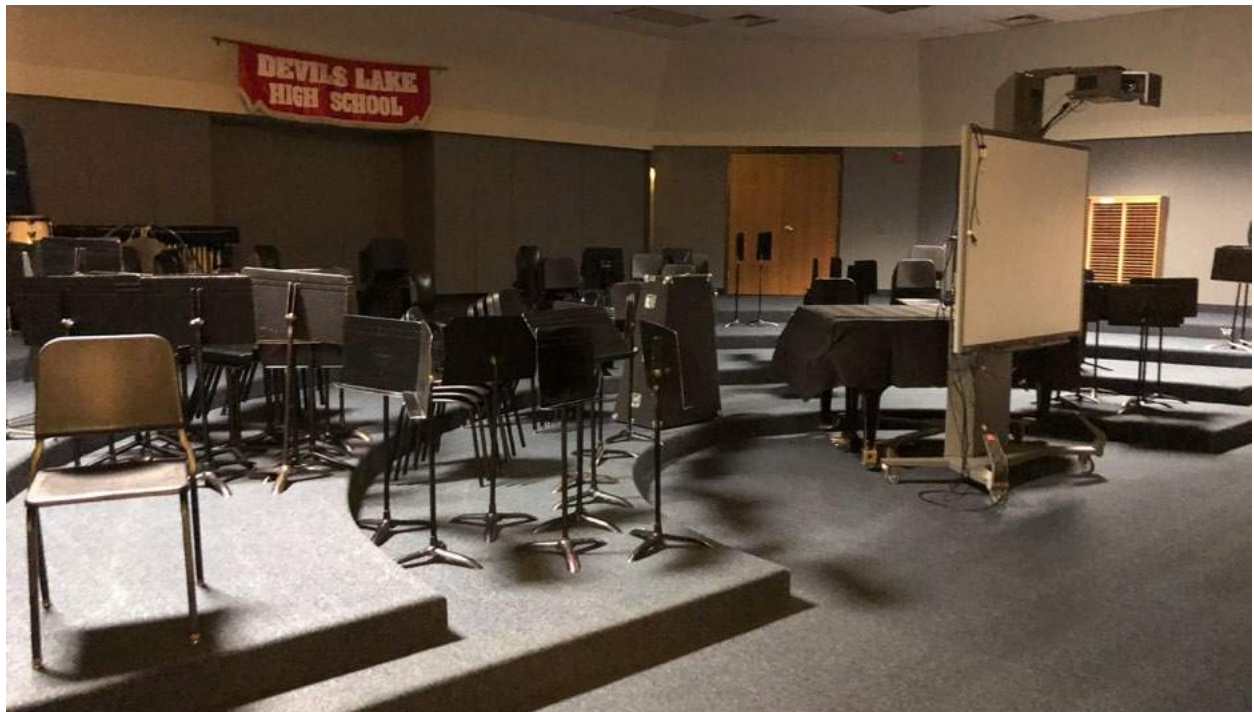
Stage, band room, storage spaces, and work room are not handicap accessible.

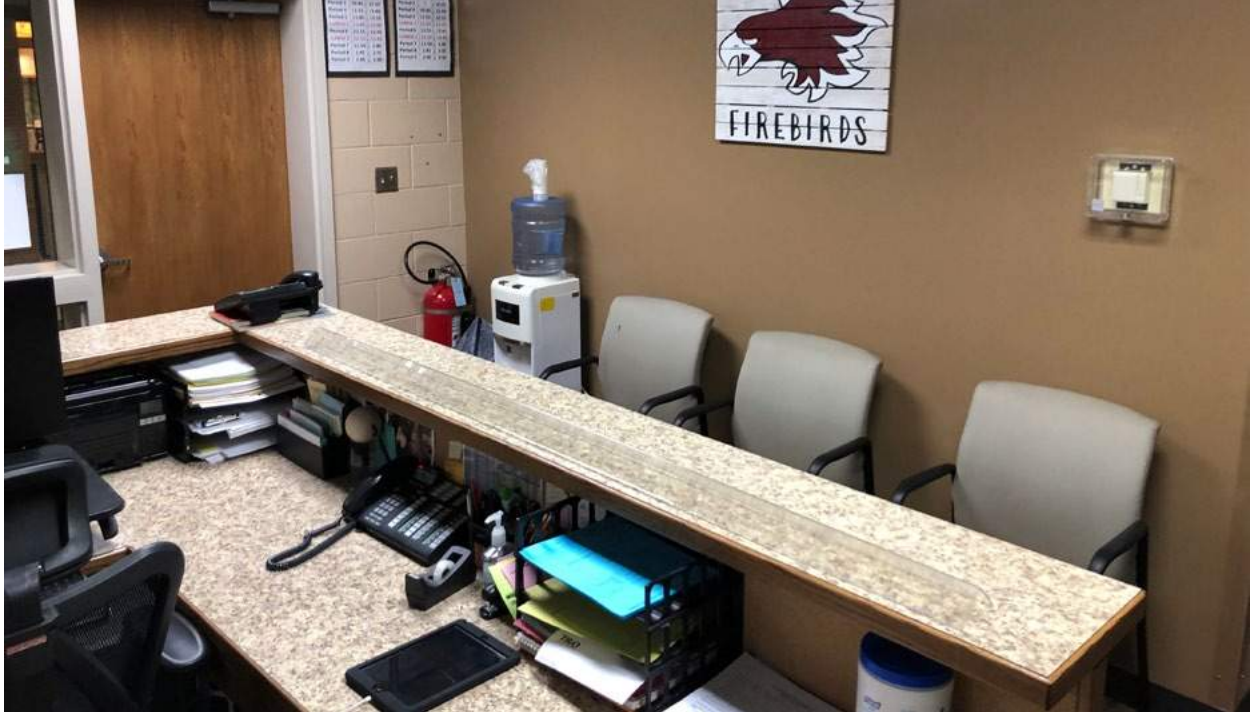
Main office does not have a handicap accessible reception desk and there is a lack of waiting space.

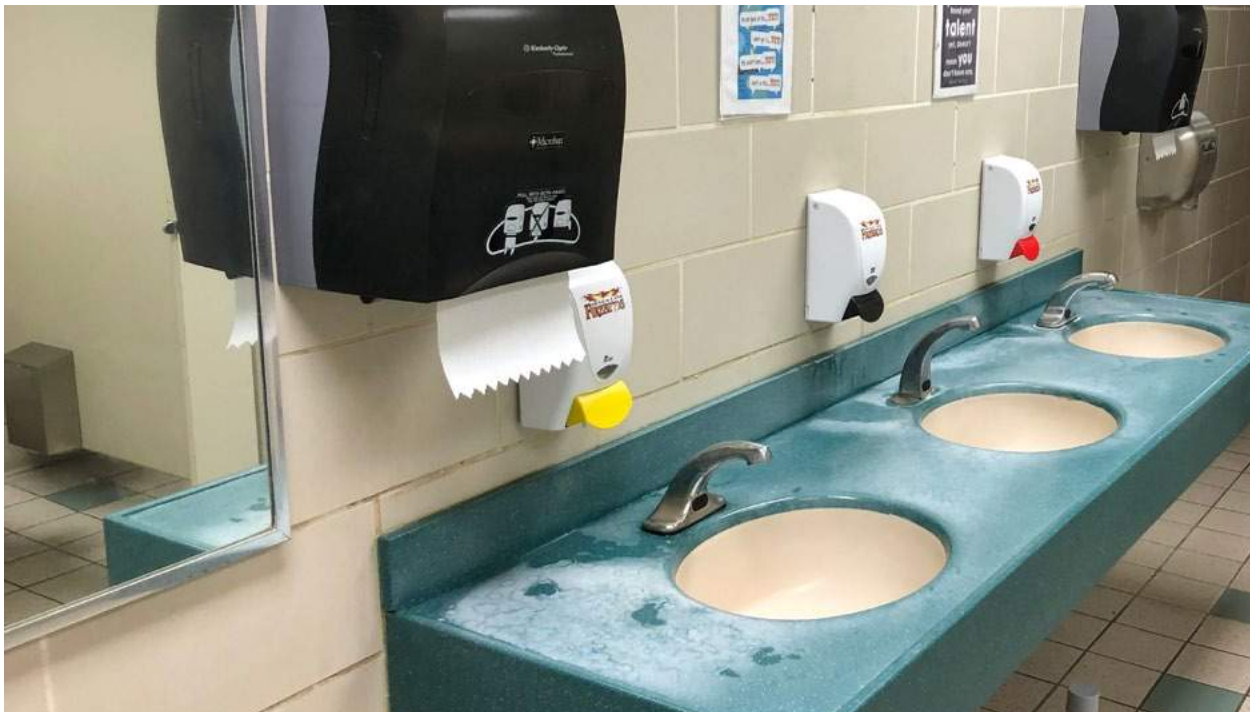
Sinks, soap dispensers, and paper towel holders in men's and women's restrooms are not handicap accessible due to reach ranges.
