ICON
ARCHITECTURAL GROUP

FACILITY ASSESSMENT FOR DEVILS LAKE PUBLIC SCHOOLS

Devils Lake, ND

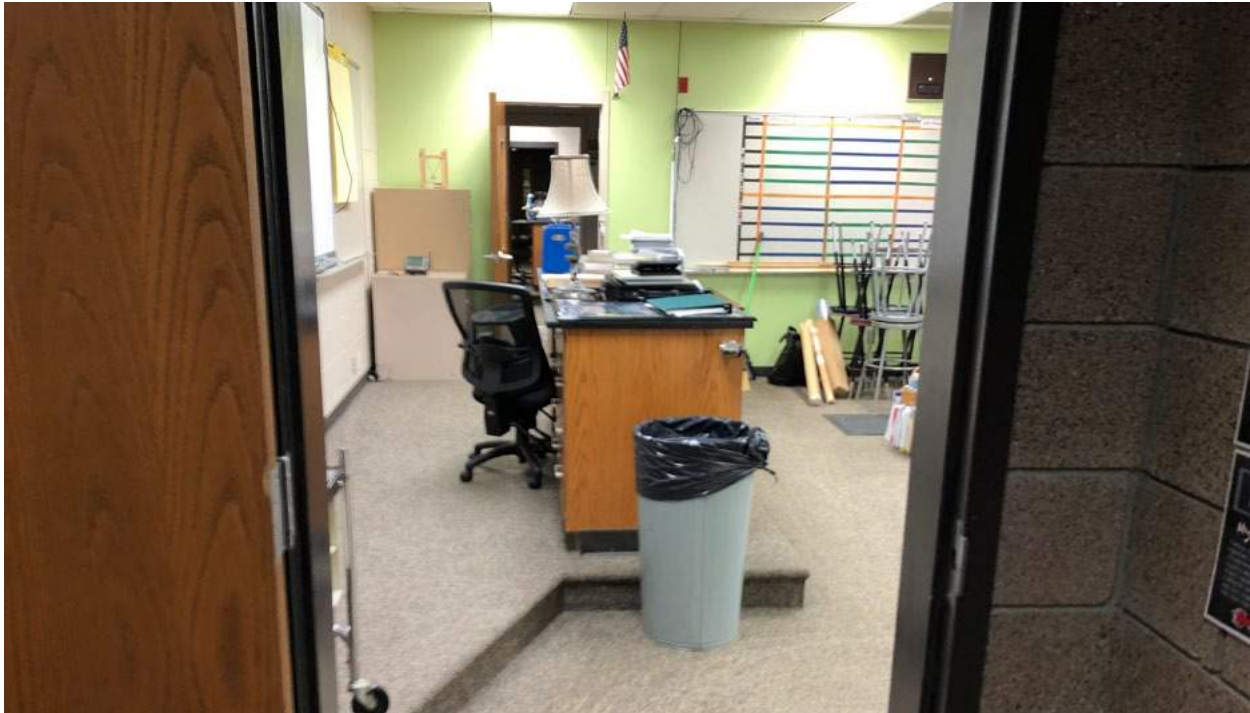
Raised teaching platforms in Science rooms are not accessible.

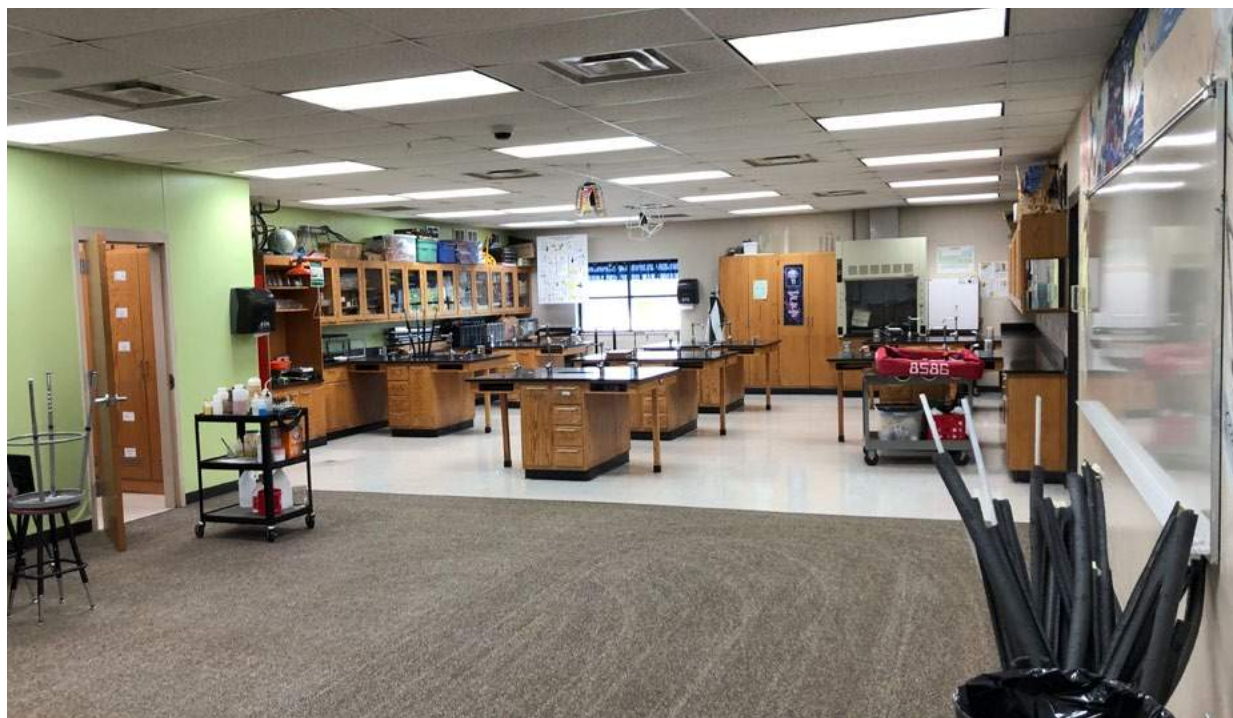
There is not a handicap accessible lab desk in the science rooms.

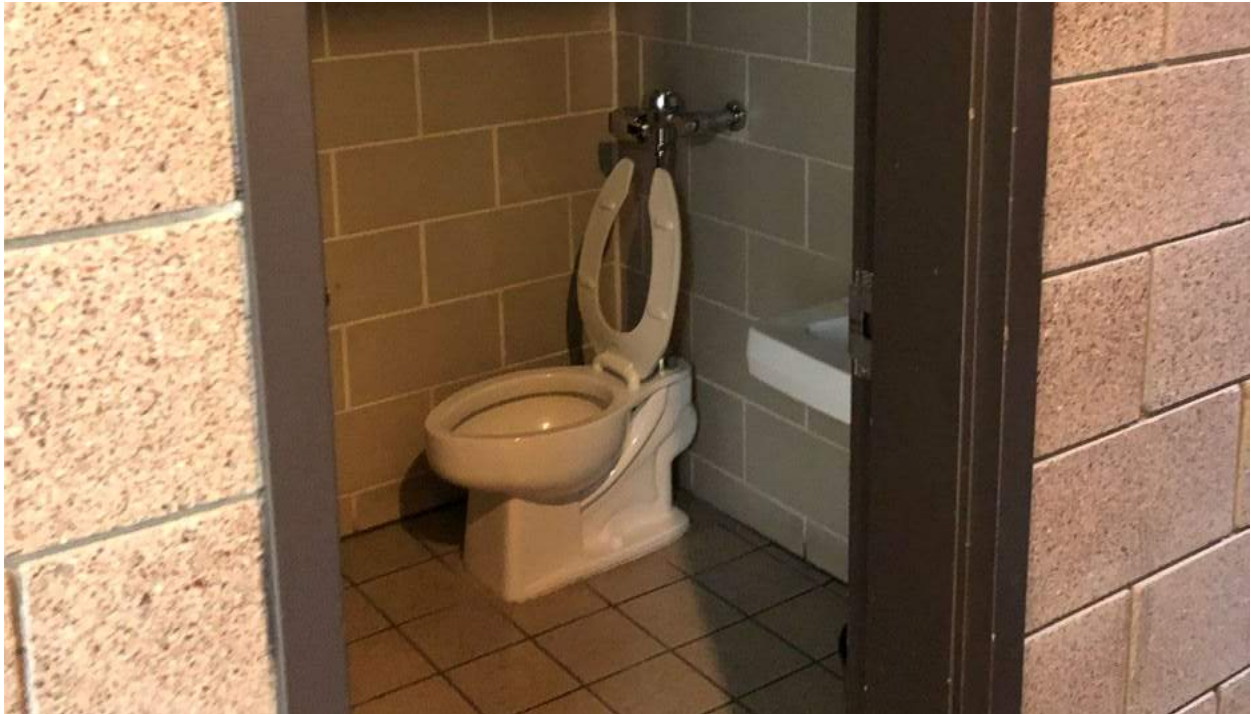
The single restroom on the second floor is not handicap accessible.

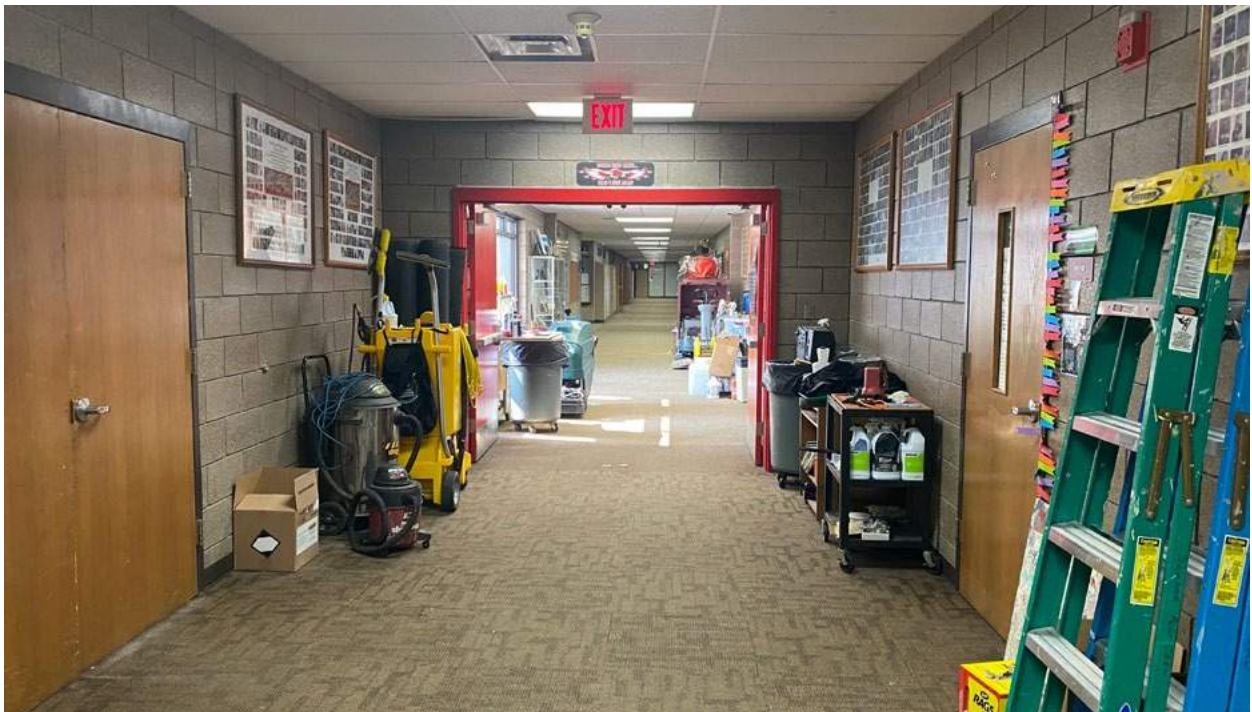
Corridor doors and frames are not fire rated and are aged. Panics on some doors are aged.

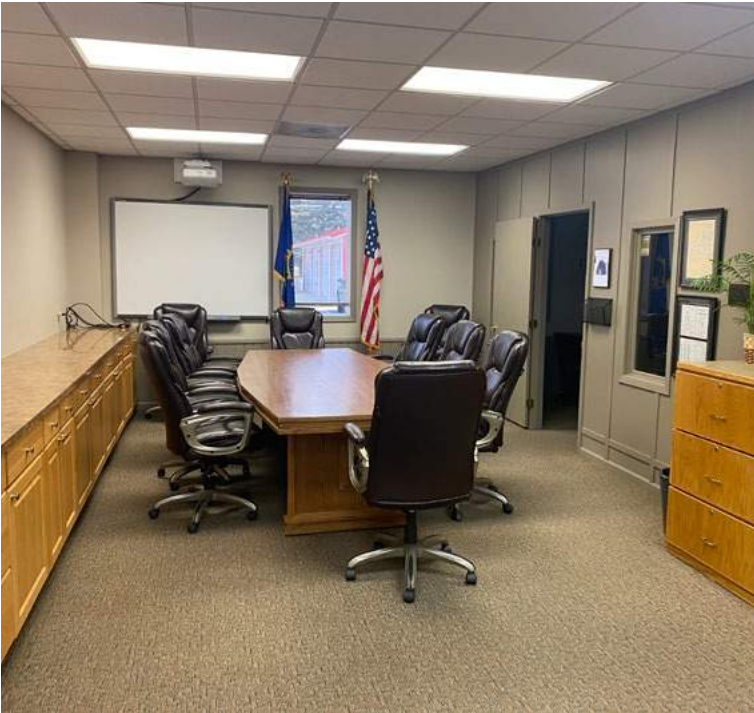
District Office Board Room is undersized and has no privacy or acoustic control. Superintendent's office is only accessible through this Board Room.

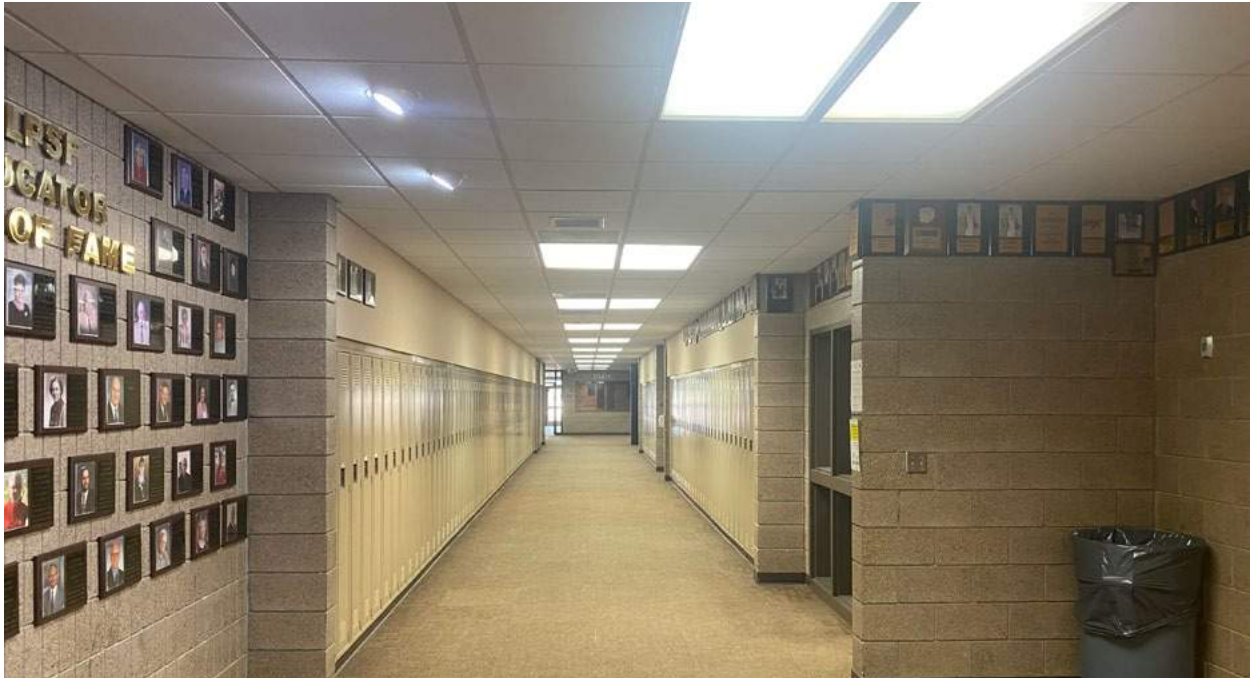
Ceiling tiles are in adequate shape, but the grids are yellow.

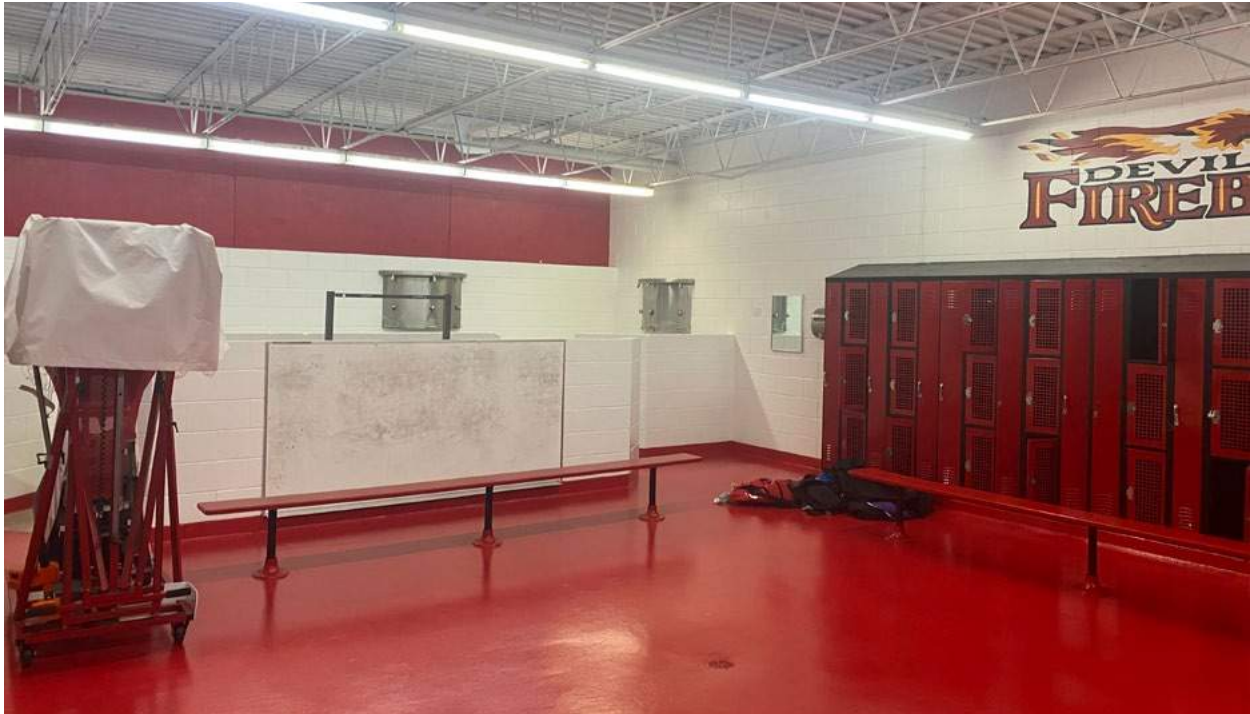
There are no handicap accessible shower stalls, sinks, or drinking fountains in the locker rooms.

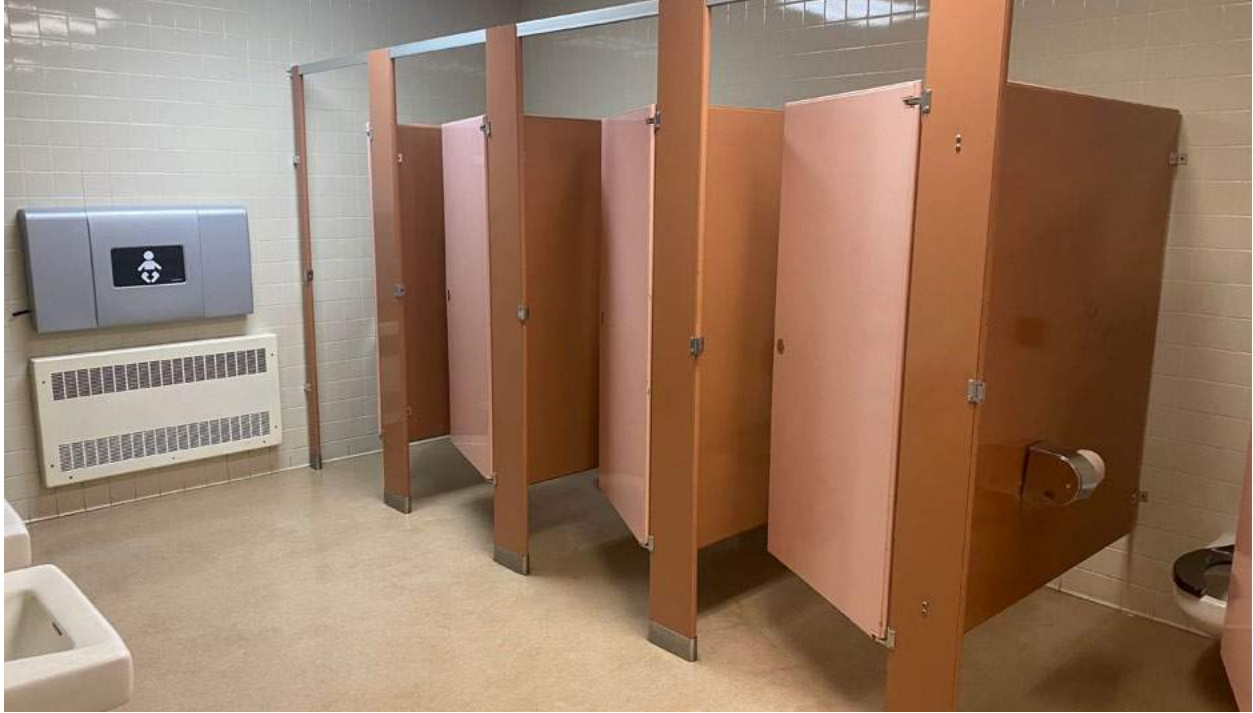
Toilet partitions need a refresh in the women's restroom.

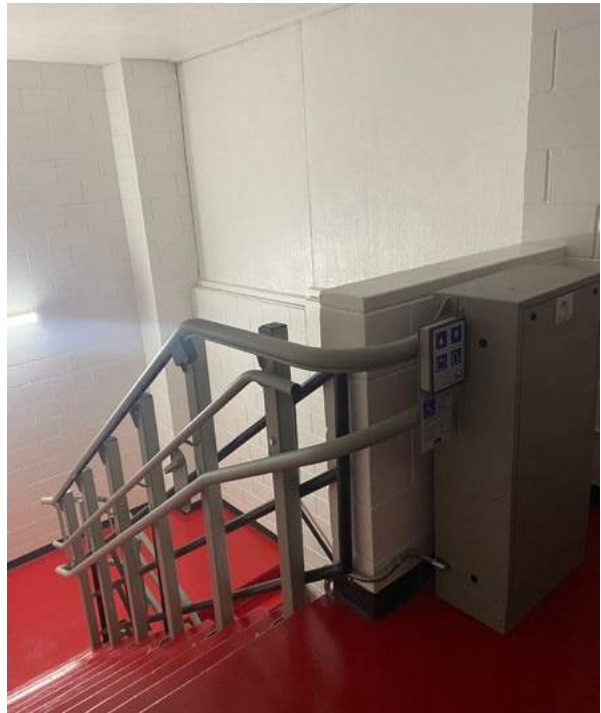
Hand and guard rails on stairs are not to code.

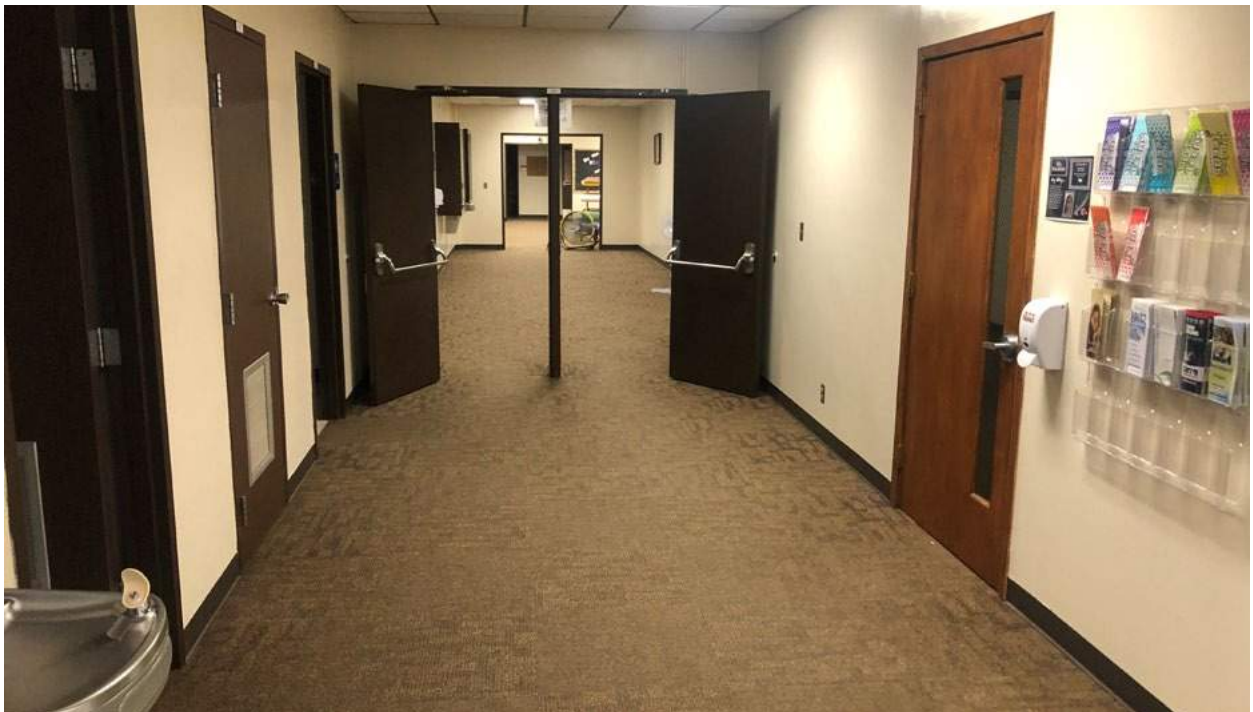
Doors and frames in corridor are not all fire rated.

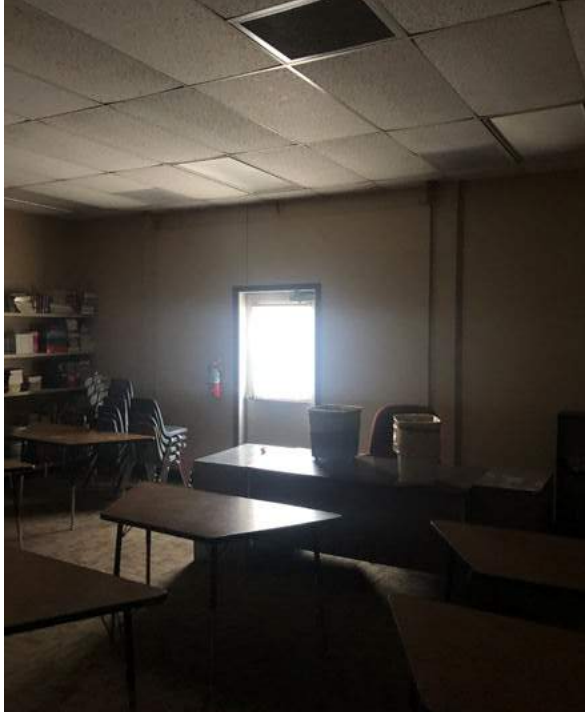
No insulation in Room 301, used to have a garage door.

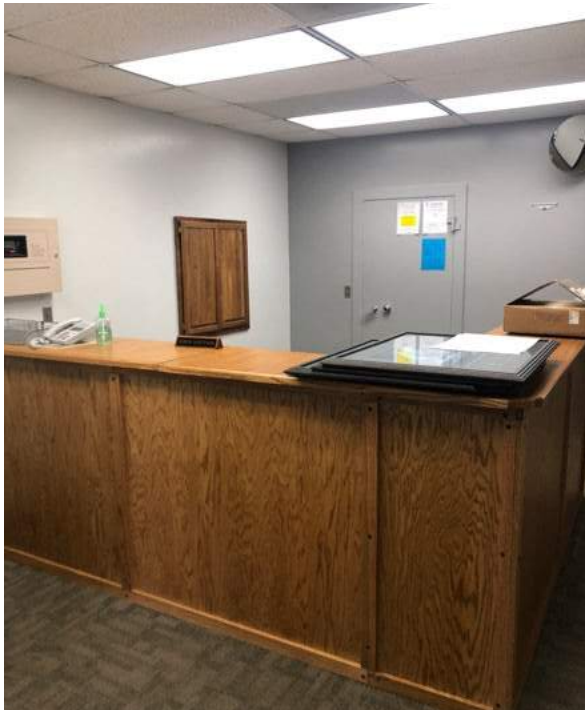
Casework in main office is not handicap accessible.

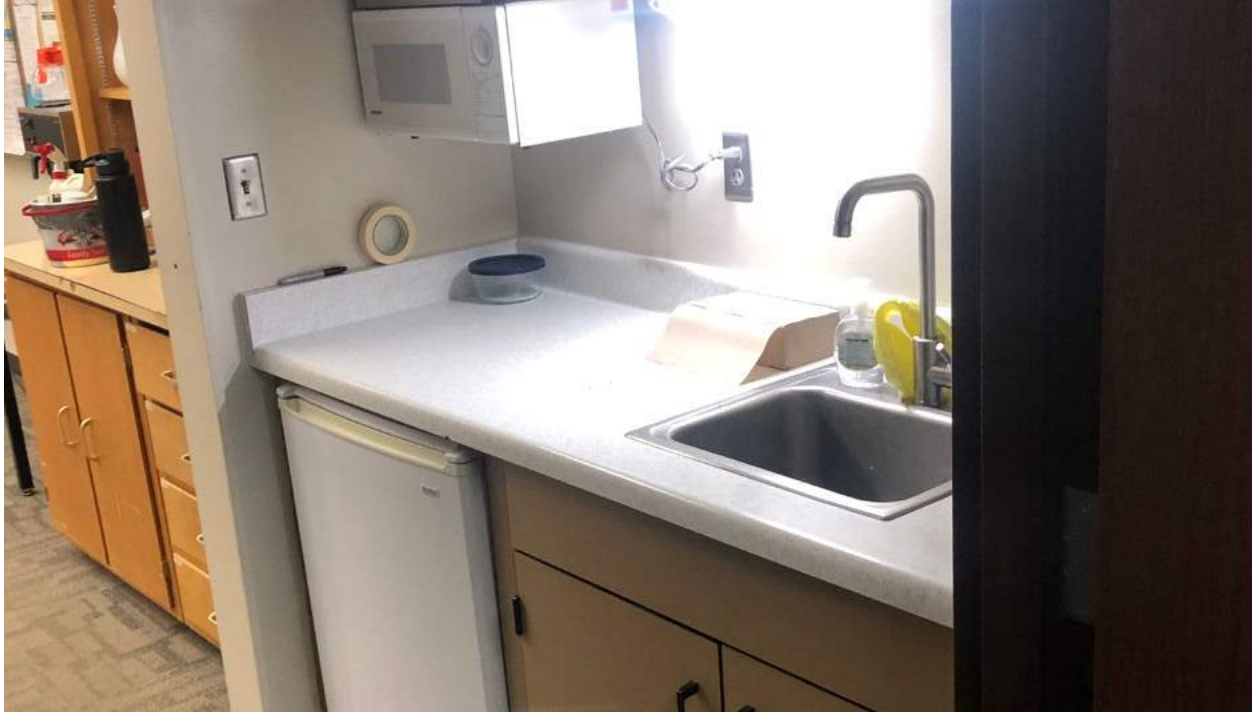
Sink and countertop not handicap accessible in staff room.

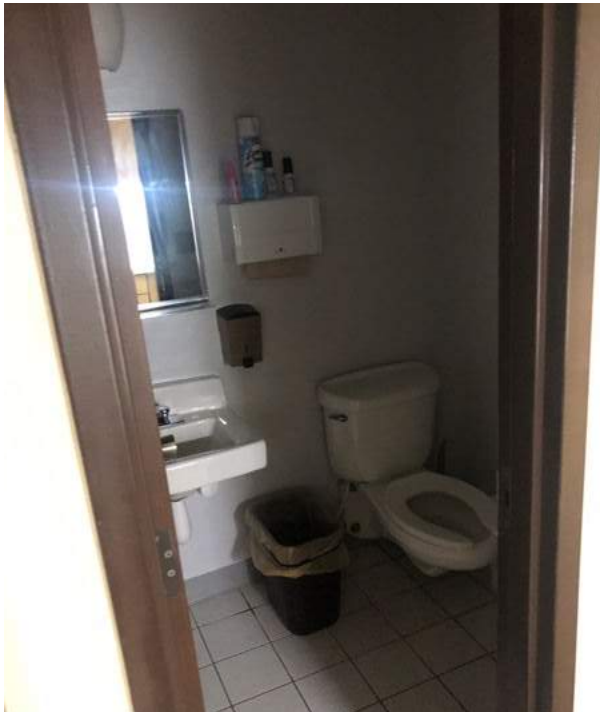
Toilet in staff room restroom is not handicap accessible.

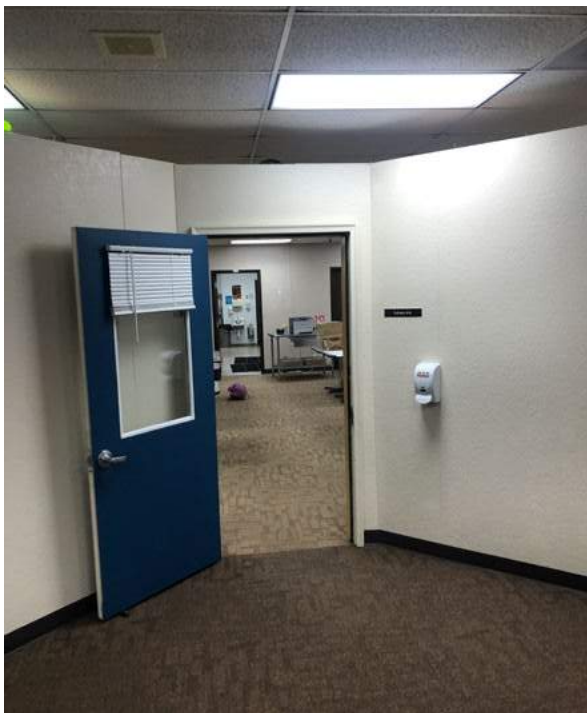
Walls for culinary arts classroom don't meet the ceiling.

General Maintenance of Doors and Windows	34,264 SF	\$1.74 /SF		\$59,755			\$59,755
New ADA Casework in Main Office	34,265 SF	\$1.20 /SF		\$41,053			\$41,053
Frame Walls in Culinary Arts Classroom past Ceiling in 5 Years	34,264 SF	\$0.89 /SF			\$30,442		\$30,442
Total Capital Maintenance	34,264 SF	\$105.19 /SF					\$3,604,093
Total				\$1,652,734	\$1,883,229	\$454,135	\$0
							\$3,990,098

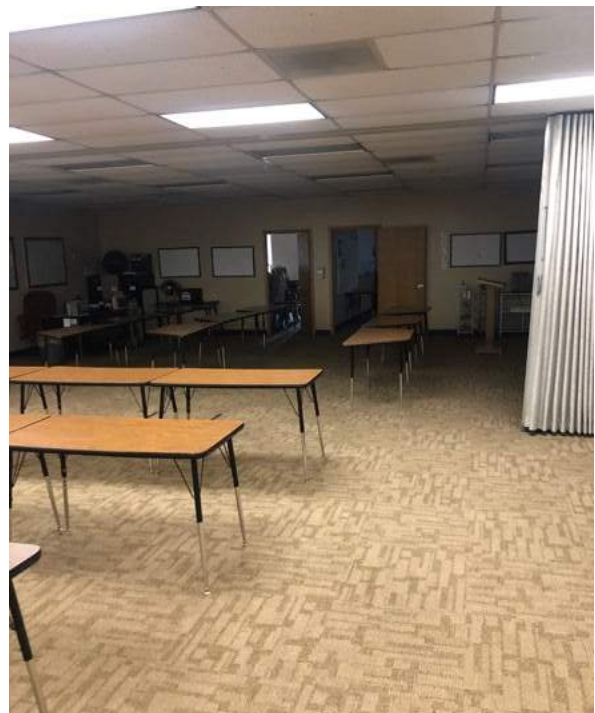
Alternative HS classrooms have no acoustic control and are considered intervening spaces, and are not code compliant.

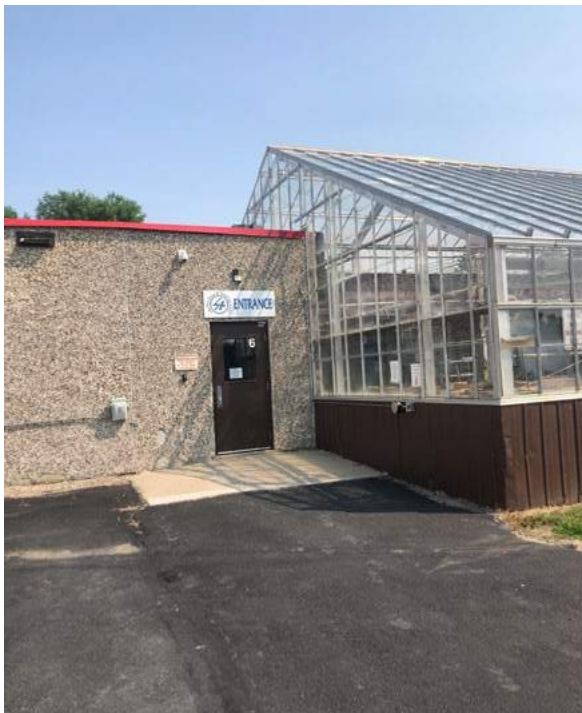
Student entrance is not a secure entry and lacks an interior vestibule.
