ICON
ARCHITECTURAL GROUP

FACILITY ASSESSMENT FOR DEVILS LAKE PUBLIC SCHOOLS

Devils Lake, ND

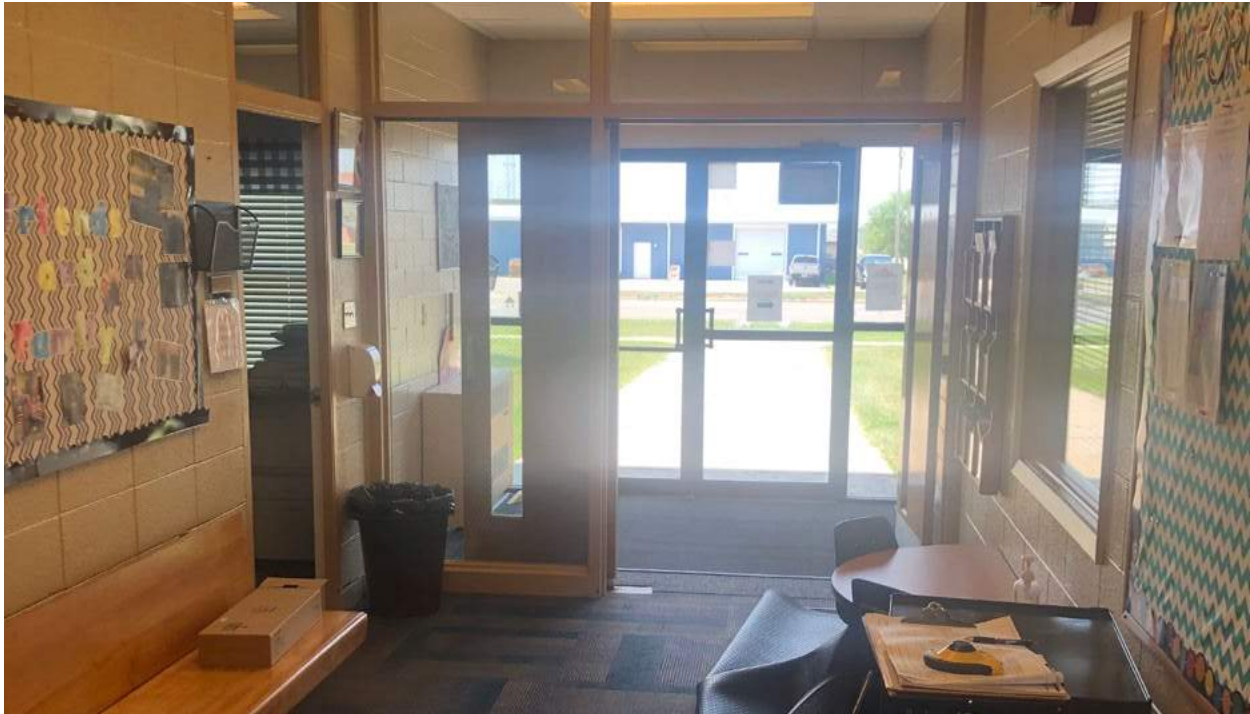
Interior vestibule doors do not have a closer.

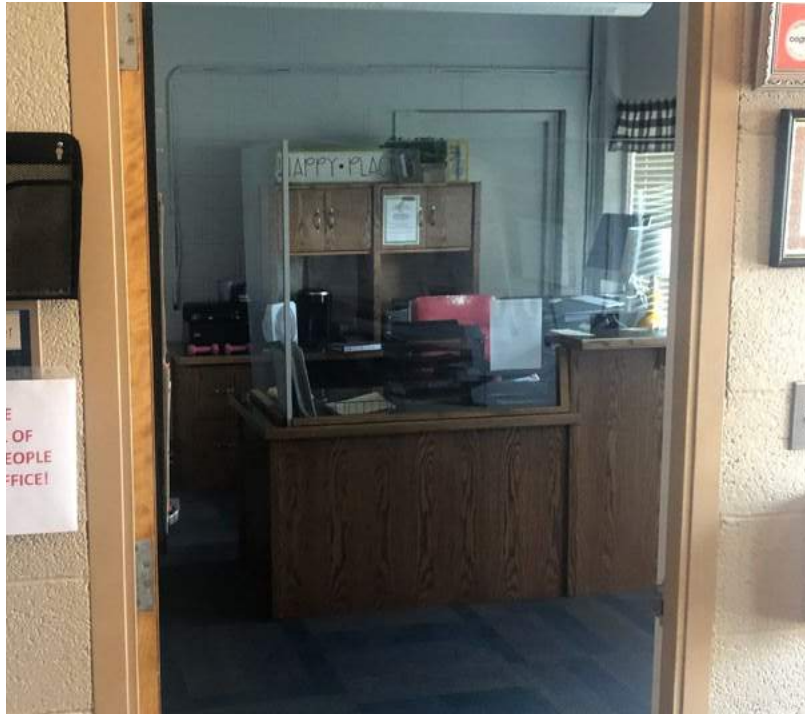
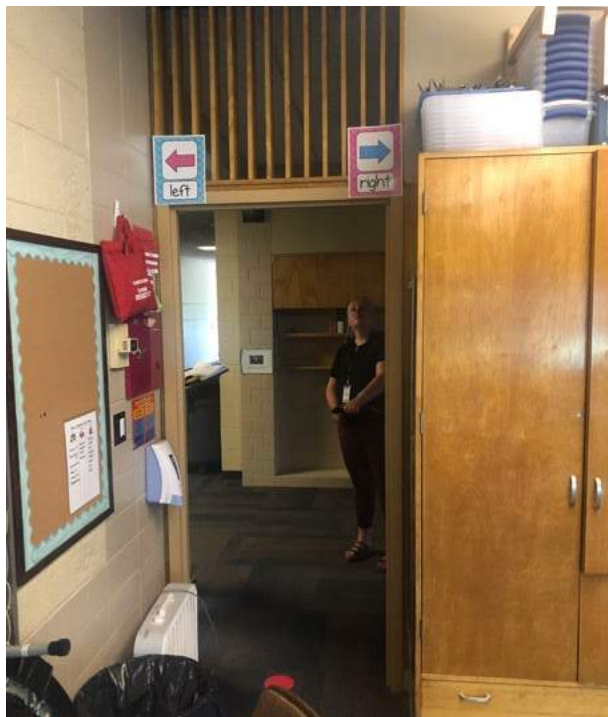
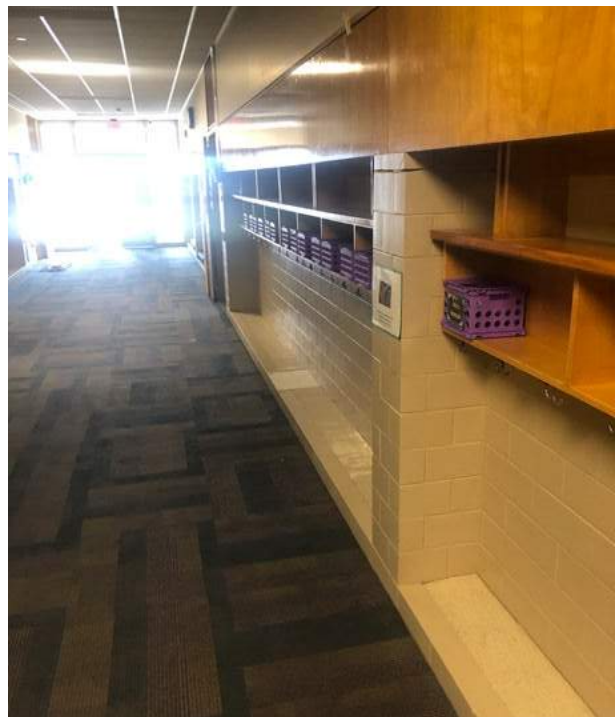
Casework is aged in corridors, classrooms, and the main office.

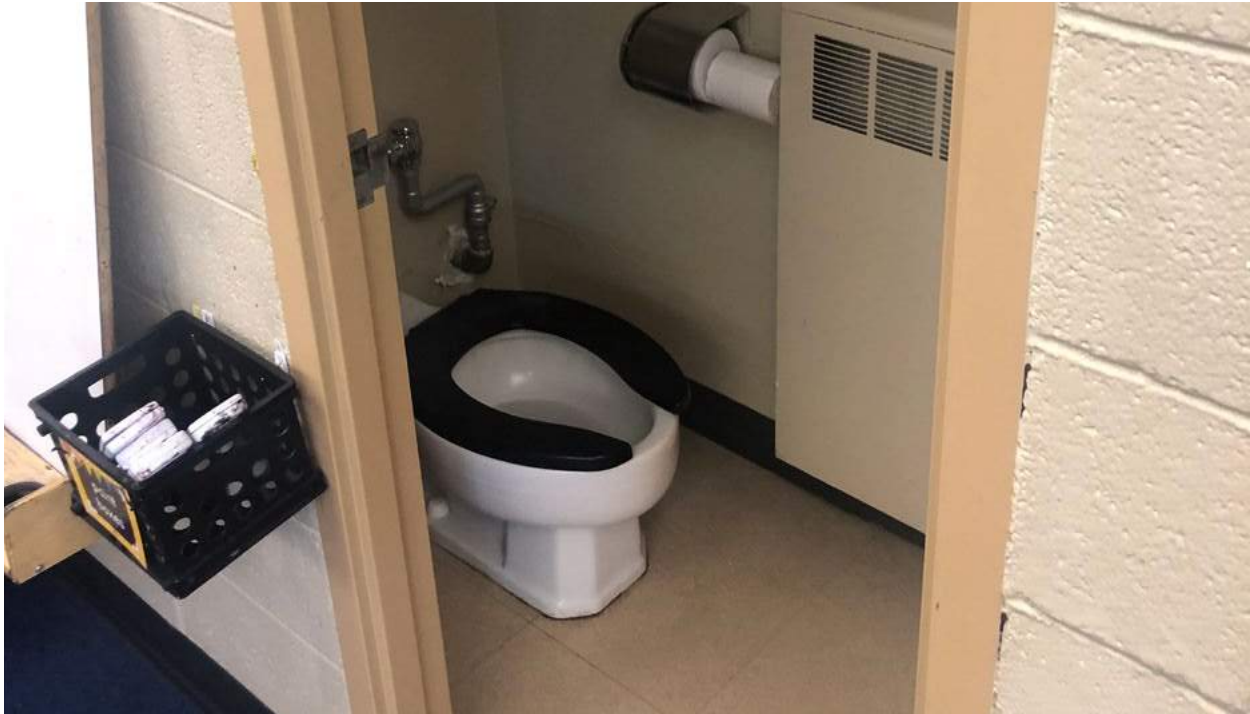
Restrooms within classrooms are very small and do not meet maneuverability and clearance requirements.

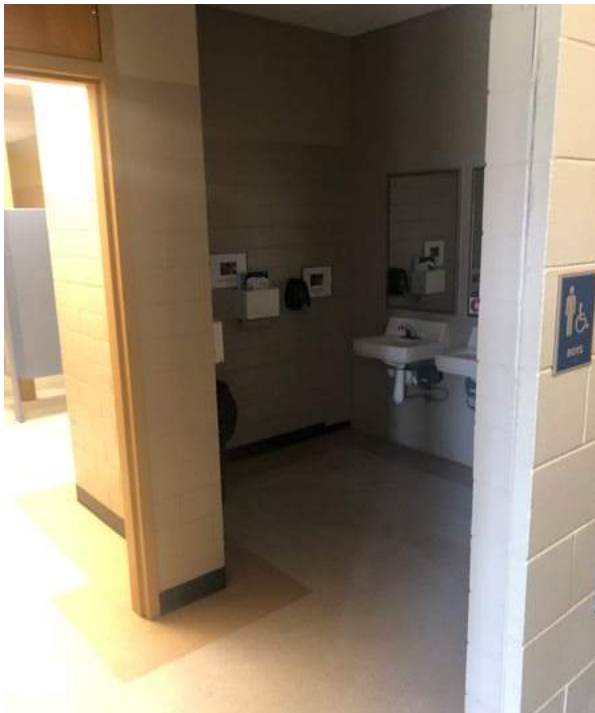
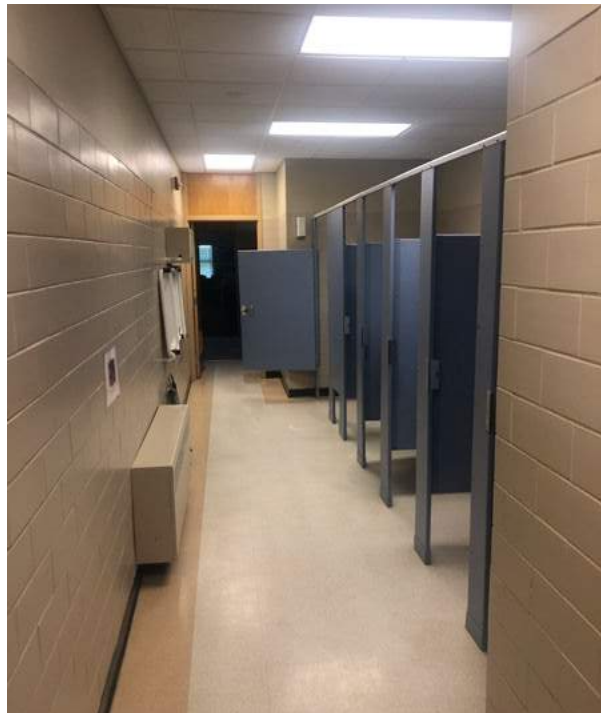
The restrooms lack privacy and do not meet handicap accessibility.

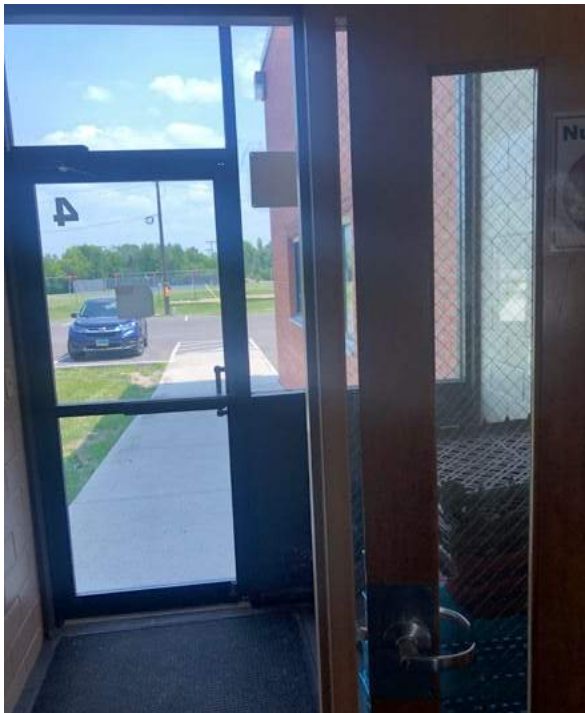
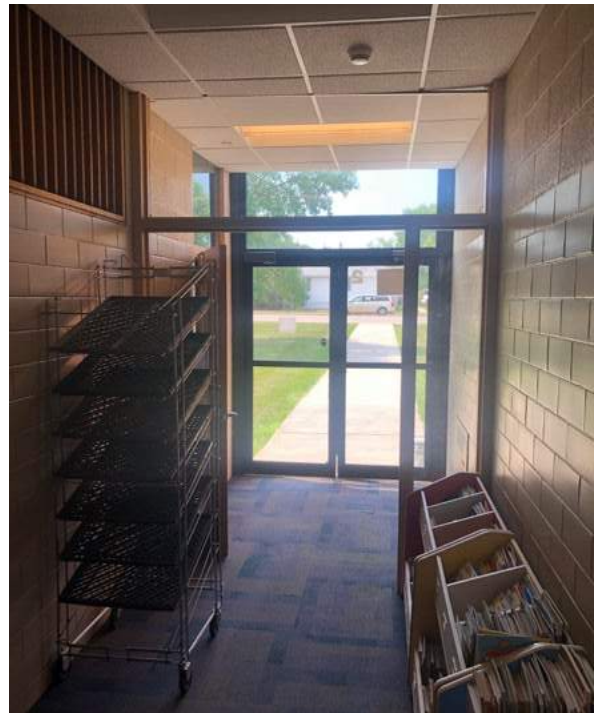
No interior vestibule doors throughout the building.

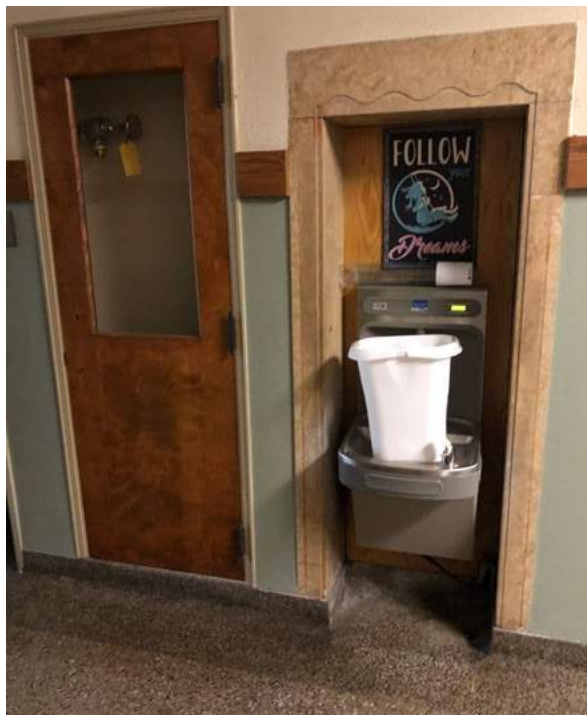
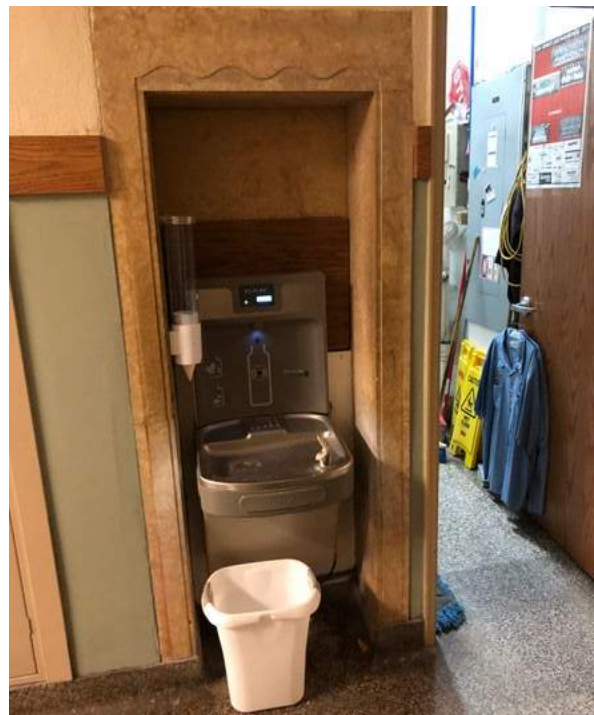
Drinking fountain alcoves around the building are not wide enough.

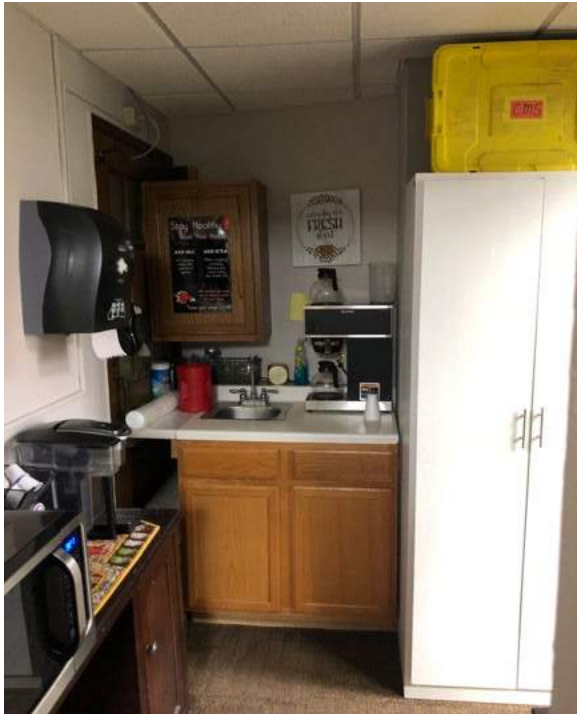
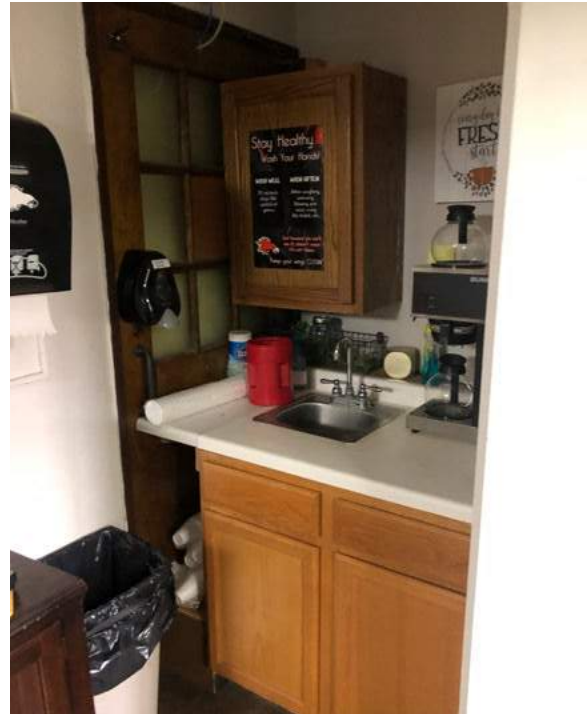
Break room in main office is not handicap accessible. Sink is too small, too high, and too far back. Space does not meet maneuverability clearance requirements.

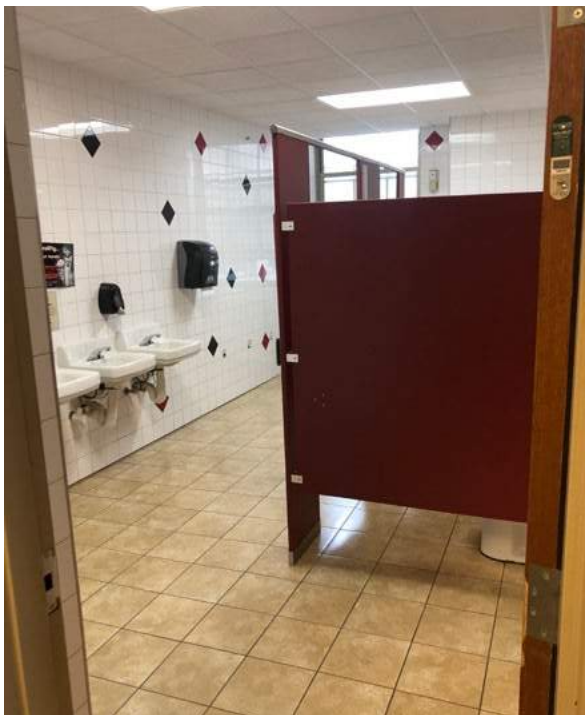
There is a lack of privacy looking into the bathrooms.

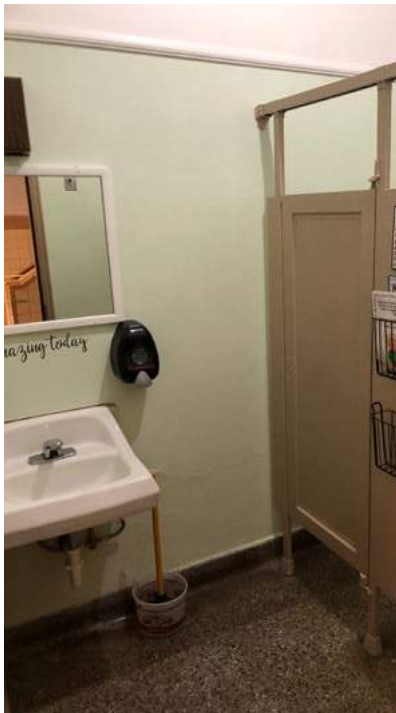
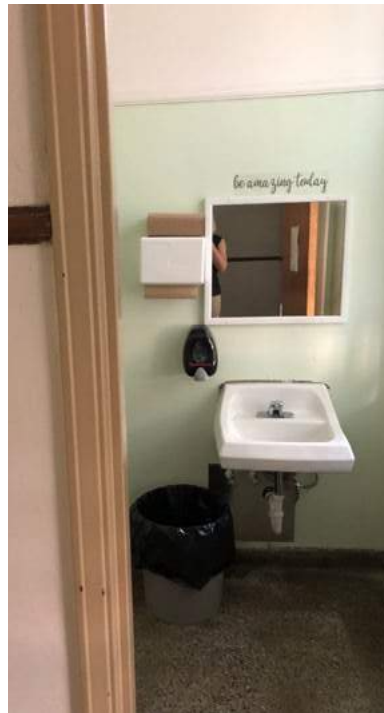
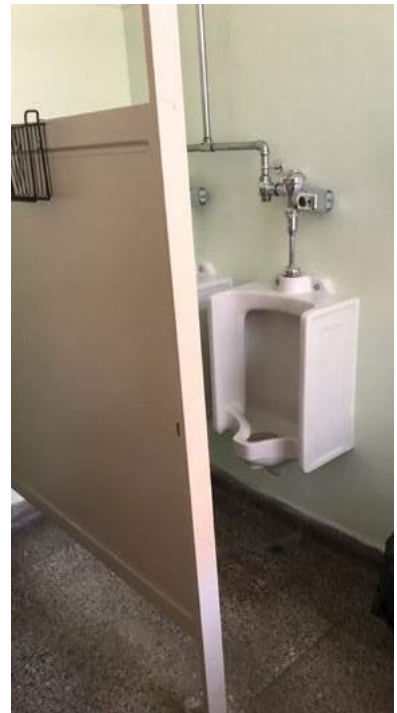
Staff restrooms are not handicap accessible. Stalls are not ADA compliant, sinks are not accessible.

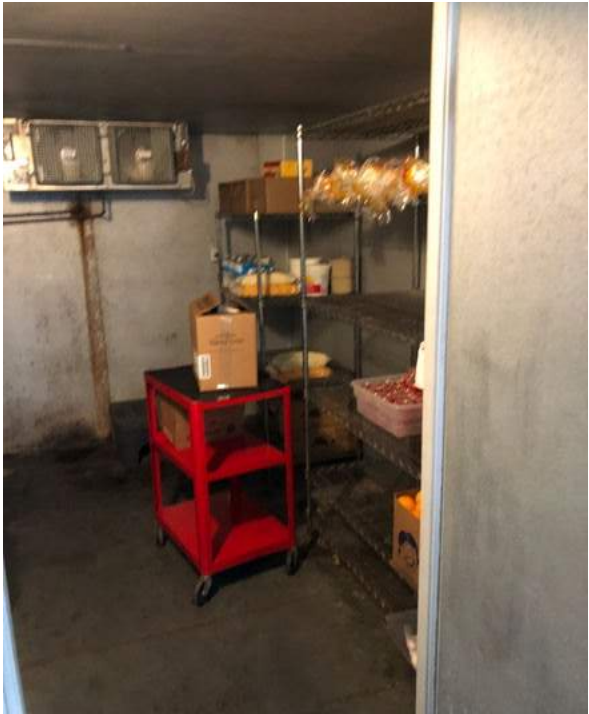
Kitchen cooler is in rough shape.

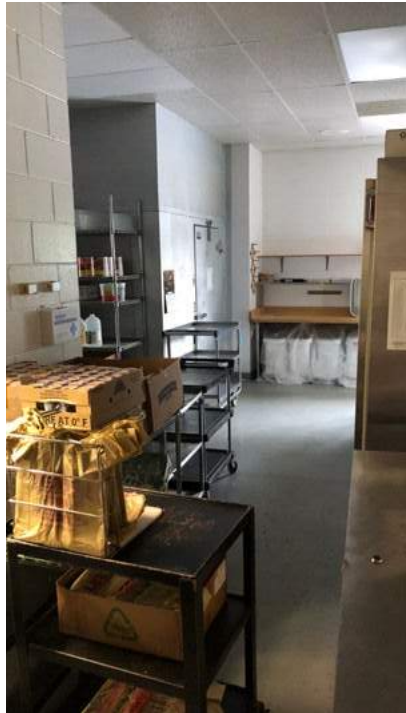
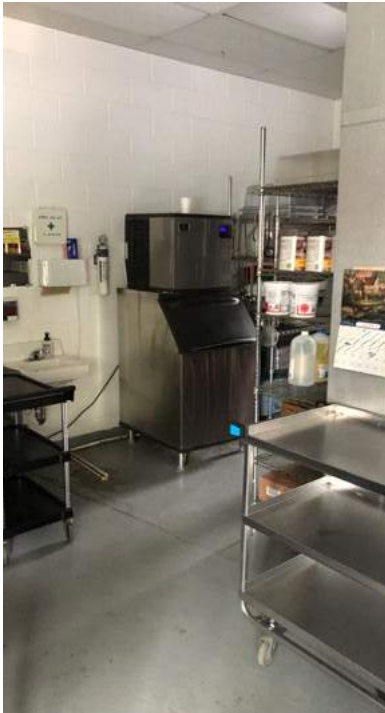
Kitchen spaces are tight and lack proper storage areas.

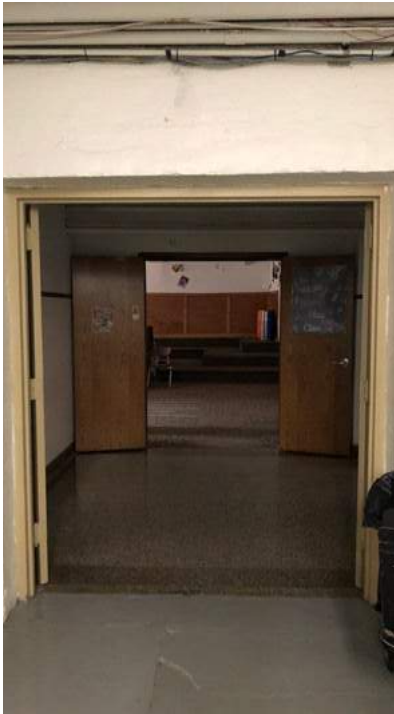
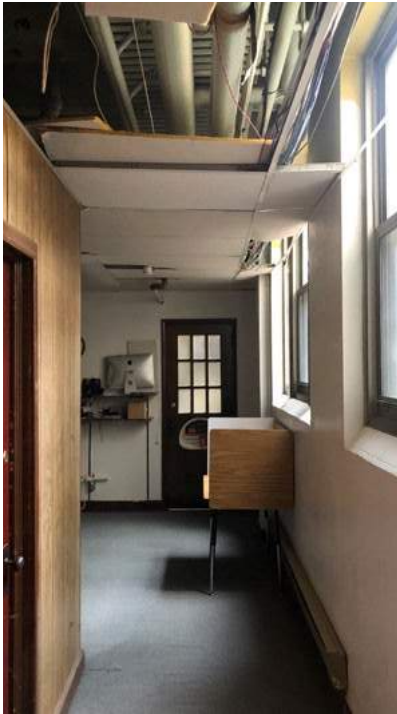
Basement lacks corridor direction, has dead end spaces and various intervening rooms.

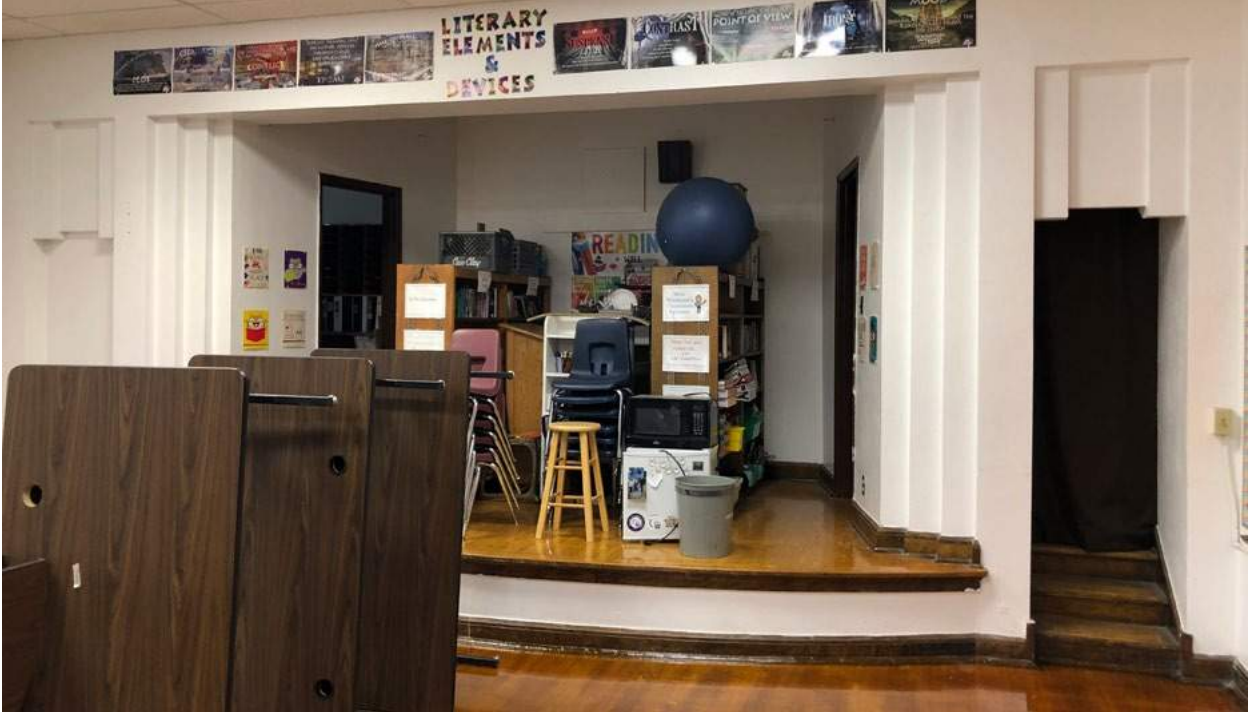
Stage in Room 214 is not handicap accessible.

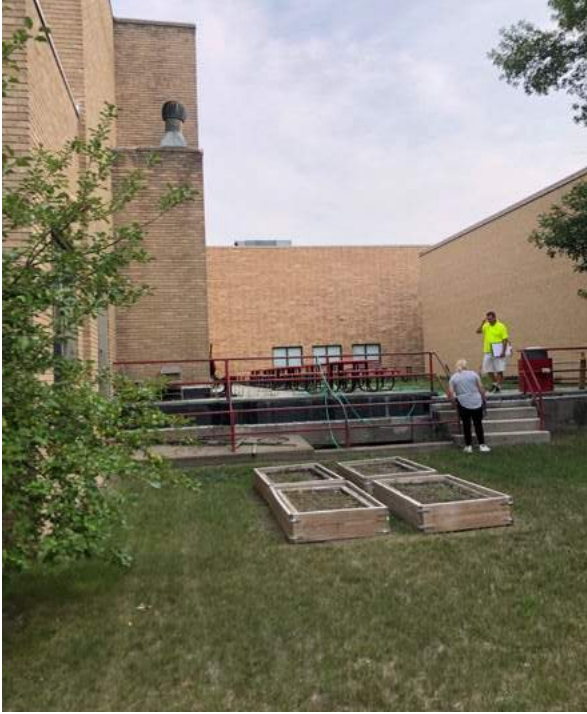
Handrails on steps in courtyard are not to code.

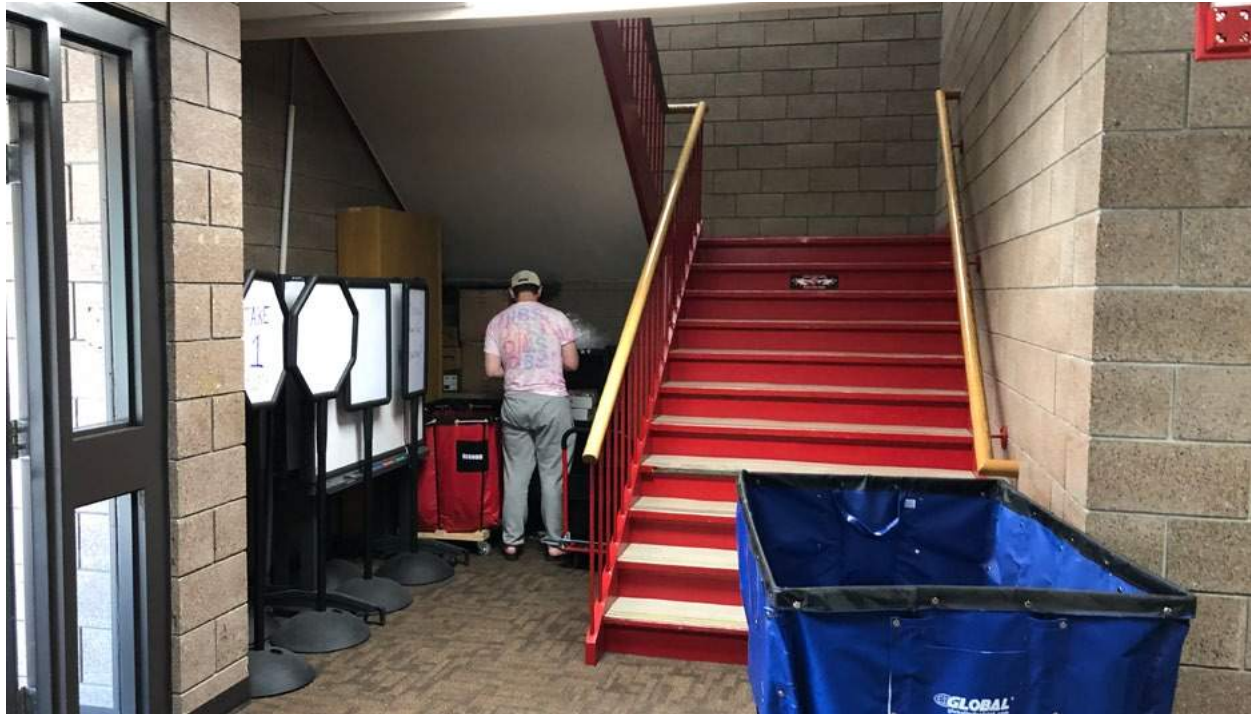
Storage being stored under staircase next to the Media Center.

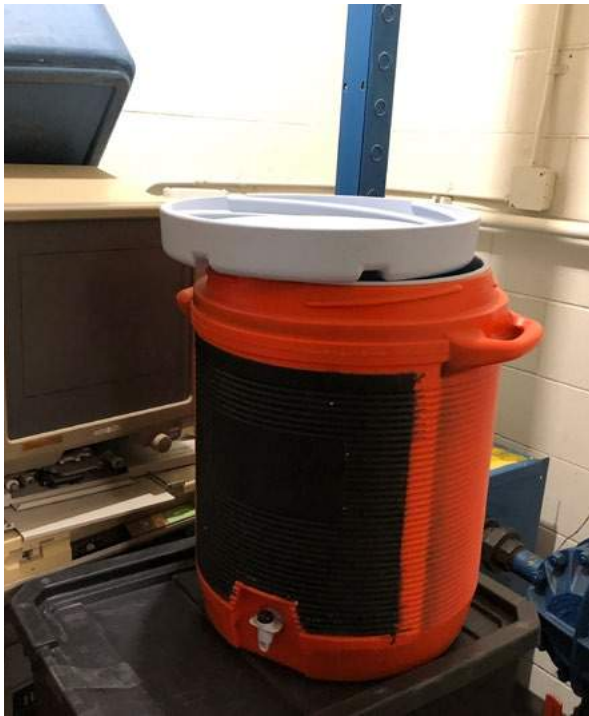
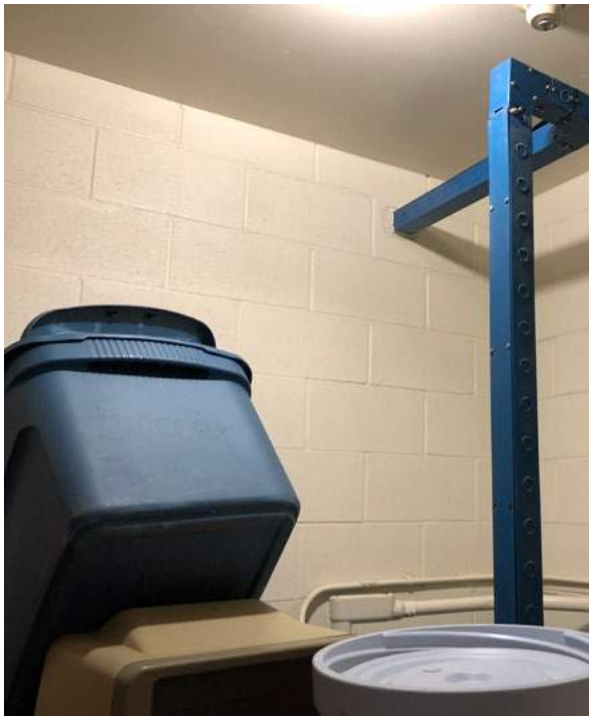
The elevator equipment room cannot be used for storage.

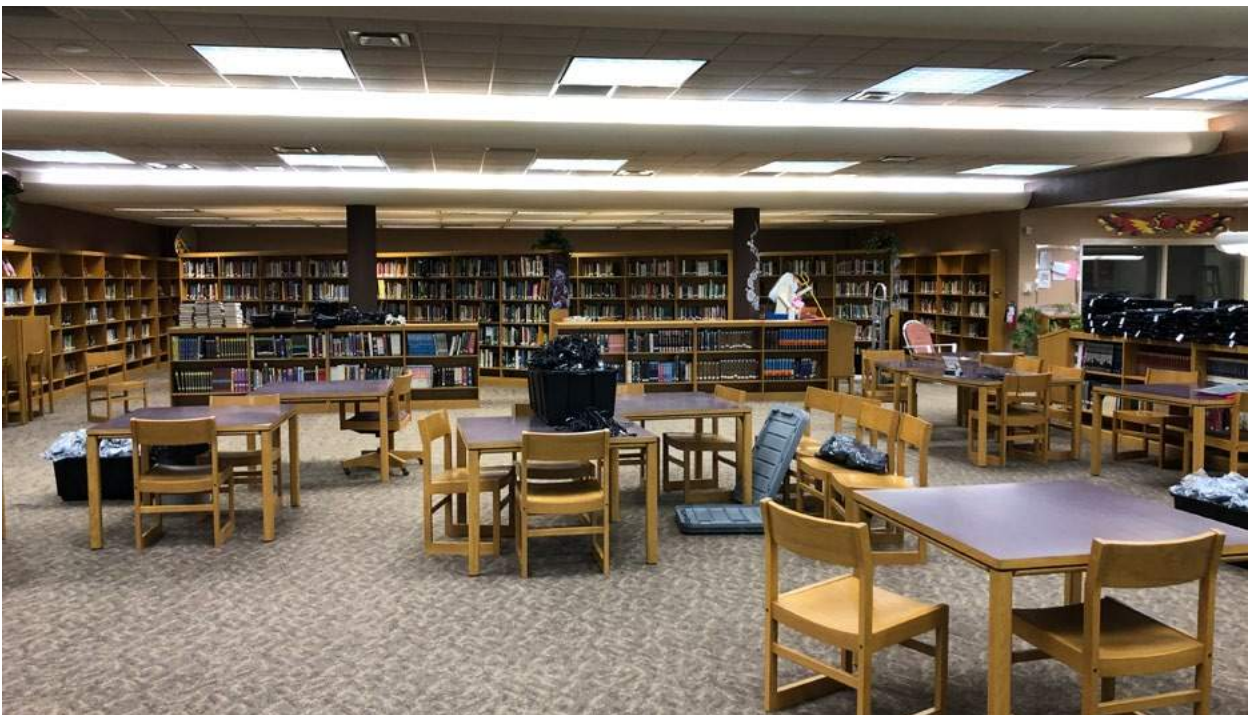
The Media Center could benefit from improved lounge furniture for students.

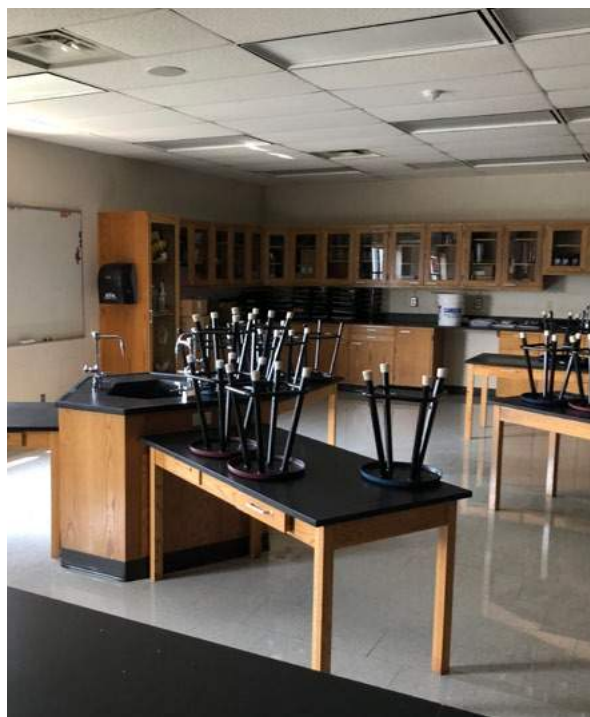
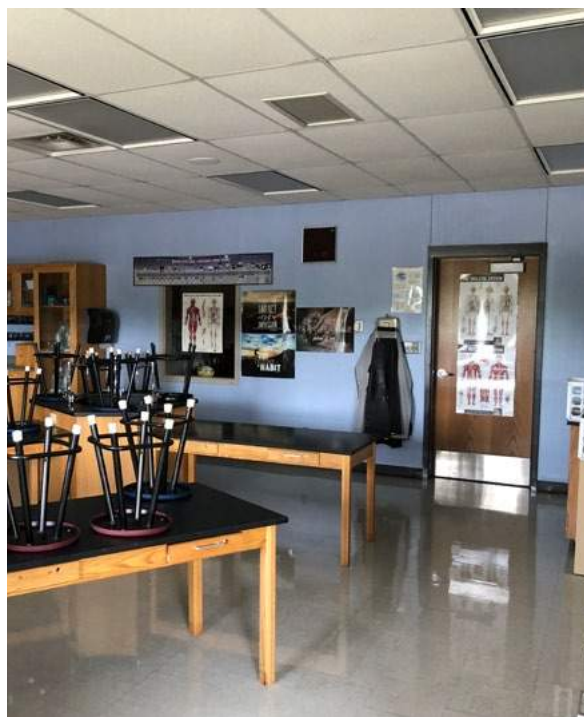
There is no emergency eye wash station or handicap accessible sink in Science Room 208.

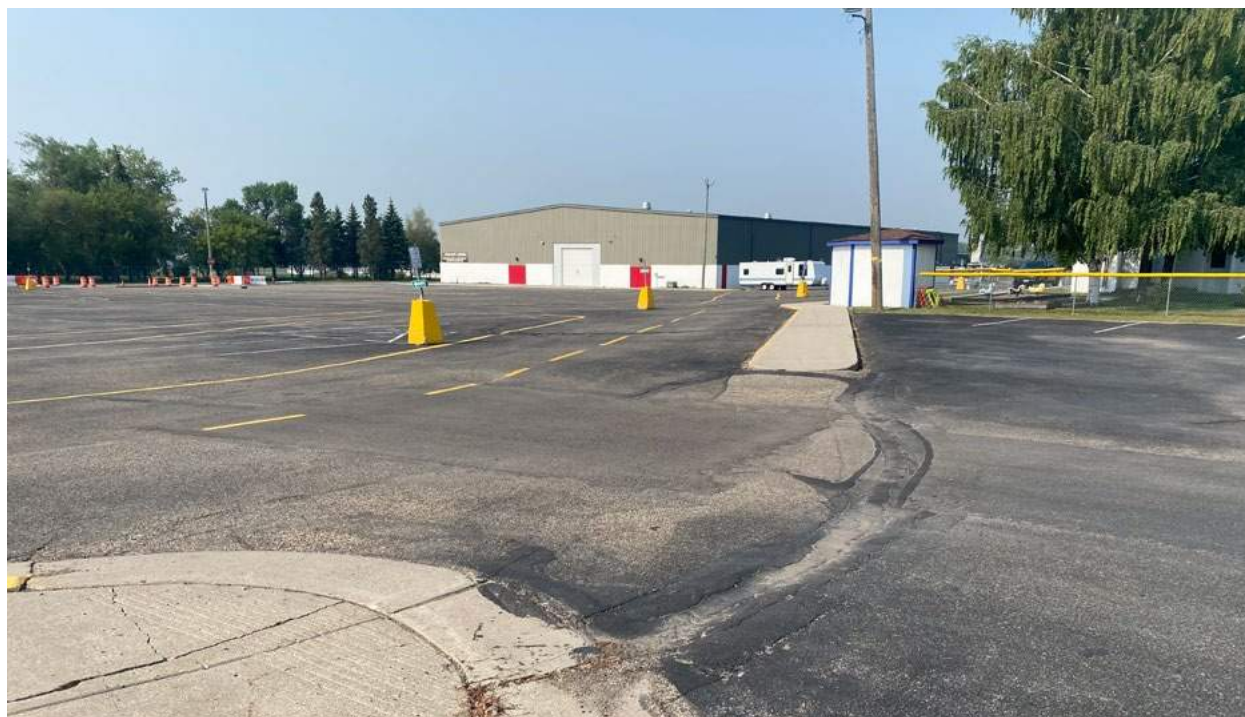
The sidewalk coming from LACTC is not handicap accessible.

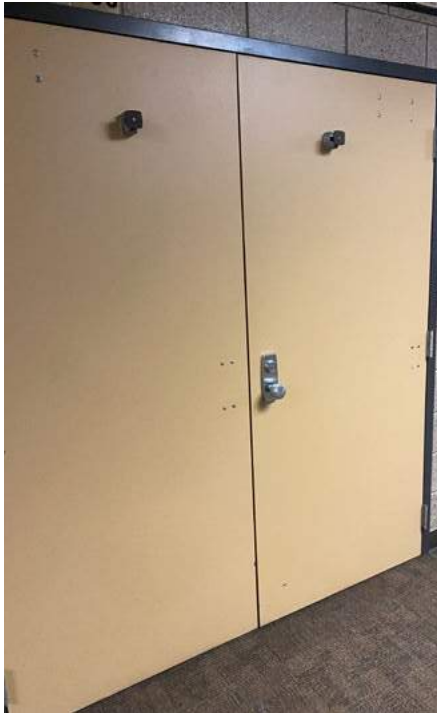
Certain doorknobs are not handicap accessible.

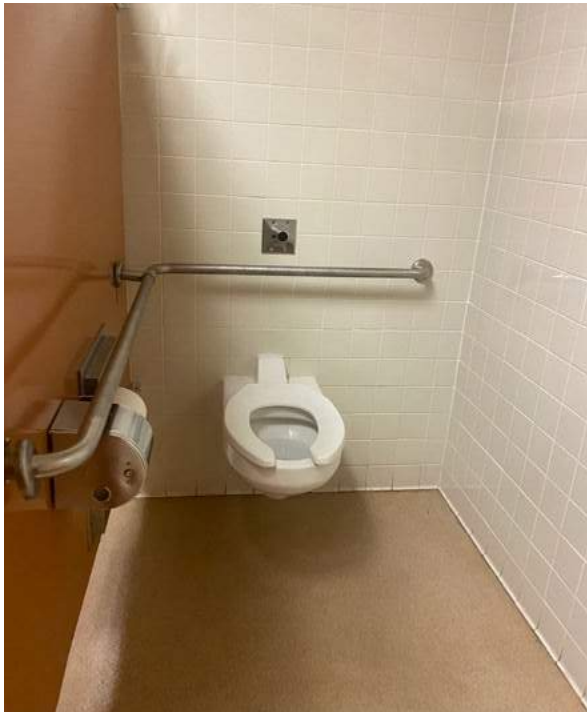
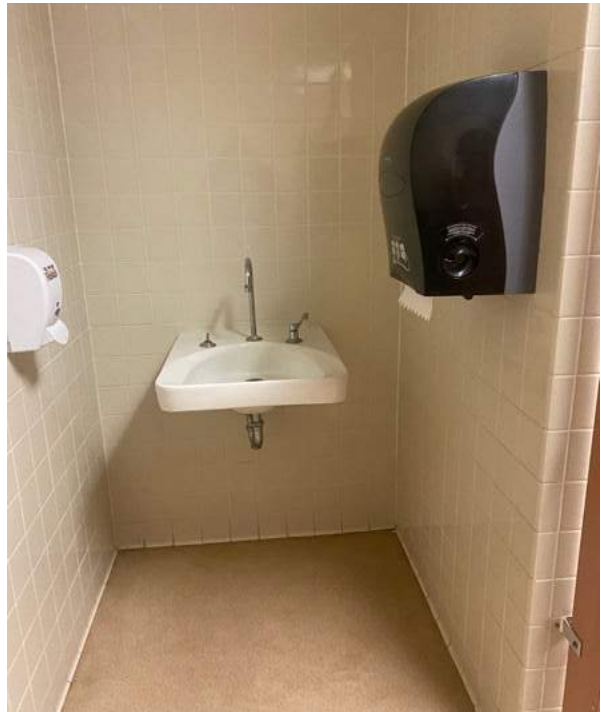
The ADA stall is not handicap accessible in the women's restroom due to grab bars, vertical bar, and stall width. The sinks in the women's restroom are not handicap accessible.

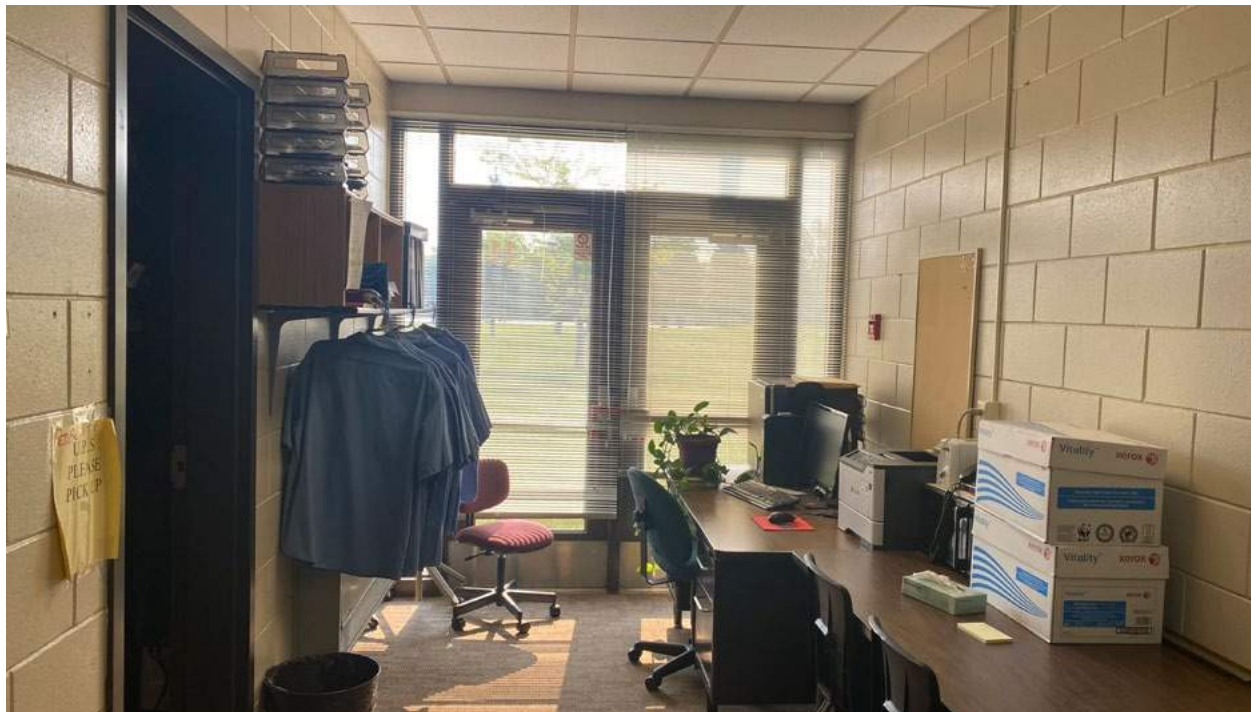
Southwest entrance is used as an office area.

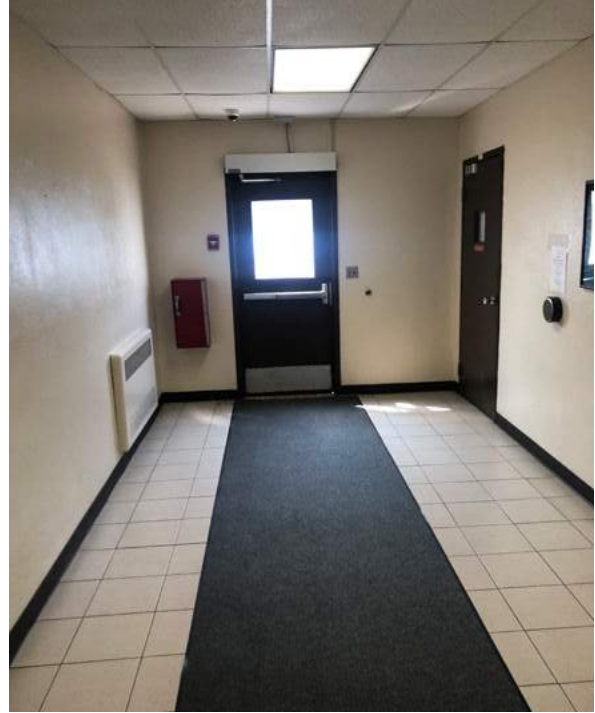
No vestibule at back door where students enter the building.

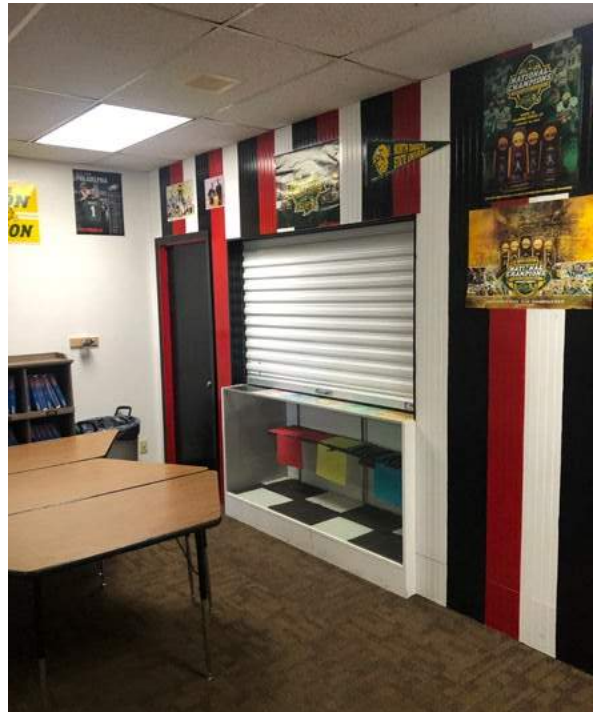
"Snack Shack" school store is only accessible through the Marketing classroom.

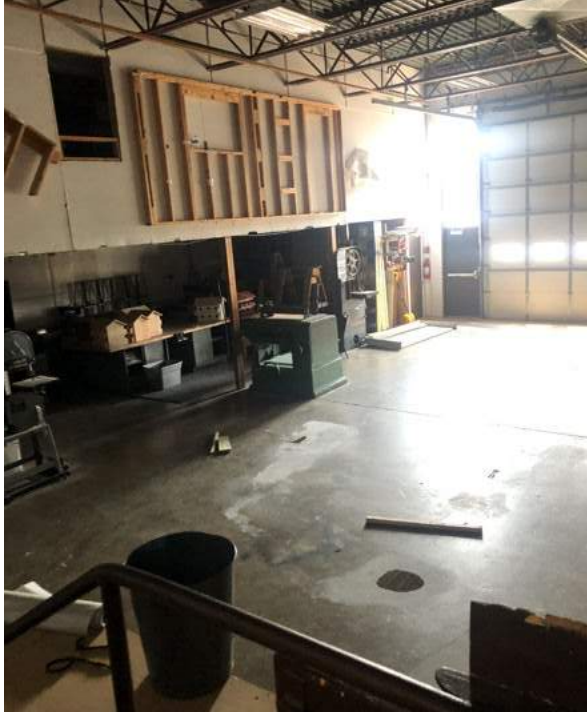
Mezzanine in construction technology area is not handicap accessible and is not to code because it is enclosed.

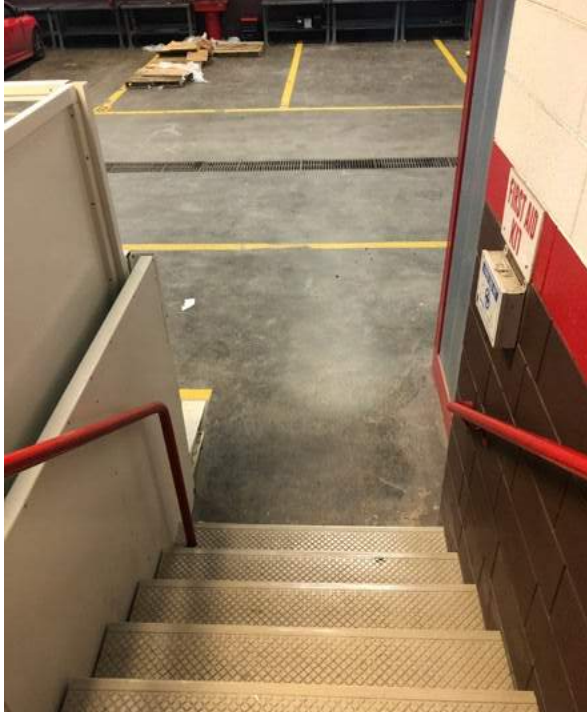
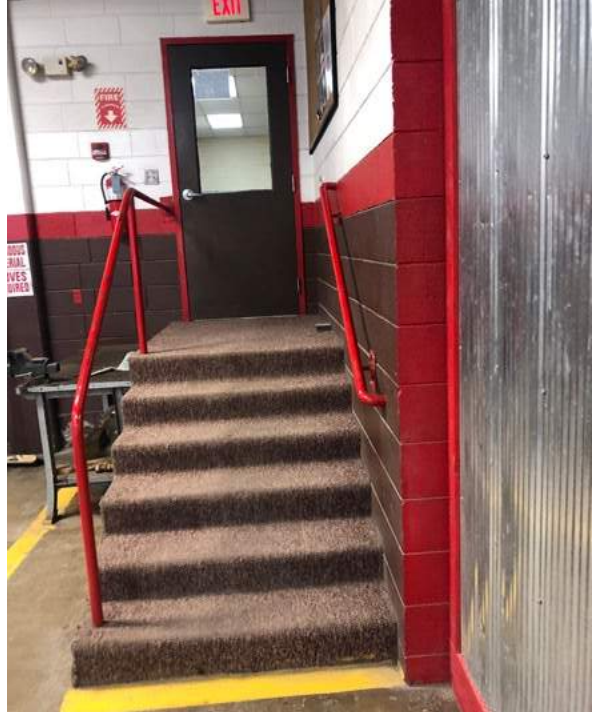
Hand and guard rails are not handicap accessible in automotive technology and construction trades classrooms.

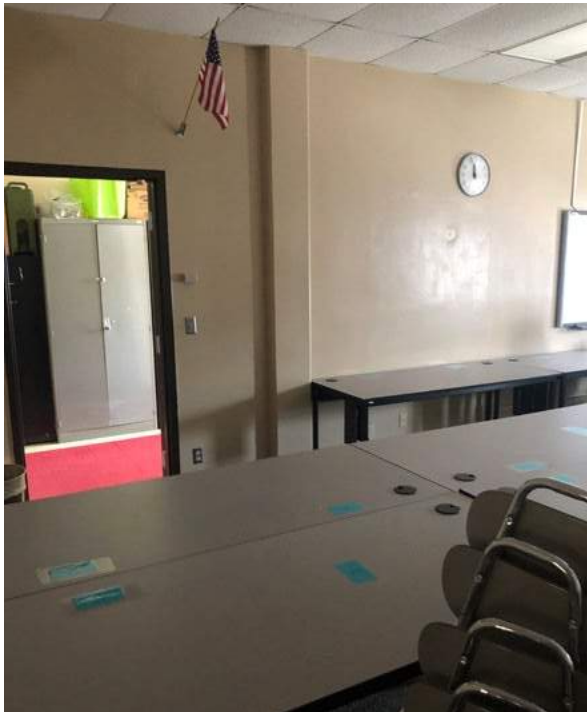
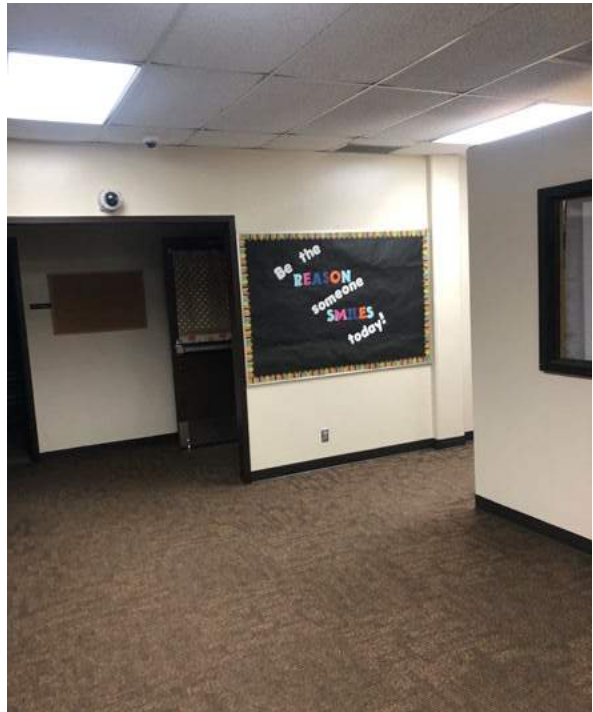
Ceiling tile is not in good shape.

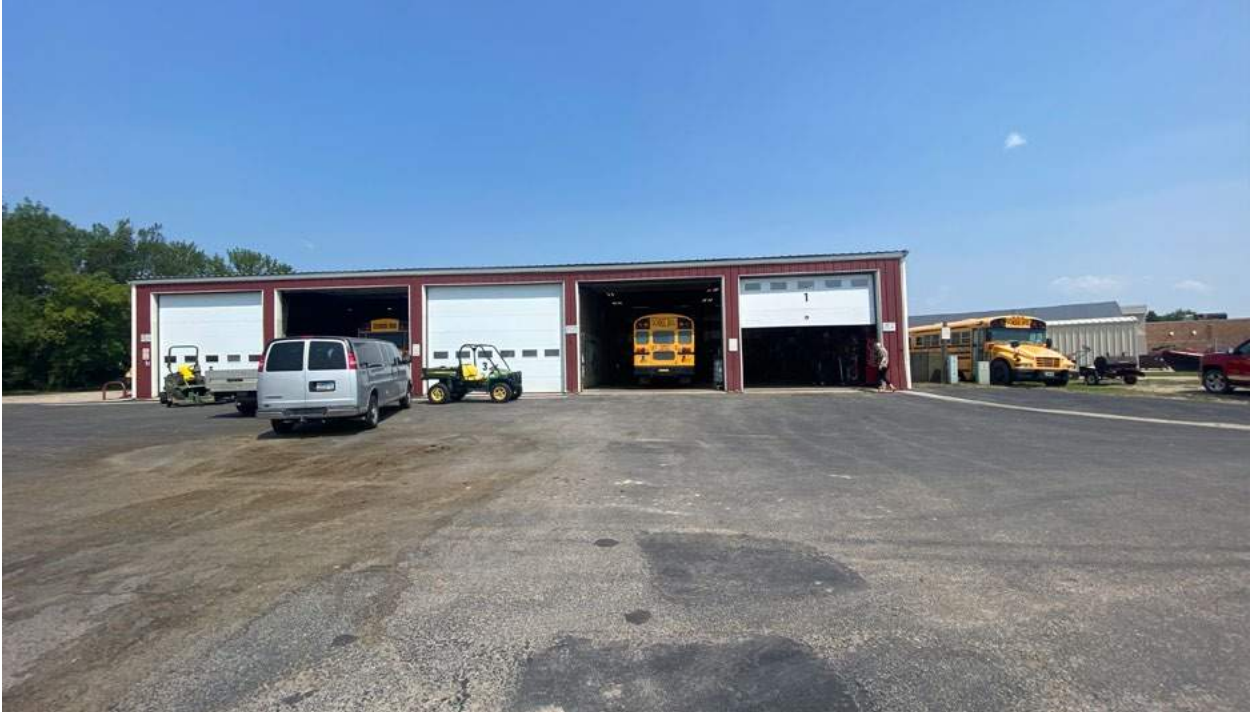
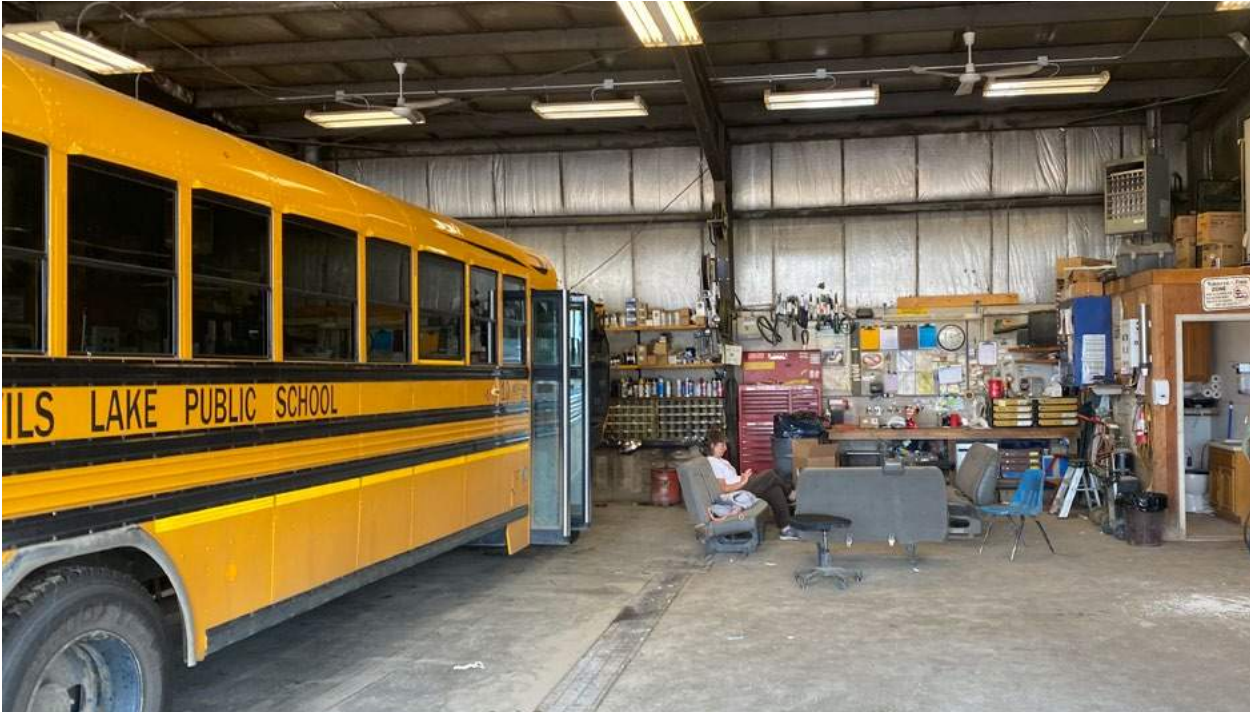
The exterior facade of the building is red and white metal panel, with corrugated metal roof. There are various dents and cracks in the metal panel that should be considered. The overall building is in decent condition. The exterior man doors lack hardware that does not require tight grasping or other special abilities to operate.
